HISTORIC BUILDING ASSESSMENT FOR MASONIC HALL

**29 OLD PORTLAND ROAD
FREEDOM, NH**

PREPARED BY: BETH MILLER, RA LEED AP, OF NORTH COUNTRY ARCHITECT

FINAL ISSUED 9/22/2025

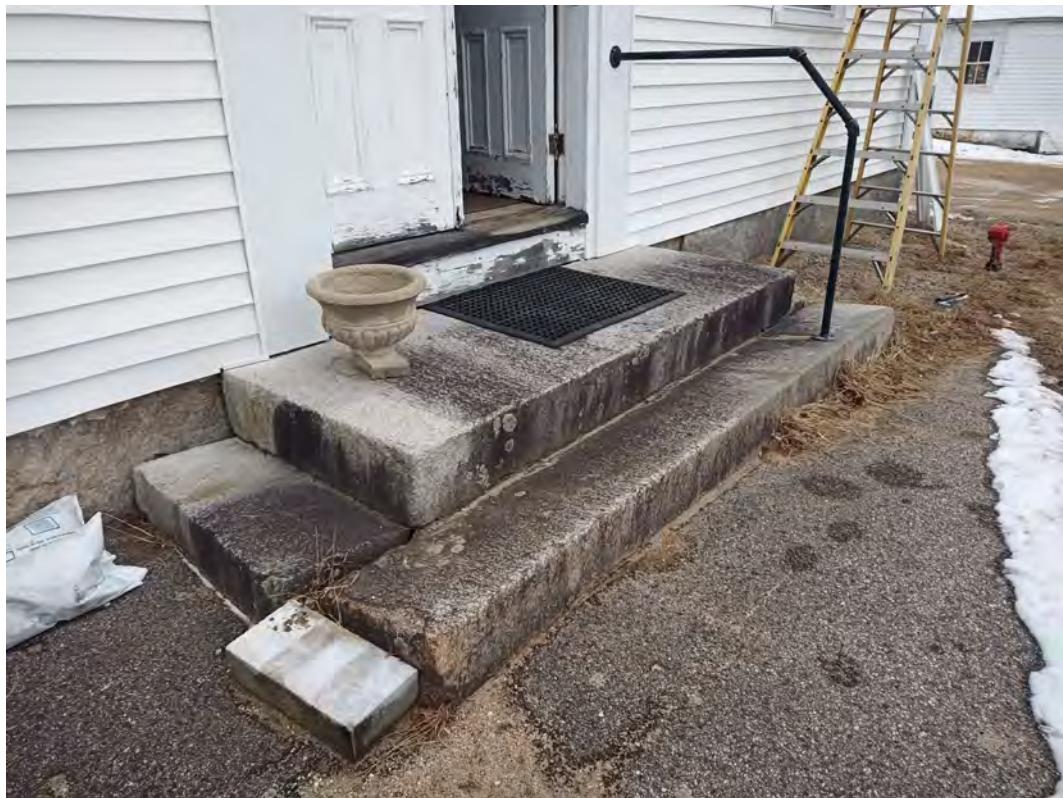
The Masonic Hall is sited atop the steep Schoolhouse Hill and the site appears to be generally well-graded away from the building with no signs of accumulated moisture observed. The exceptions are the front entry granite steps, which pitch back toward the building, and the seam where the wood accessibility ramp meets the building wall. The entry stones should be reset to be level, with slight pitch (1/8-1/4" per 1'-0") away from building to direct rainwater, and cleaned with a soft hose wash (<300psi), mild PH-neutral, non- ionic detergent, and scrubbed with a soft bristle brush. The parking lot asphalt will soon be due for a new tack coat, or the Town may consider re-paving the site after the upcoming major renovations are completed.

Figure 76: Stone entry steps have sunk with pitch toward building; Stones exhibit staining and biological growth due to moisture accumulation

Clean steps with a soft hose wash (<300psi), mild PH-neutral, non-ionic detergent, and scrub with a soft bristle brush. Always try a small test area first and select cleaners carefully, as chemicals may permanently stain.

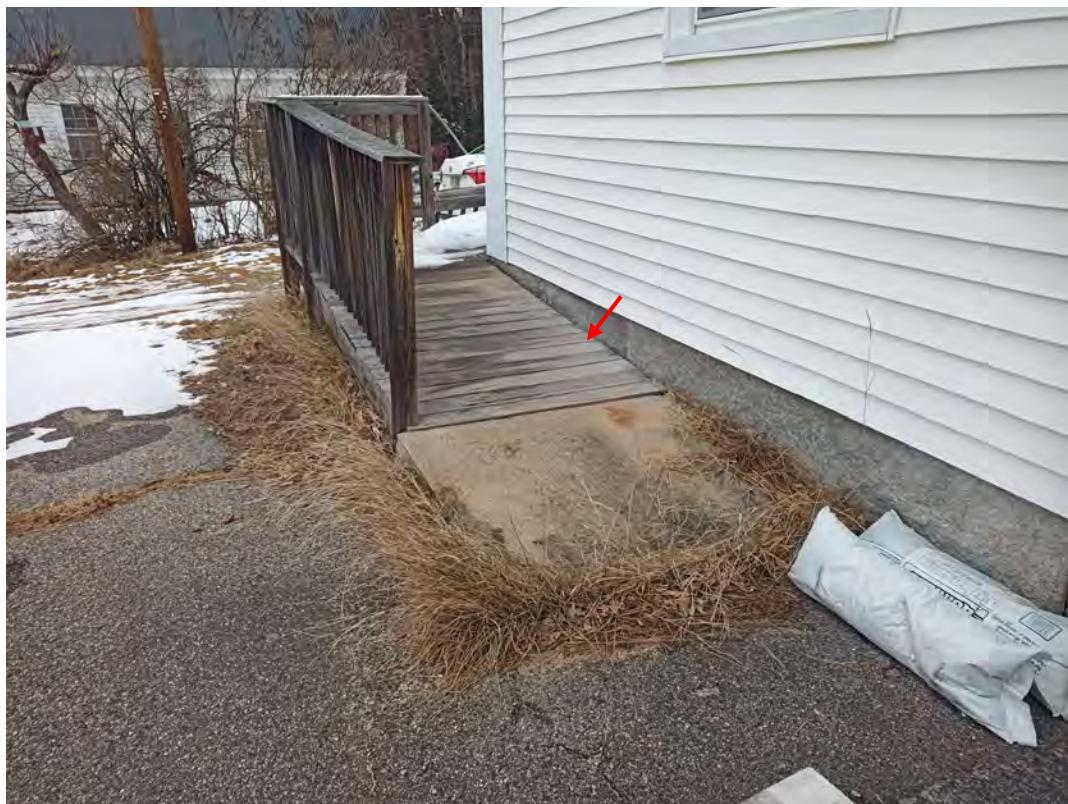
Figure 77: Accessible ramp butts up against building wall resulting in moisture accumulation along joint

The accessibility ramp is in poor condition and is due for replacement. The new ramp should be kept at least 1-foot off the building wall and should be set atop a gravel (crushed stone) pad of generous size to allow for better stormwater drainage and prevent weed growth around perimeter. This will protect both the building and the ramp. Reorienting or relocating the ramp in entirety should be considered to avoid continued damage from roof snow runoff.

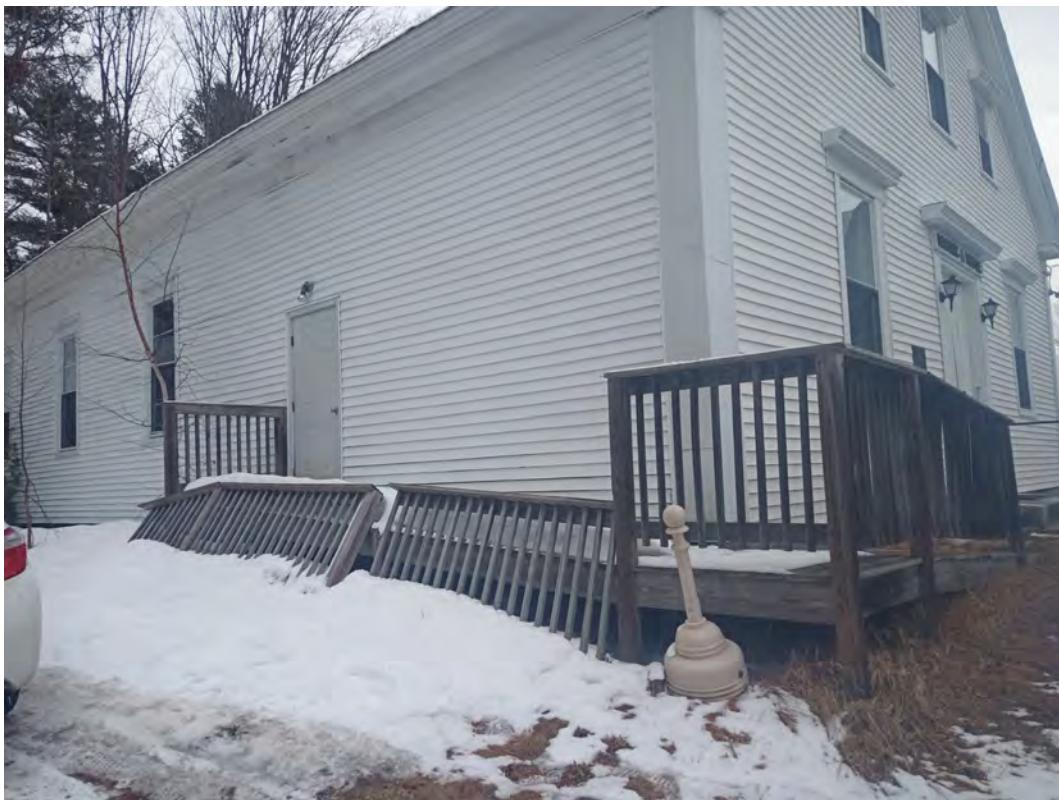
Figure 78: Ramp railing blown off due to snow sliding off roof

New ramp should be held at least 1-foot off of building and set atop a pad of crushed stone to allow drainage and prevent plant growth. Snow fences and/or an awning roof should be installed above to prevent damage from snow melt. Alternatively the ramp could be set further off the building to remove the issue of roof snow slide damage.

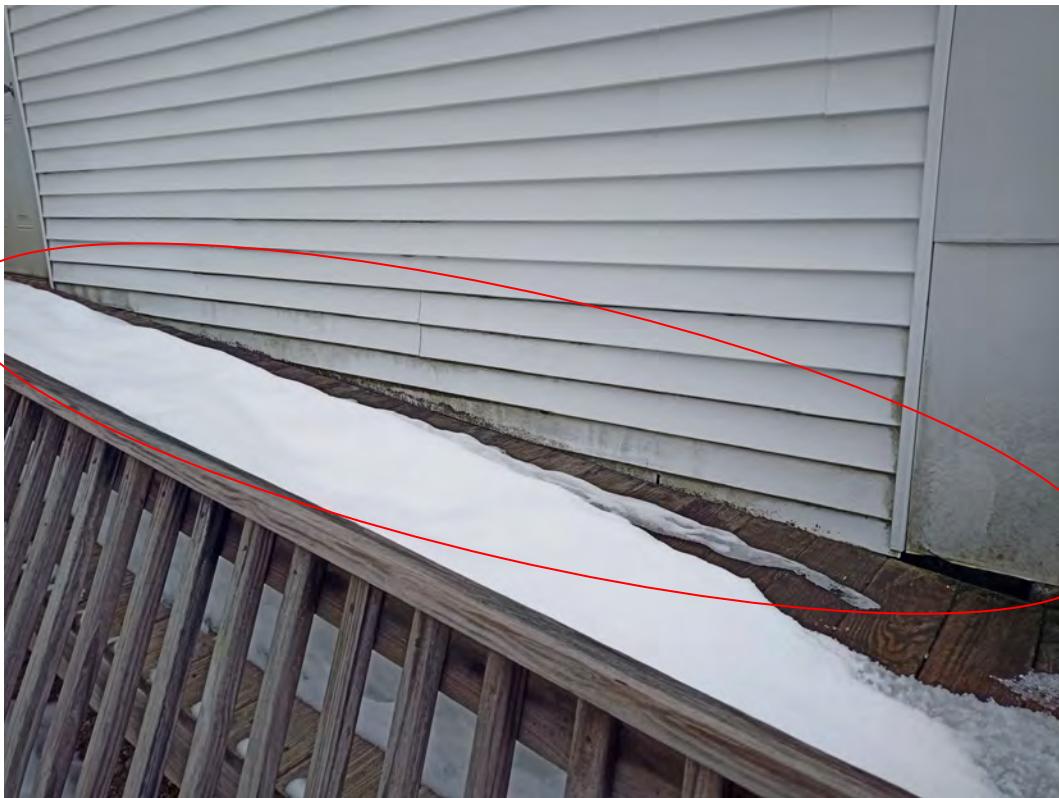
Figure 79: Accessible ramp butts up against building wall resulting in moisture accumulation, note staining

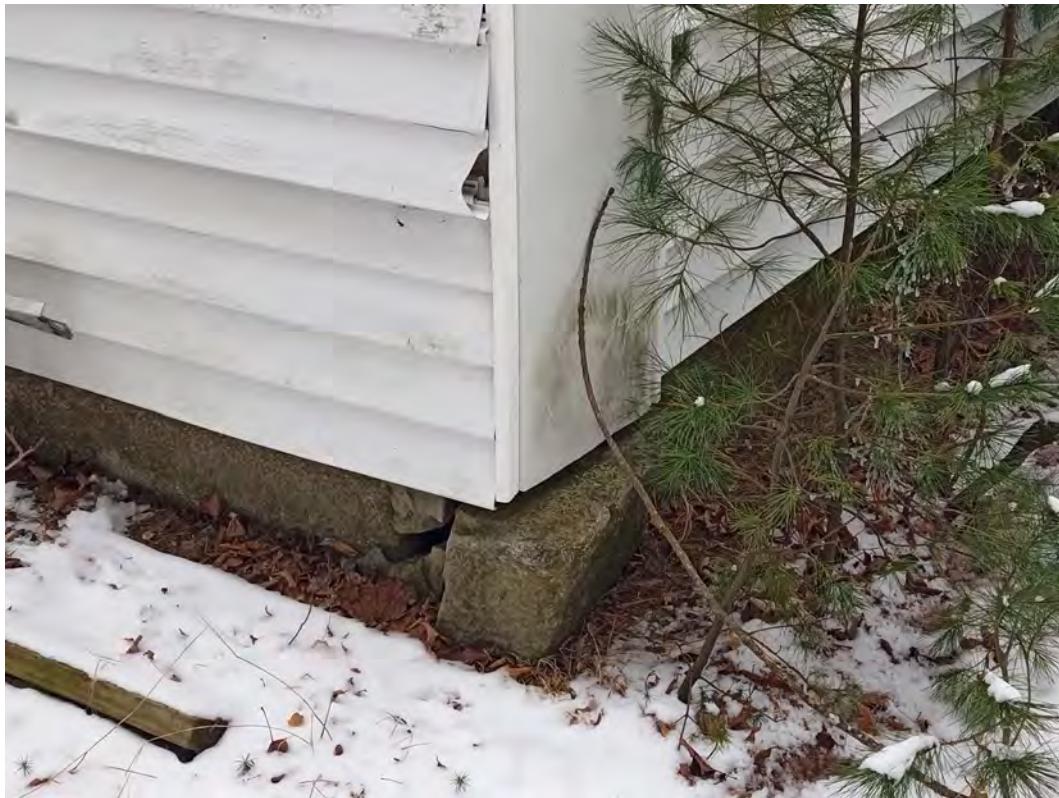
The building has no basement but a crawl-space of about 18" in height. The perimeter split-granite stones are displaced throughout and some are cracked. The first- floor framing beams are set on dry-laid stone and joists are reinforced with wood posts. Joists were reportedly recently treated for powder post beetles. The first floor has significant rolls toward the rear of the building. When work is next undertaken, posts propping joists should be checked, installed more uniformly, and supplemented. The crawlspace should be cleared of debris, wood posts repaired and reset as needed. All split granite perimeter stones should be reset to be vertical with full bearing of sill beams.

Figure 80: Displacement and cracking at split-granite stones, typical

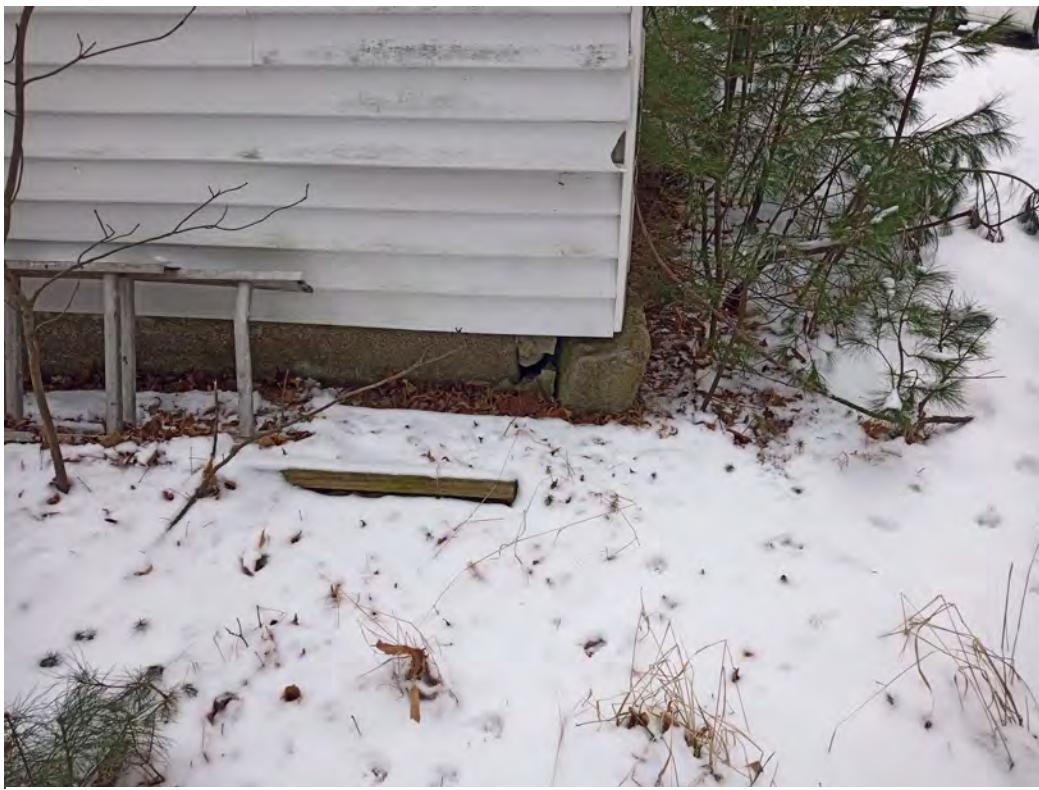
Figure 81: Displacement and cracking at split-granite stones, typical

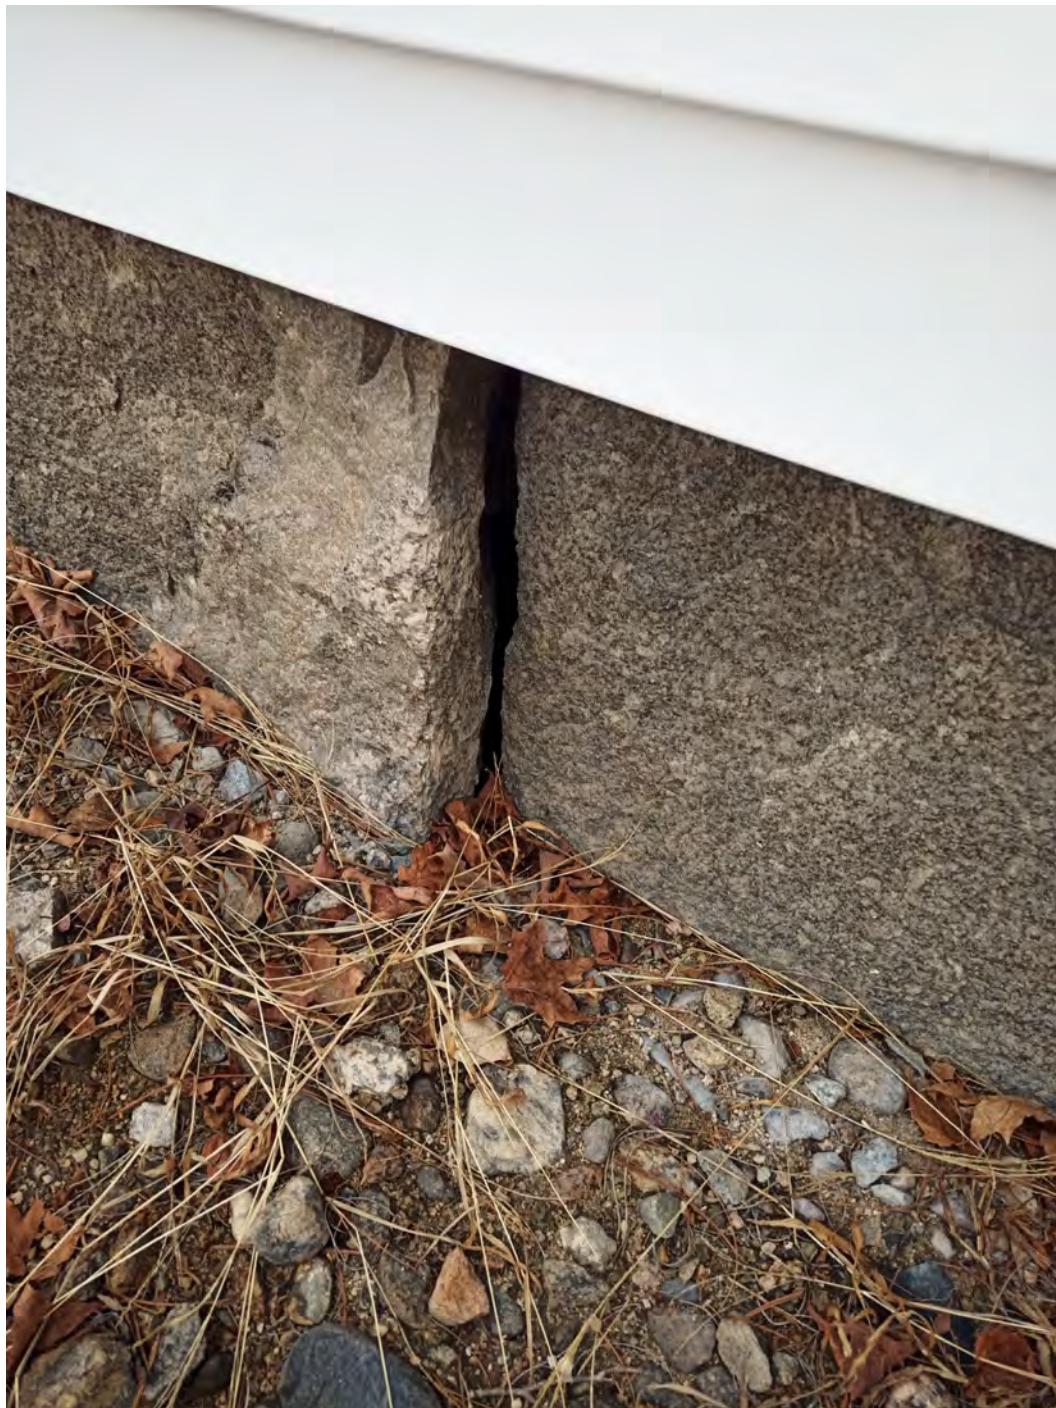
Figure 82: Displacement at split-granite stones, typical

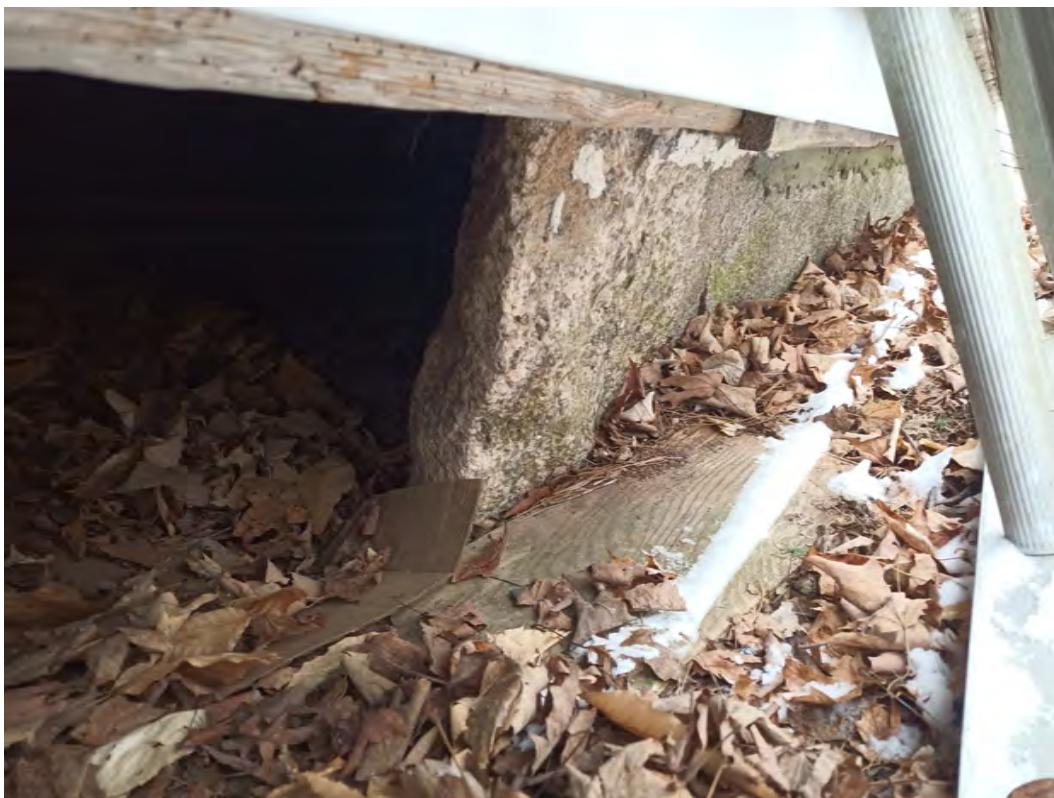
Figure 83: Displacement and cracking at split-granite stones, typical

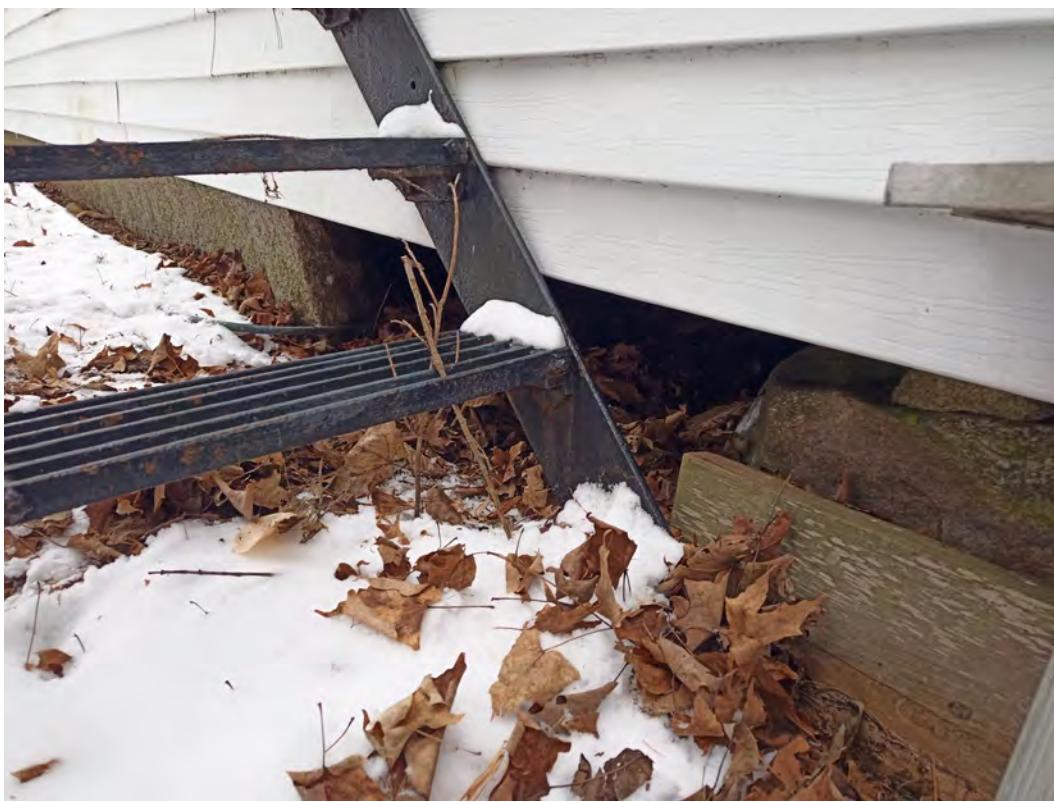
Figure 84: Displacement and cracking at split-granite stones, typical

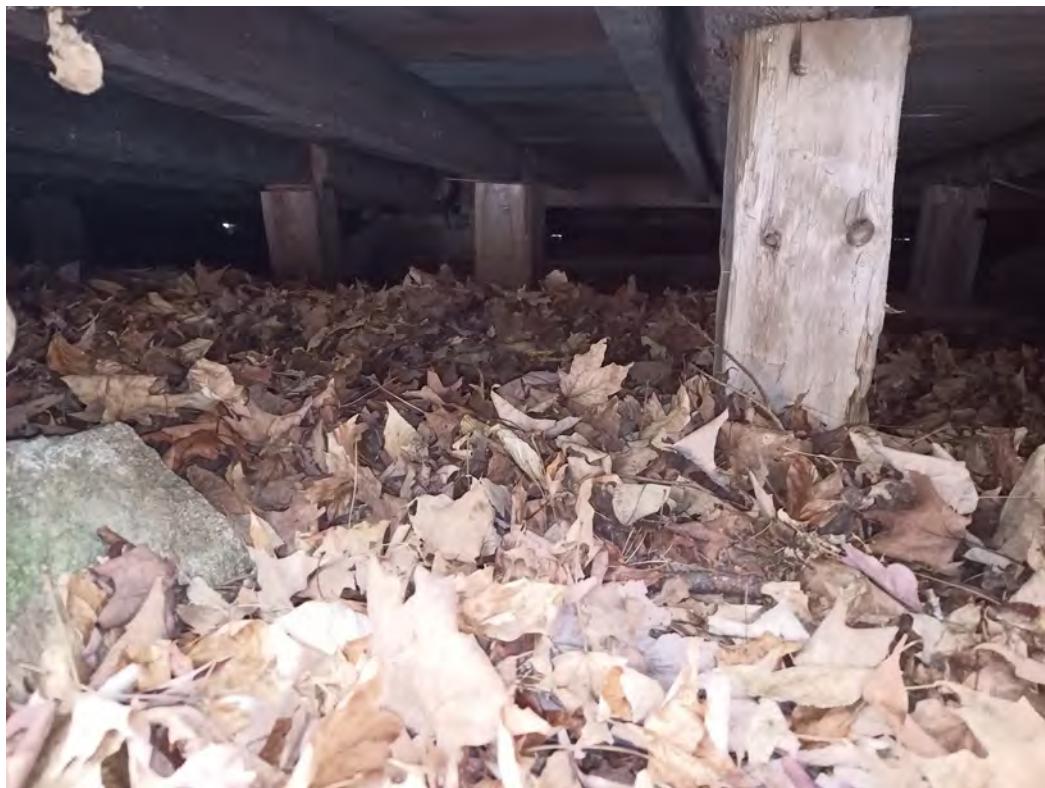
Figure 85: Debris accumulation in crawlspace. First-floor beams supported on dry-laid stone, joists reinforced with wood posts throughout. Check and supplement posts regularly, and as needed.

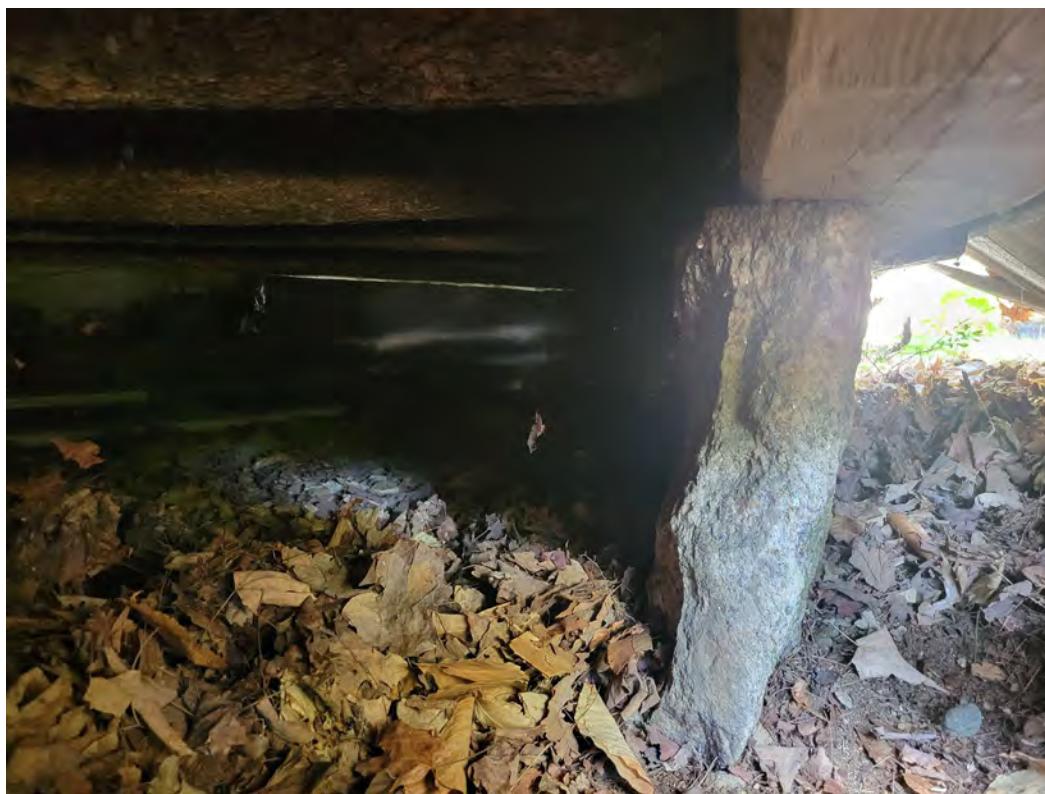
Figure 86: Split granite stone – Reset for full bearing

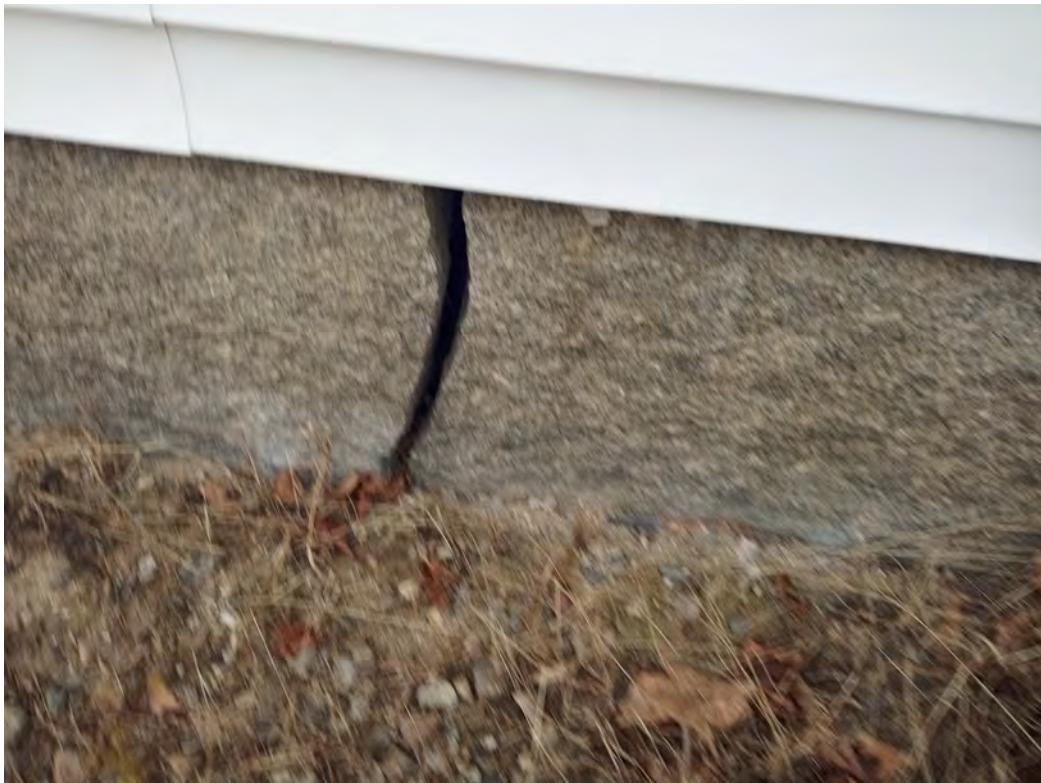
Figure 87: Cracking through split-granite foundation stone

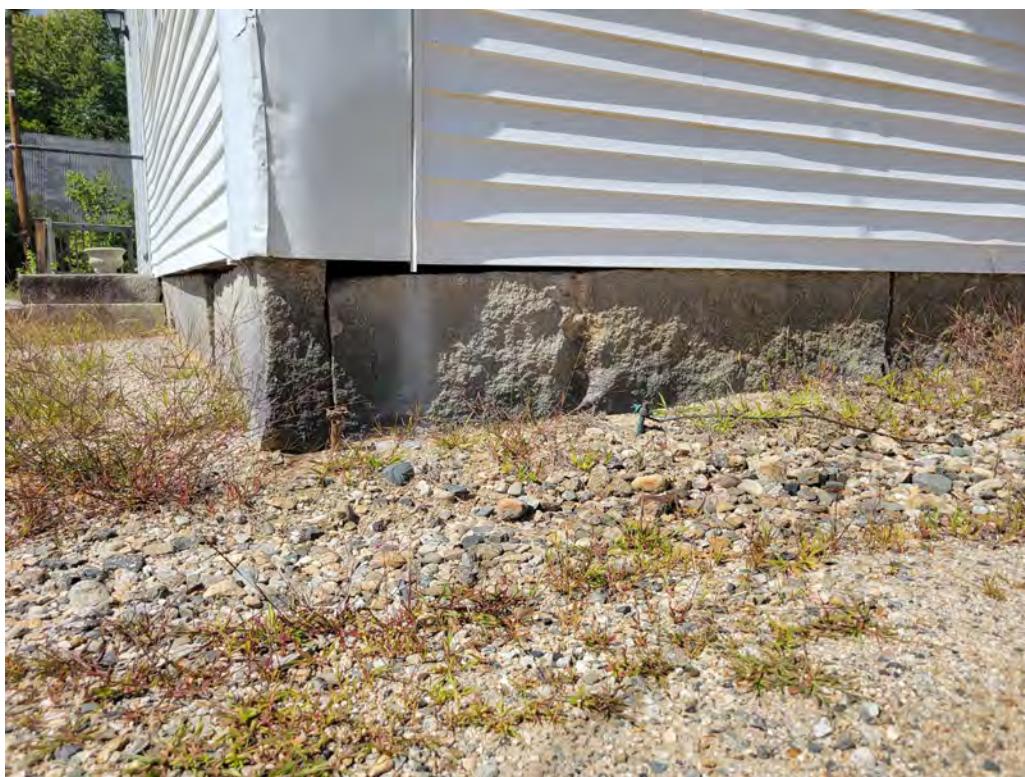
Figure 88: Displacement and cracking at split-granite stones, typical

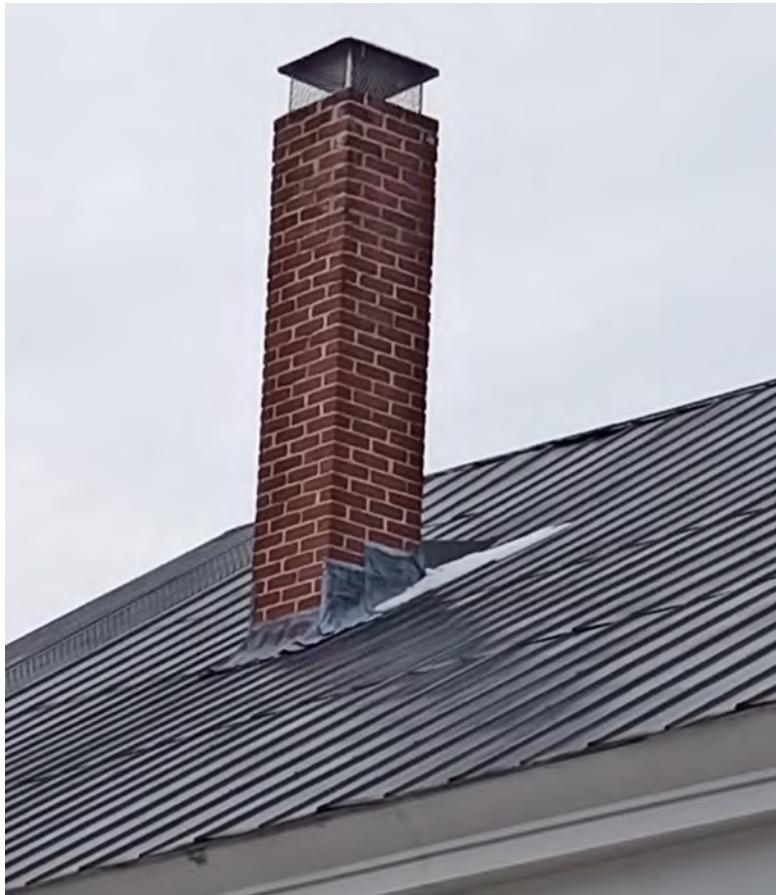
Figure 94: Chimney and step flashing

The chimney flashing is relatively new, installed to address leaks the result of which are still evident in bubbled, peeled interior paint and staining at interior finishes. The flashing appears well-installed and intact. Chimney brick masonry and mortar joints appear in good condition and intact, as does the vent cap.

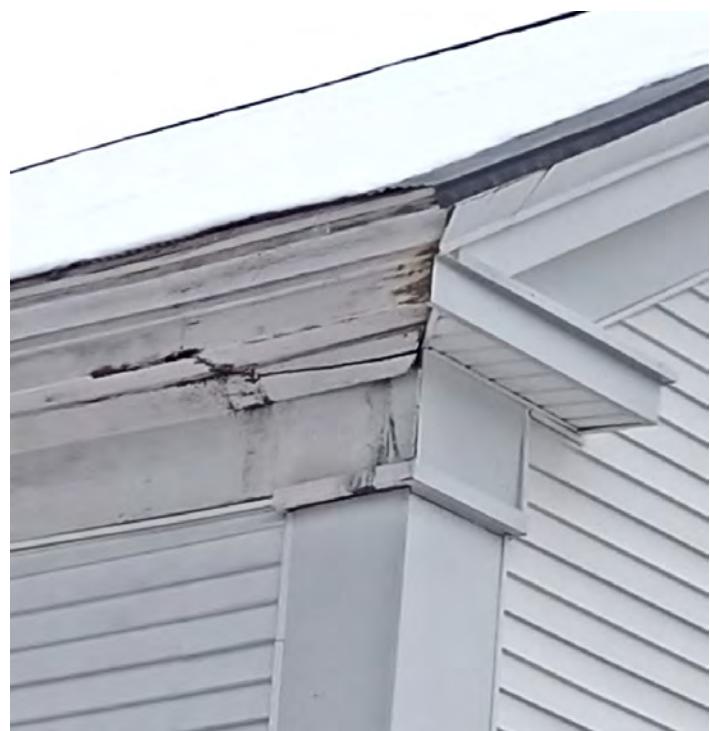
Figure 102: Intact wood cornice / eave trim; Cracking and worn paint observed, typical.

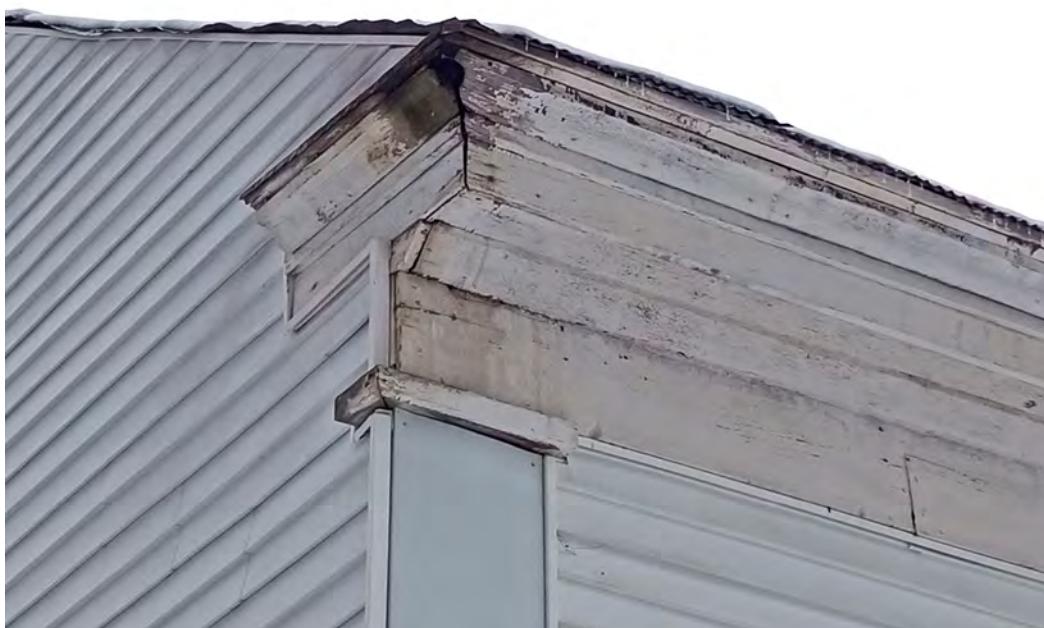
Figure 103: Intact wood cornice / eave trim; Cracking, material loss (hole likely due to squirrel entry), and worn paint observed, typical.

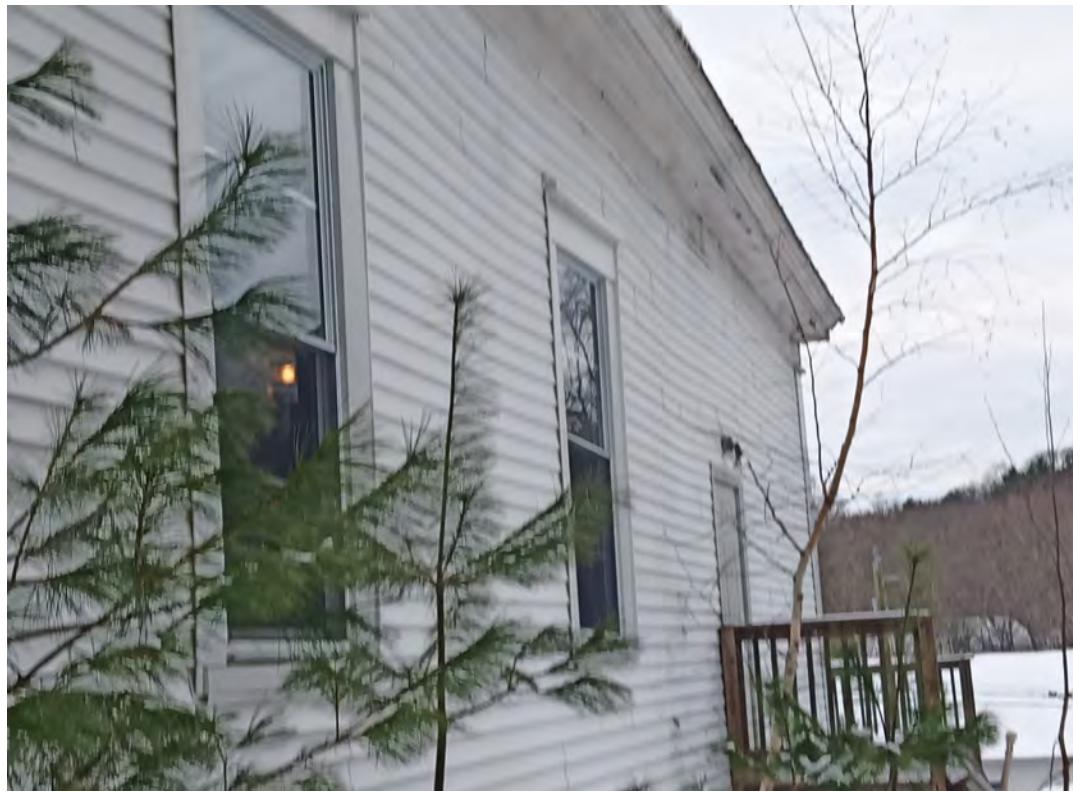
Figure 105: West façade vinyl-covered clapboards exhibit waving. Upon removal of vinyl, portions of clapboards may need to be resecured to framing. Remove tree growth at building perimeter.

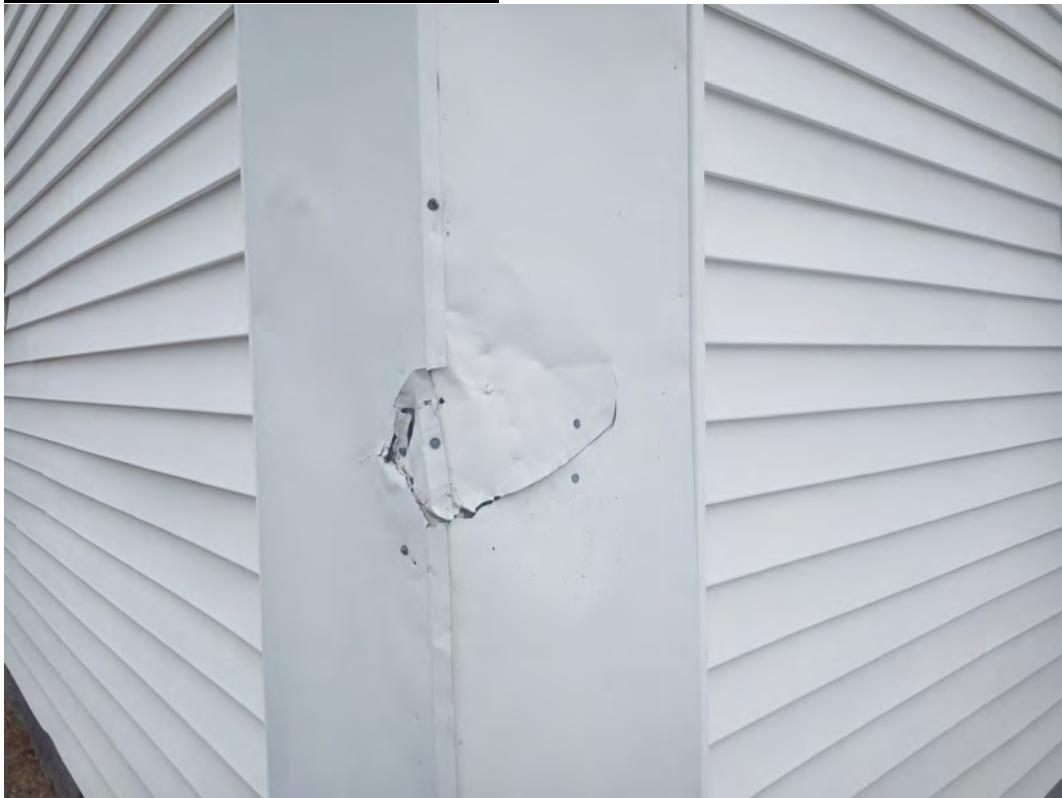
Figure 106: Damage at southeast vinyl corner trim

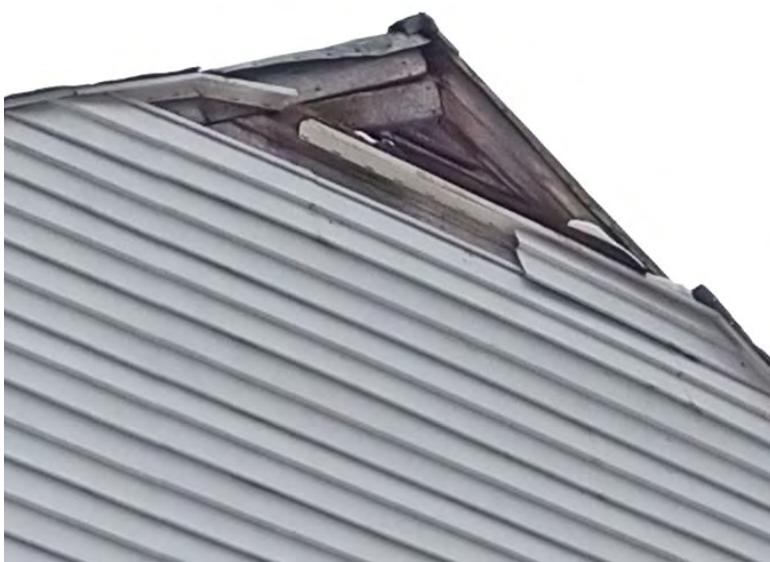
Figure 107: Missing vinyl siding, large opening at rear (north) attic ridge

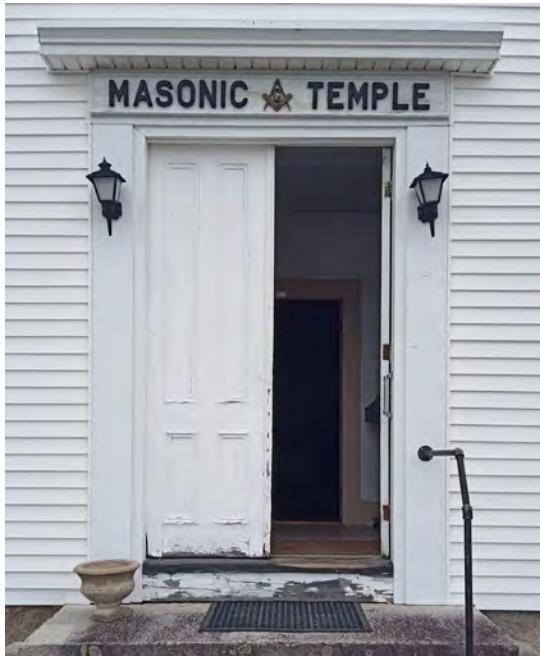
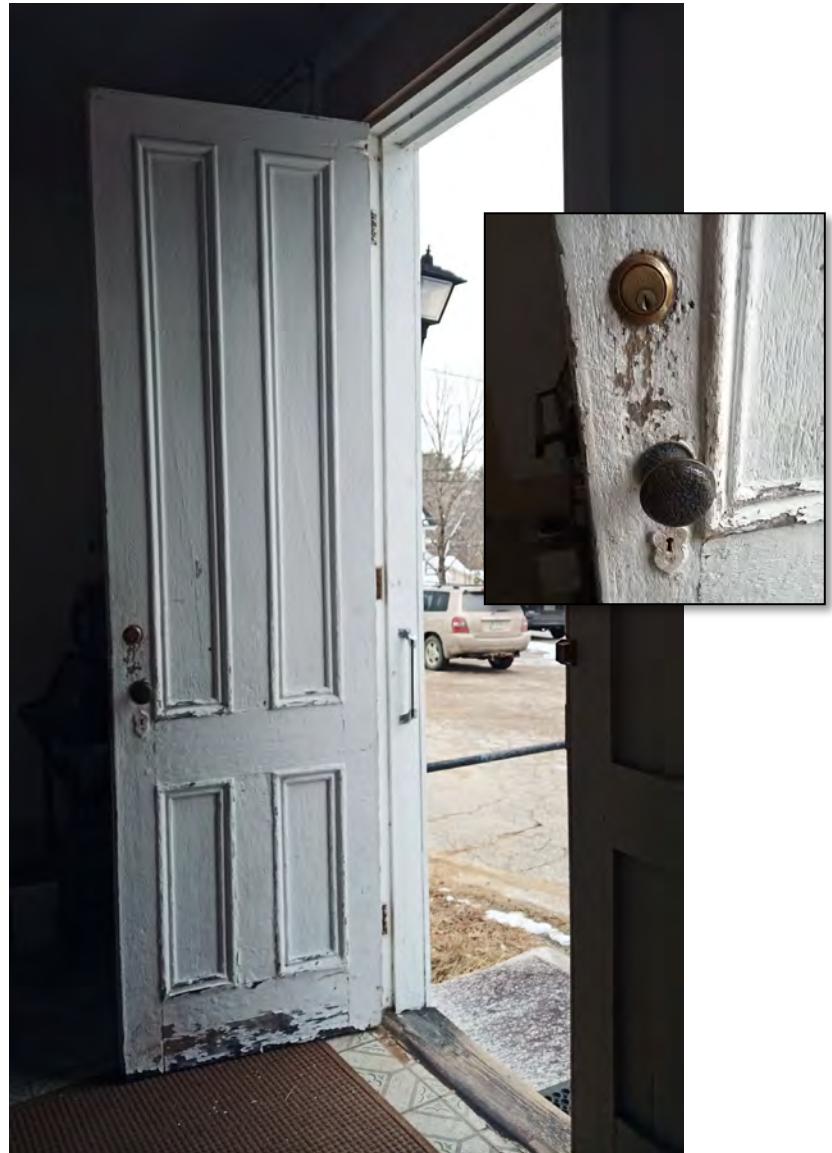
Figure 113: Front entry door – Paint loss and wood loss throughout, most severe at bottom rail. Sill and fascia also exhibit severe wear and deterioration. Restoration of all elements is recommended.

The four-panel front entry doors, reportedly original to the 1830 Church, but certainly dating to the 1926 Masonic Lodge, should be restored in full by a qualified restoration specialist including leafs, frame, sill, sill fascia, and all hardware. The front doors currently swing in. It is recommended to re-hang the restored doors with an outswing for improved egress safety.

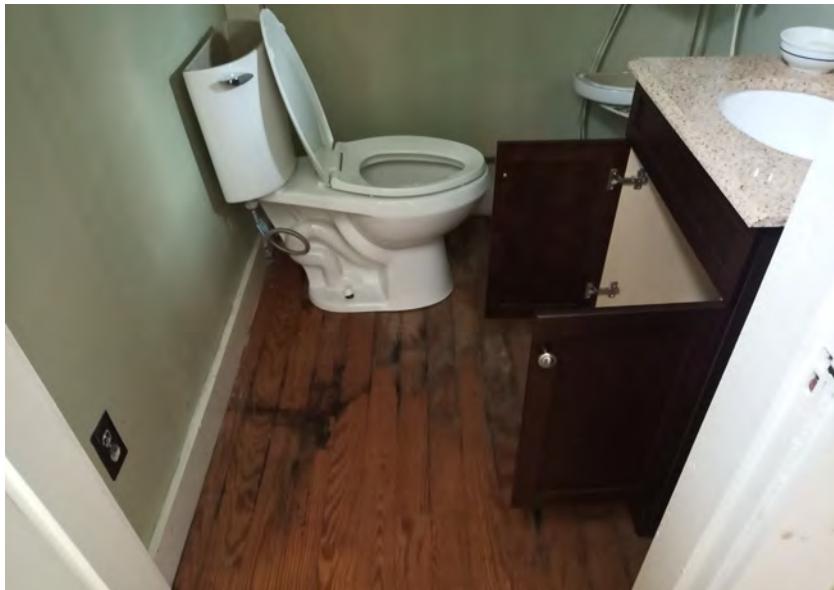
Figure 117: Northeast bathroom – Staining and floor damage

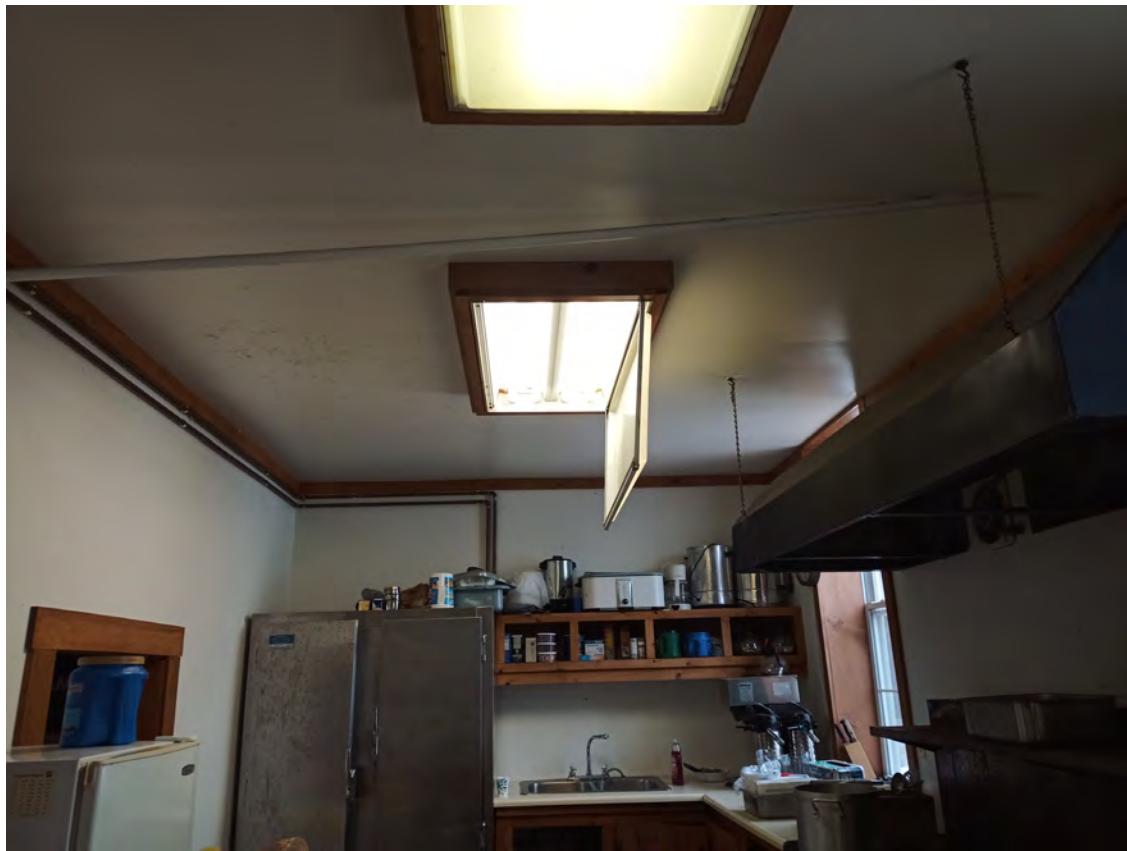
Figure 119: Fluorescent lighting and loose light cover (unsafe) in kitchen

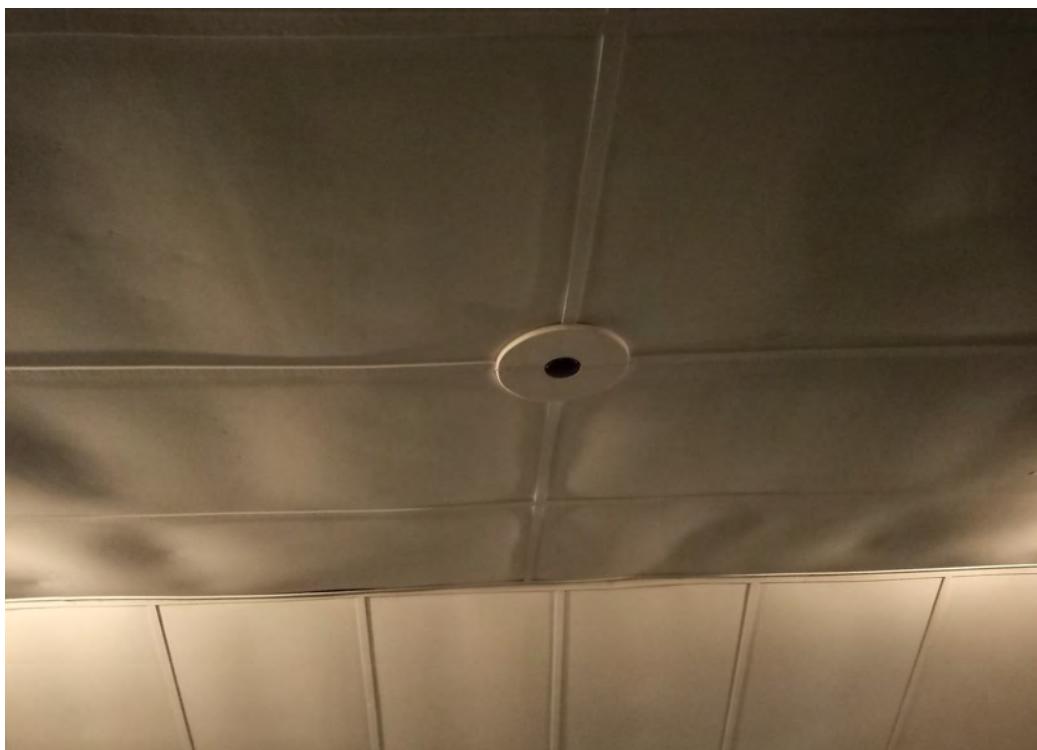
Figure 120: Cupping and bubbling at second floor ceiling, possibly due to moisture or water infiltration

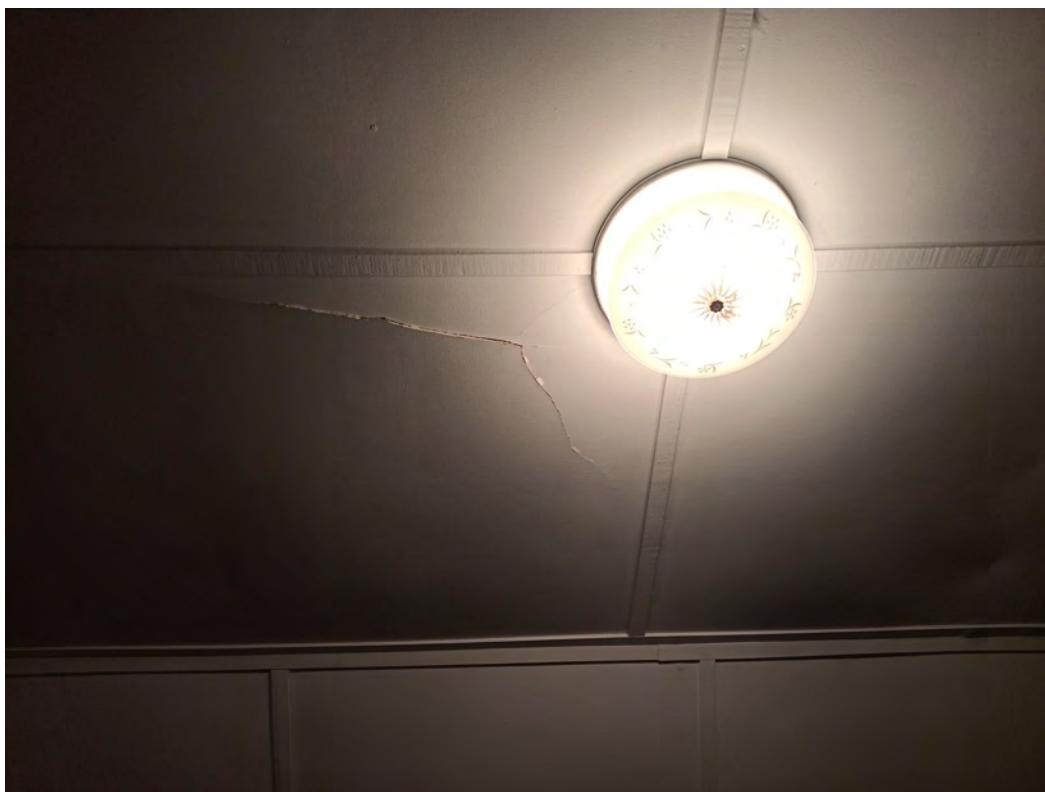
Figure 121: Cracked second floor ceiling finishes

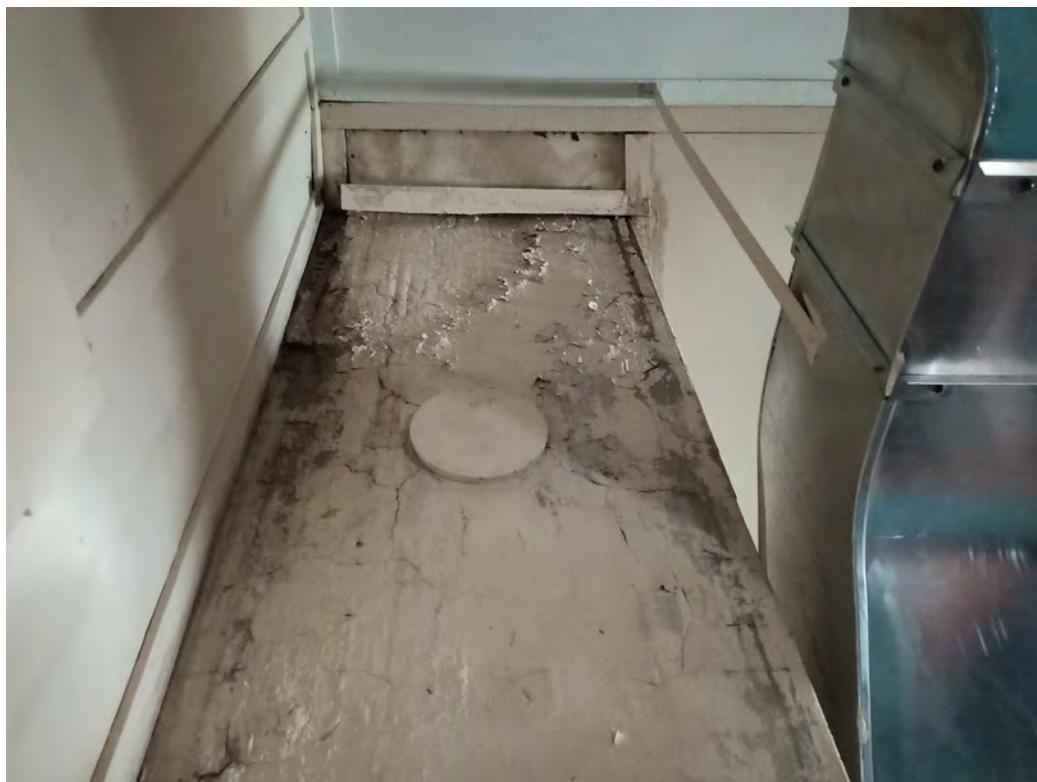
Figure 122: Severe cracked, peeling, bubbling paint due to water infiltration at southeast chimney

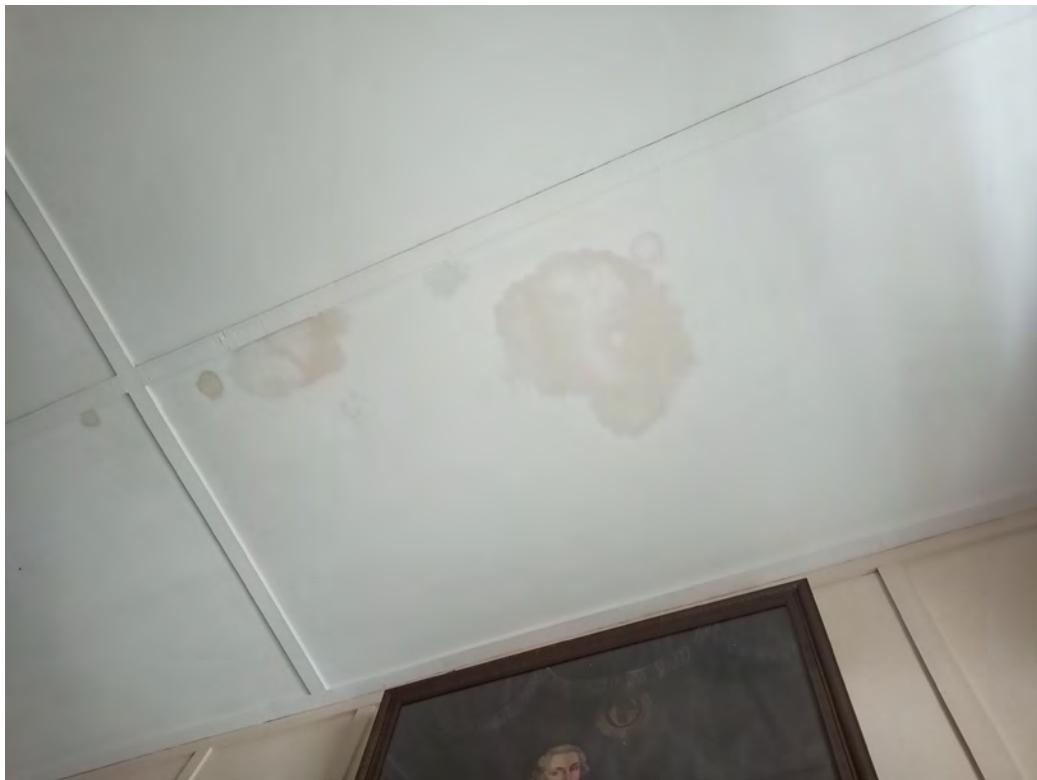
Figure 123: Staining due to water infiltration at second floor ceiling
