HISTORIC BUILDING ASSESSMENT FOR MASONIC HALL

**29 OLD PORTLAND ROAD
FREEDOM, NH**

PREPARED BY: BETH MILLER, RA LEED AP, OF NORTH COUNTRY ARCHITECT

FINAL ISSUED 9/22/2025

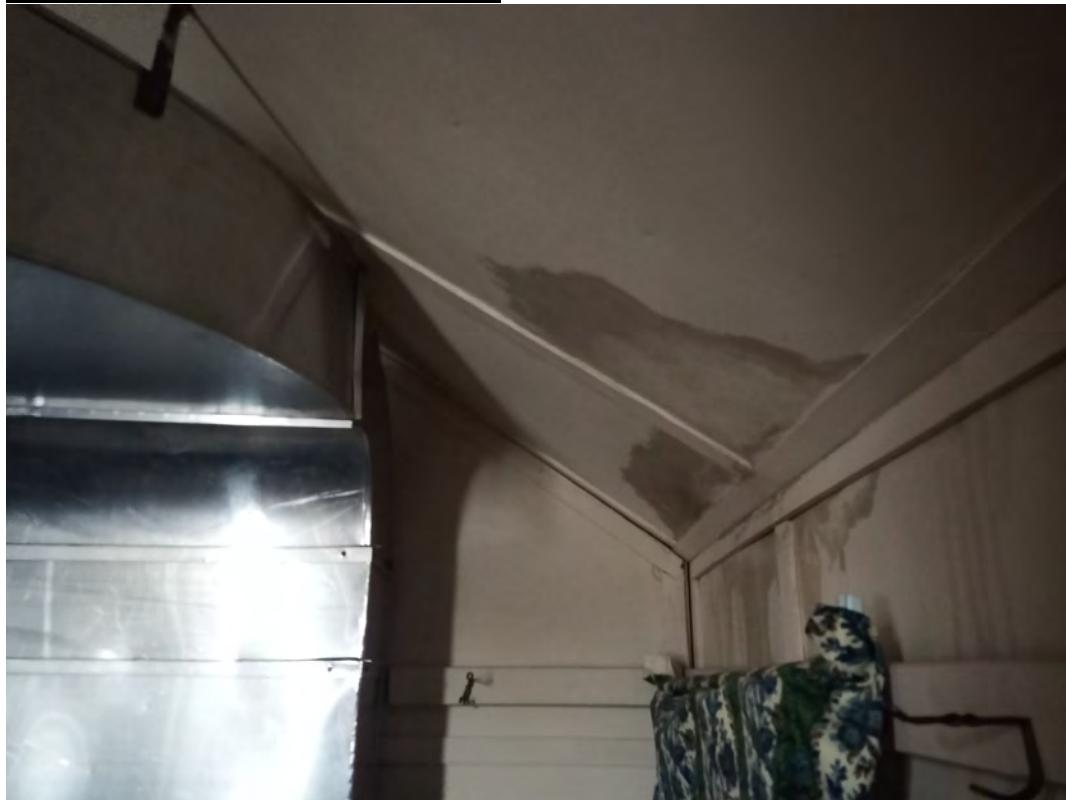
Figure 124: Staining due to water infiltration at second floor ceiling

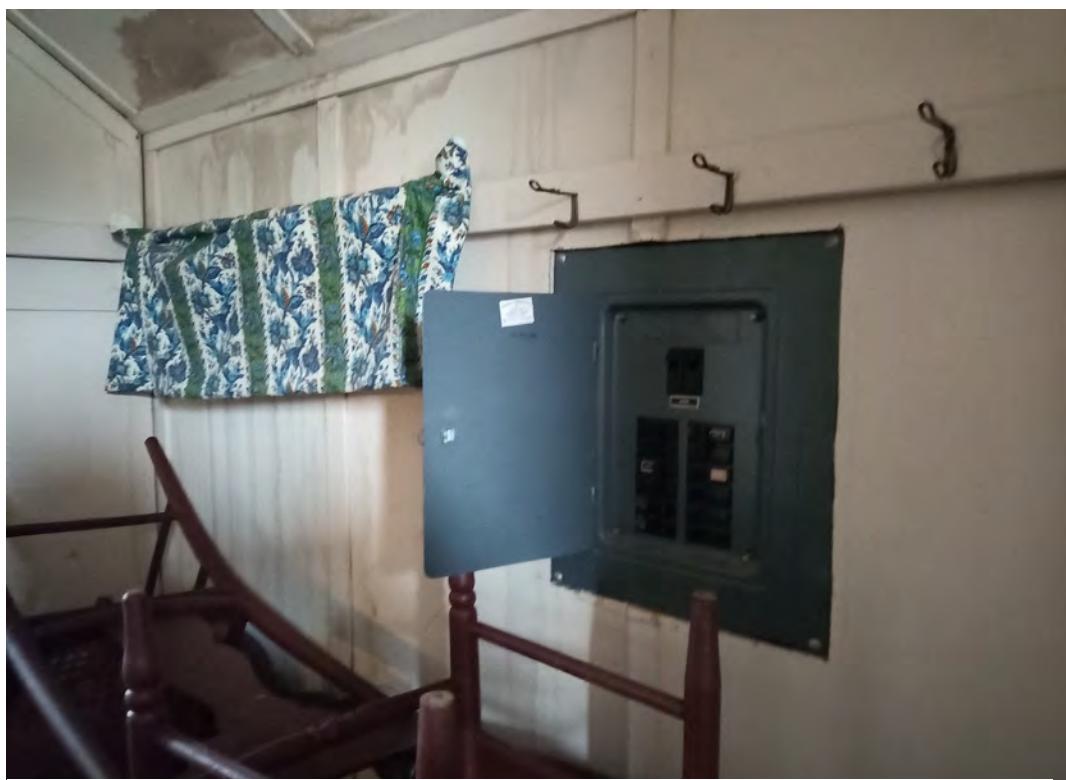
Figure 125: Staining due to water infiltration at second floor ceiling and wall

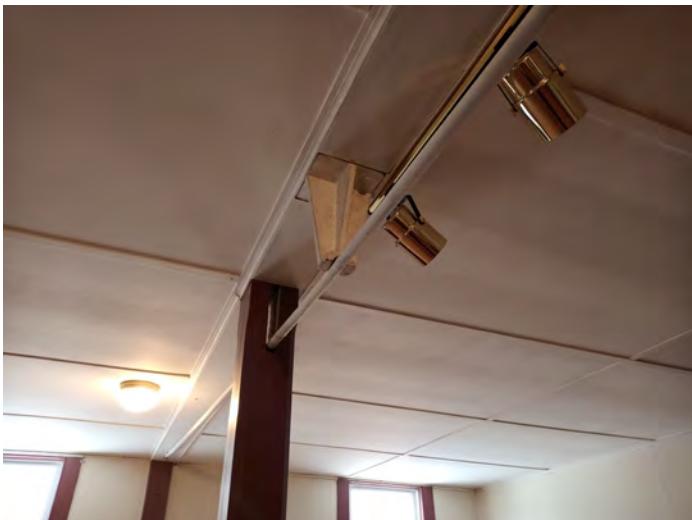
Figures 126-130: First floor tension rods, attic roof timbers, cut collar ties.

Structural deficiencies of the roof framing were identified by Bergeron Technical Services in 2022. In 2024/25, Annette Dey Engineering LLC was contracted to design reinforcement and that remediation work is currently underway. Scope includes installation of new knee braces at roof trusses, installation of custom angles tying rafters to second floor girders, and additional screws to reinforce all joints. All relevant documents are included in the Appendix of this report.

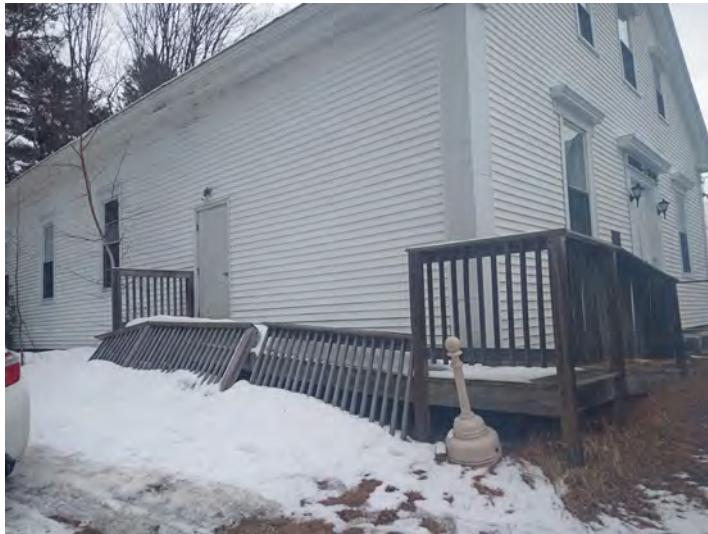
Figure 131: Accessible ramp at west façade requires repair or replacement

The accessibility ramp is in poor condition and is due for replacement. The new ramp should be kept at least 1-foot off the building wall and should be set atop a gravel (crushed stone) pad of generous size to allow for better stormwater drainage and prevent weed growth around perimeter. This will protect both the building and the ramp. Reorienting or relocating the ramp in entirety should be considered to avoid continued damage from roof snow runoff.

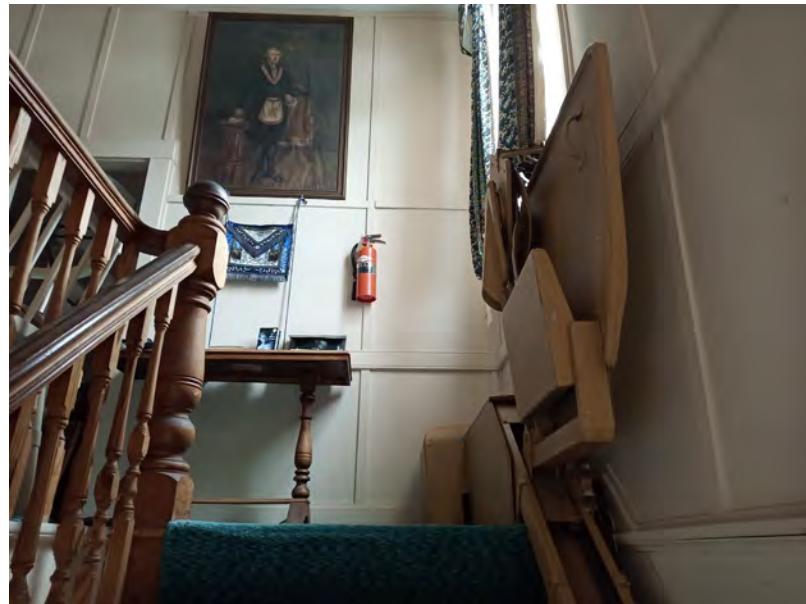
Figures 133 & 134: Access to the second floor is via a wooden stair chairlift that is no longer functional. If replaced in-kind, standby power must be maintained for this to be considered a code-compliant accessible means of egress.

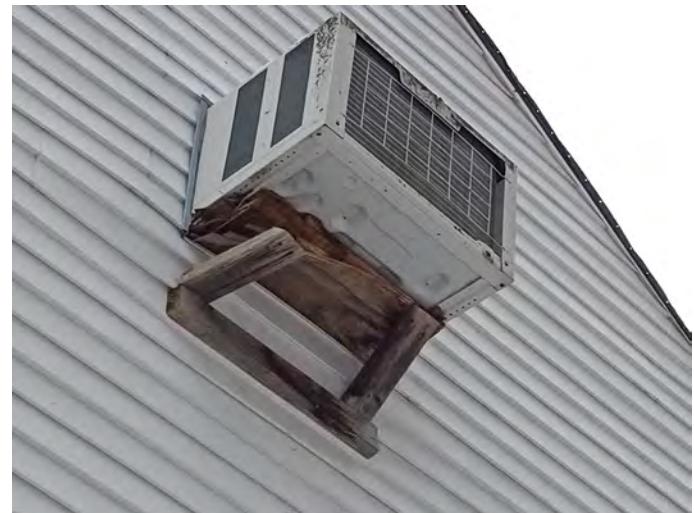
Figures 146-147: Blocked up rear second floor window (2/2 double-hung) with air conditioner unit. AC supports are not safe and should be repaired as soon as possible.

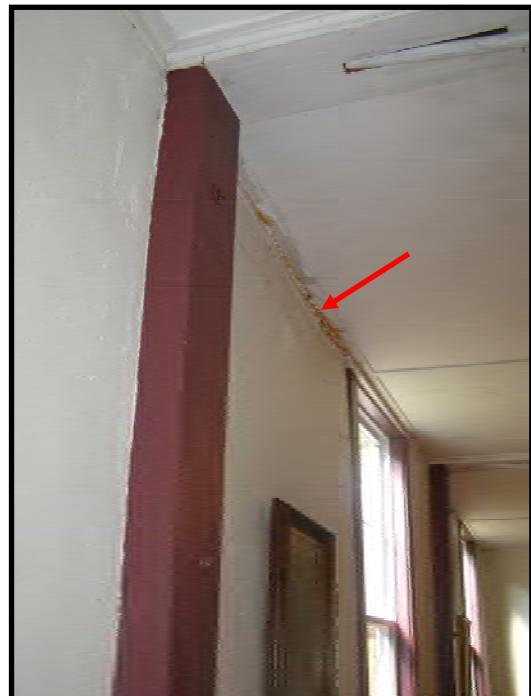
Westerly exterior wall of the Masonic Temple, viewed from inside the banquet hall. Signs of wall splaying can be observed at the wall-ceiling intersection.

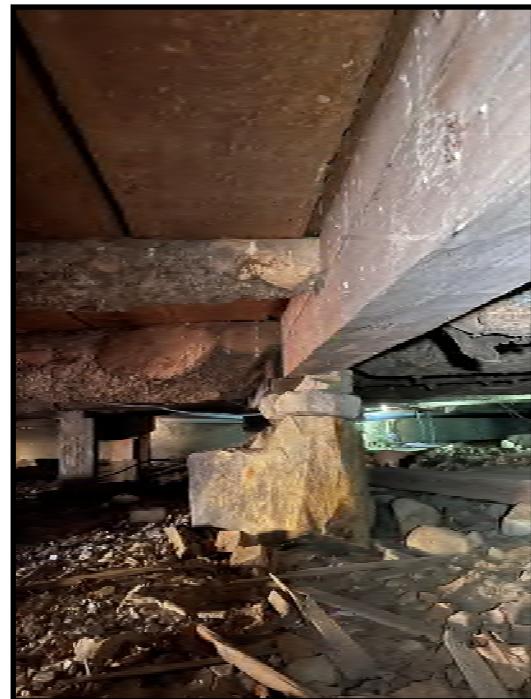
Side view of the timber joist connection to the main beams. The beam is supported by dry-stacked stones. Beyond, light can be seen coming through the granite perimeter foundation, where mortar has deteriorated and fallen away.

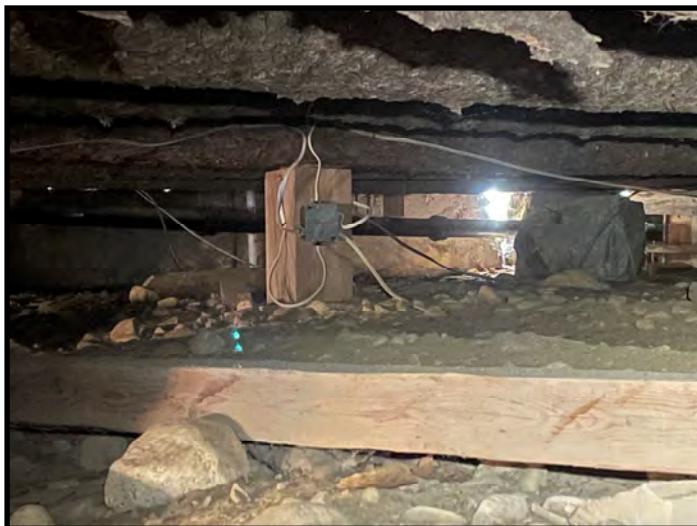
Masonic Temple crawl space/floor system. The condition of the crawl space is quite good, dry with sufficient space between the dirt floor and undersides of the wood floor members. This photo also shows an electrical junction box with exposed and unsupported non-metallic wiring.

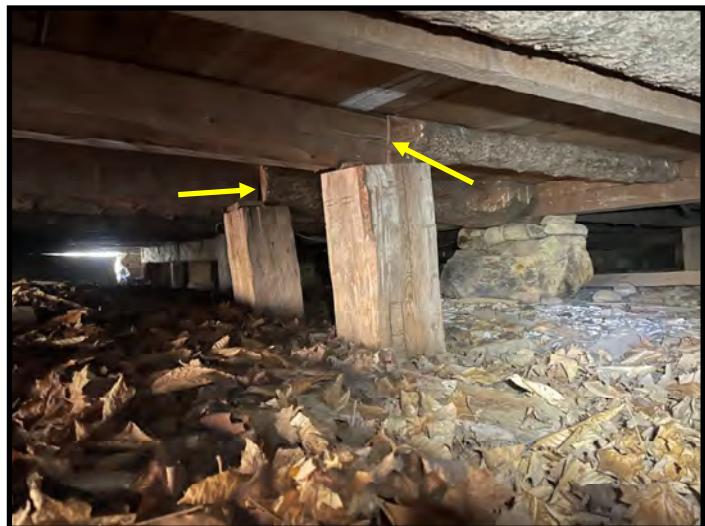
Masonic Temple crawl space/floor system. Yellow arrow indicates where timber joists have been cut/removed and replaced, with new wood posts installed at the joint. Wood posts have moved out of plumb, likely a result of seasonal movement over time.

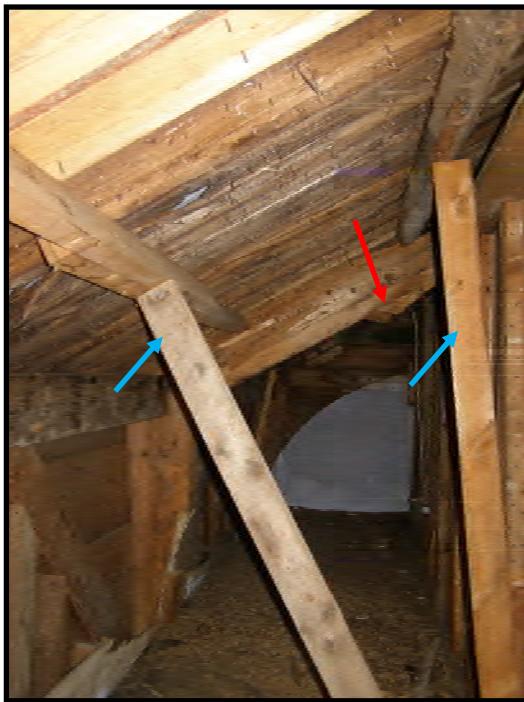
Westerly eave space at second story of Masonic Temple. Evidence of the original arched ceiling can be seen at the end (gable) wall. The original collar tie joint at a bent can also be observed (red arrow). This side of the roof remains sheathed in 1x boards. Additional dimensional lumber bracing has been added to support the roof purlins (blue arrow)

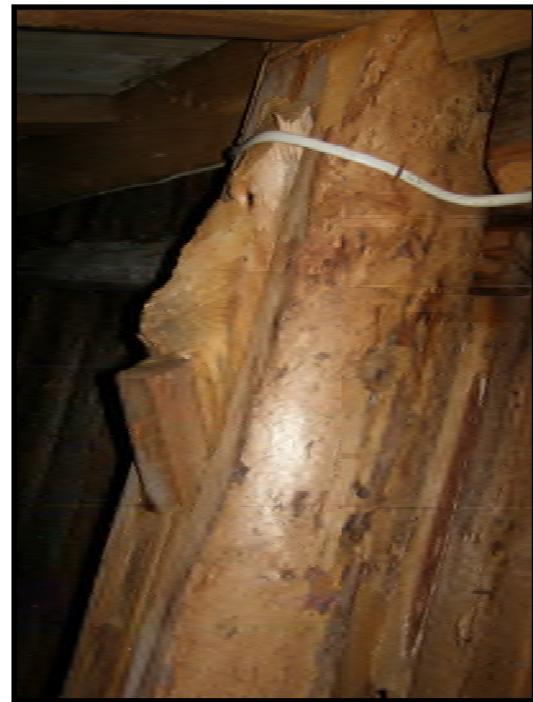
A close view of a joint where an original collar tie member was removed from the bent frame

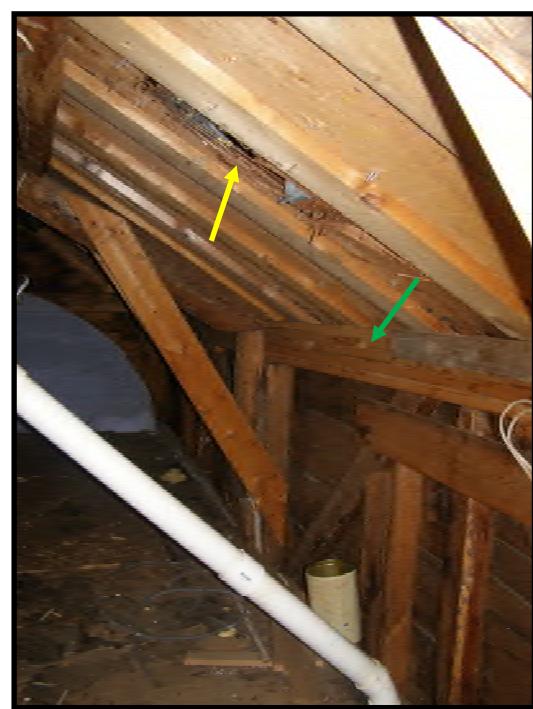
Easterly eave space at second story of Masonic Temple. The yellow arrow is indicating a hole in the OSB roof sheathing. Additional diagonal bracing has been added to the bent framing between the post and rafter. A section of the top plate has been replaced with dimensional lumber (green arrow).
