**HISTORIC BUILDING ASSESSMENT  
FOR  
FREEDOM TOWN OFFICE**

**33 OLD PORTLAND ROAD  
FREEDOM, NH**

PREPARED BY: BETH MILLER, RA LEED AP, OF NORTH COUNTRY ARCHITECT

DRAFT ISSUED 12/15/2025

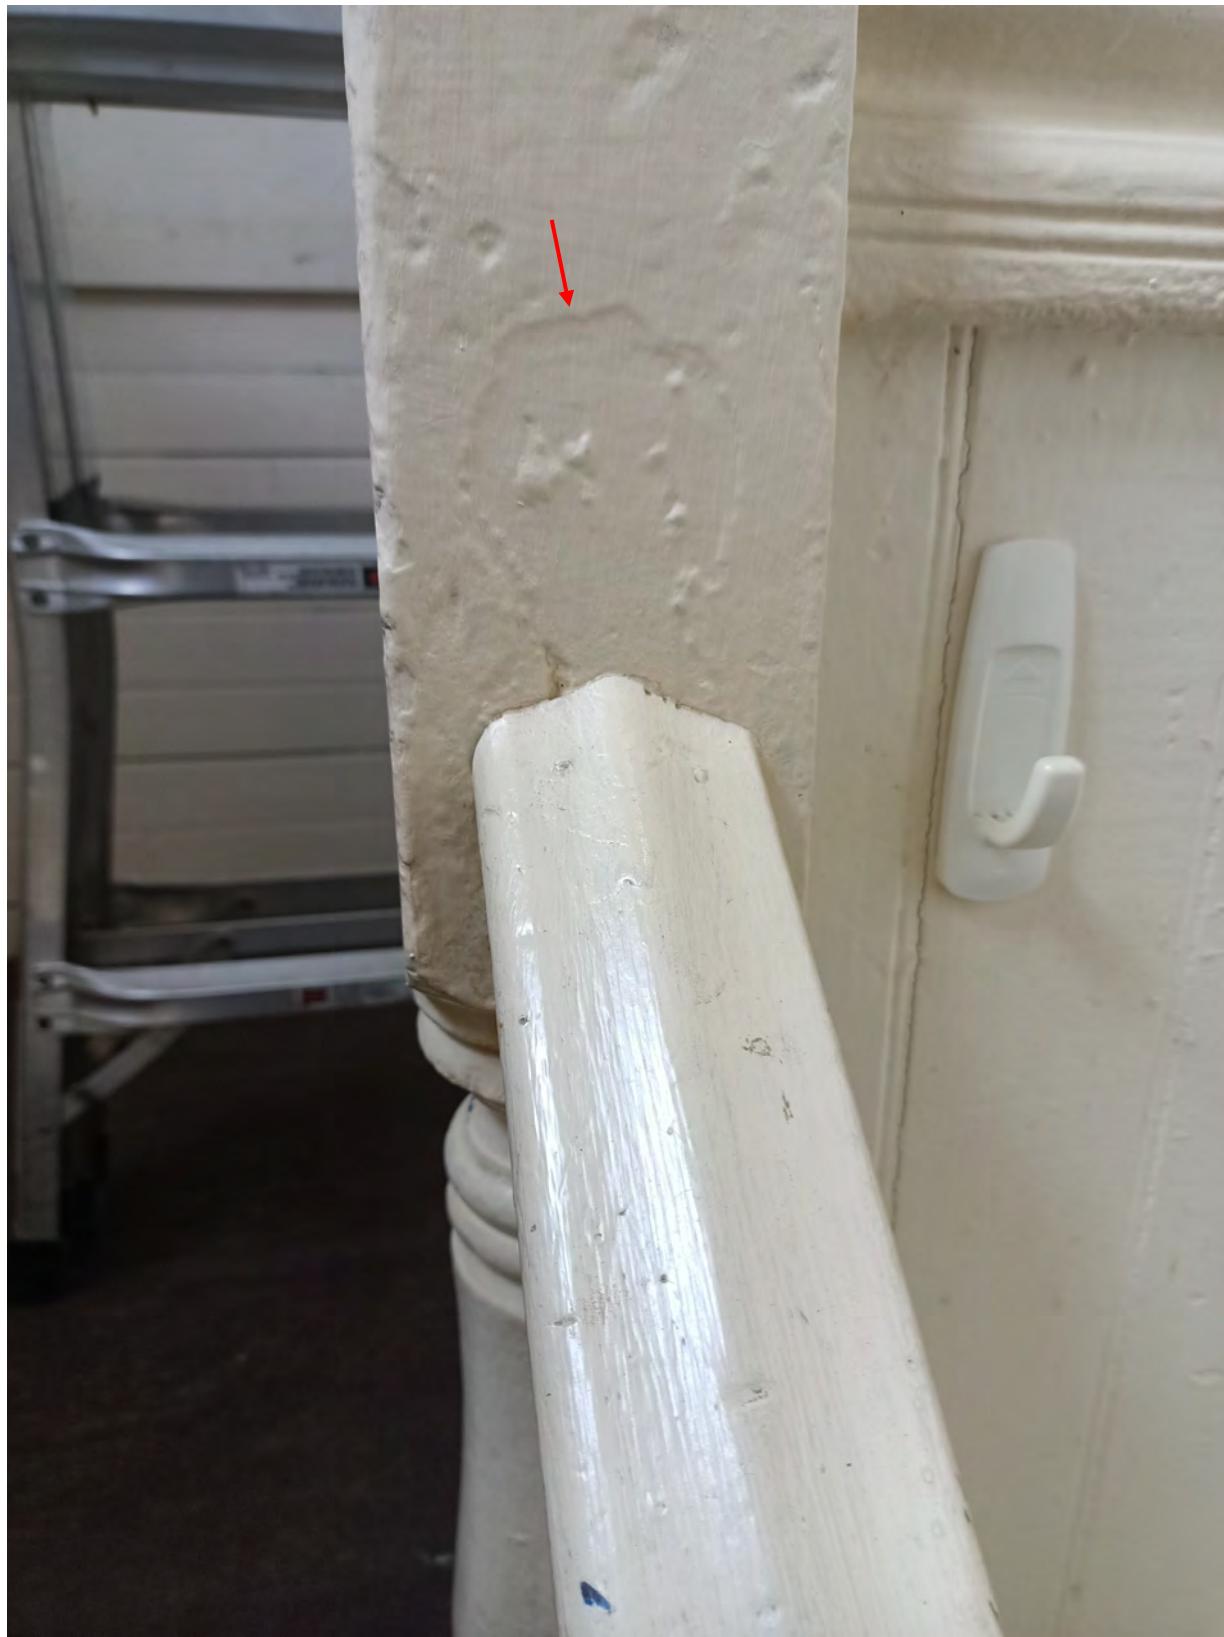
The original stair is intact, as is the stair wall beadboard, though treads are covered with rubber. There are several signs that the stair may have been modified including a ghost outline of a previous handrail profile, newels at the landing being mostly obscured at the base, and ghost outlines of steeper risers visible when lifting the edge of rubber treads. Further investigation is recommended at the next renovation.

Figure 53: Detail view of stair handrail; Note possible ghost / outline of previous rail.

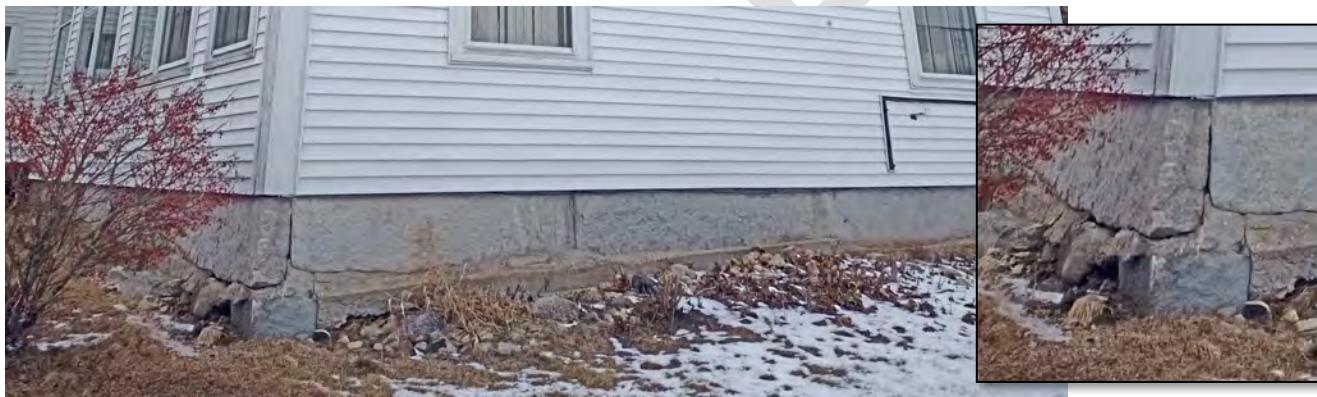
Figure 67: Southeast corner

The Freedom Town Office is sited atop the steep Schoolhouse Hill and the site appears to be generally well-graded away from the building with no signs of accumulated moisture observed at the perimeter. Some granite foundation stones are out-of-plumb and voids between stone and grade have been filled haphazardly with mortar. Out-of-plumb stone should be reset to plumb. Remove all loose mortar and pour new continuous curb / sill, and/or build up grade at perimeter and fill with gravel.

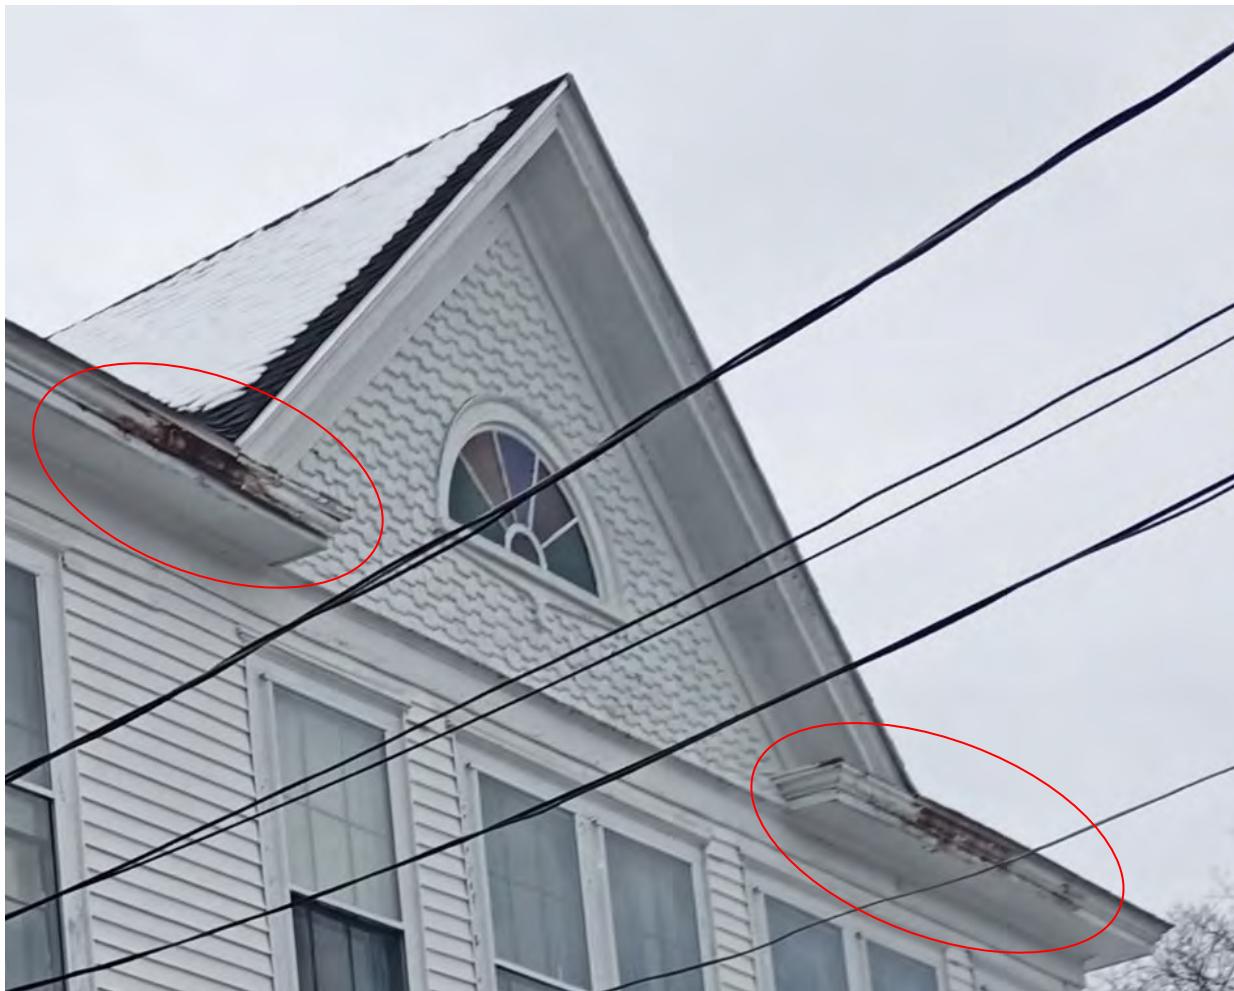
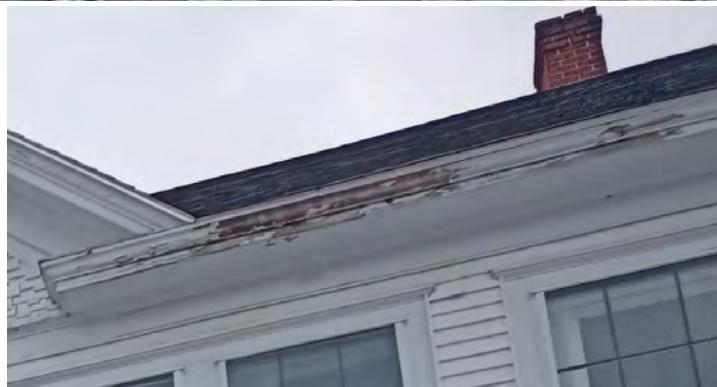
The exterior walls are clad with vinyl siding installed in the 1990's. The exterior wood trim that has remained exposed exhibits localized deterioration and should be repaired. Where clad, the original wood clapboards and trim behind appear to be intact and restorable. It is recommended to remove all vinyl siding and restore facades to their original appearance. It is further recommended, once exposed, to undertake paint sample analysis.

Figures 69 & 70: Paint loss, rotted wood trim at eaves beneath valleys

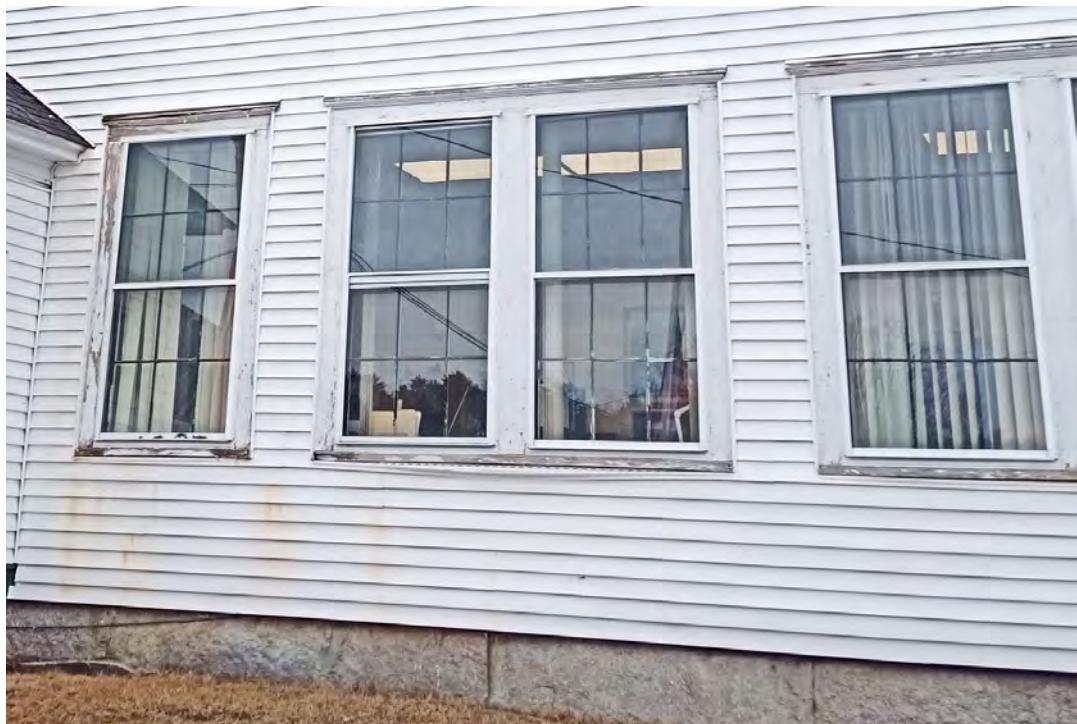
Figure 71: Paint loss, deterioration of wood trim at first floor windows

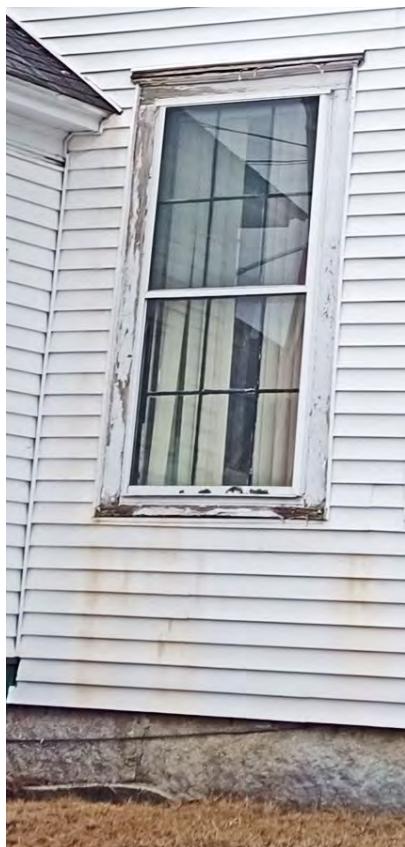
Figure 72: Paint loss, deterioration of wood trim at first floor windows; Staining of vinyl siding

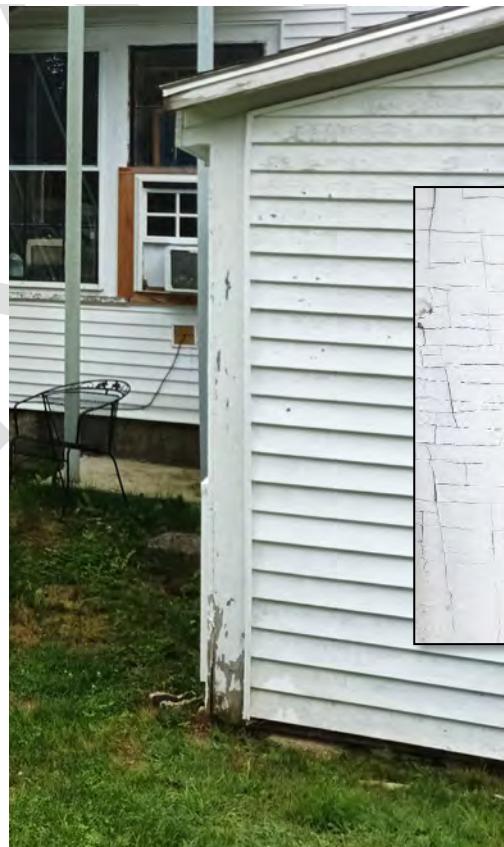
Figure 73: Paint loss, deterioration of wood corner trim rear addition; Inset: Example of crazed lead paint at corner trim

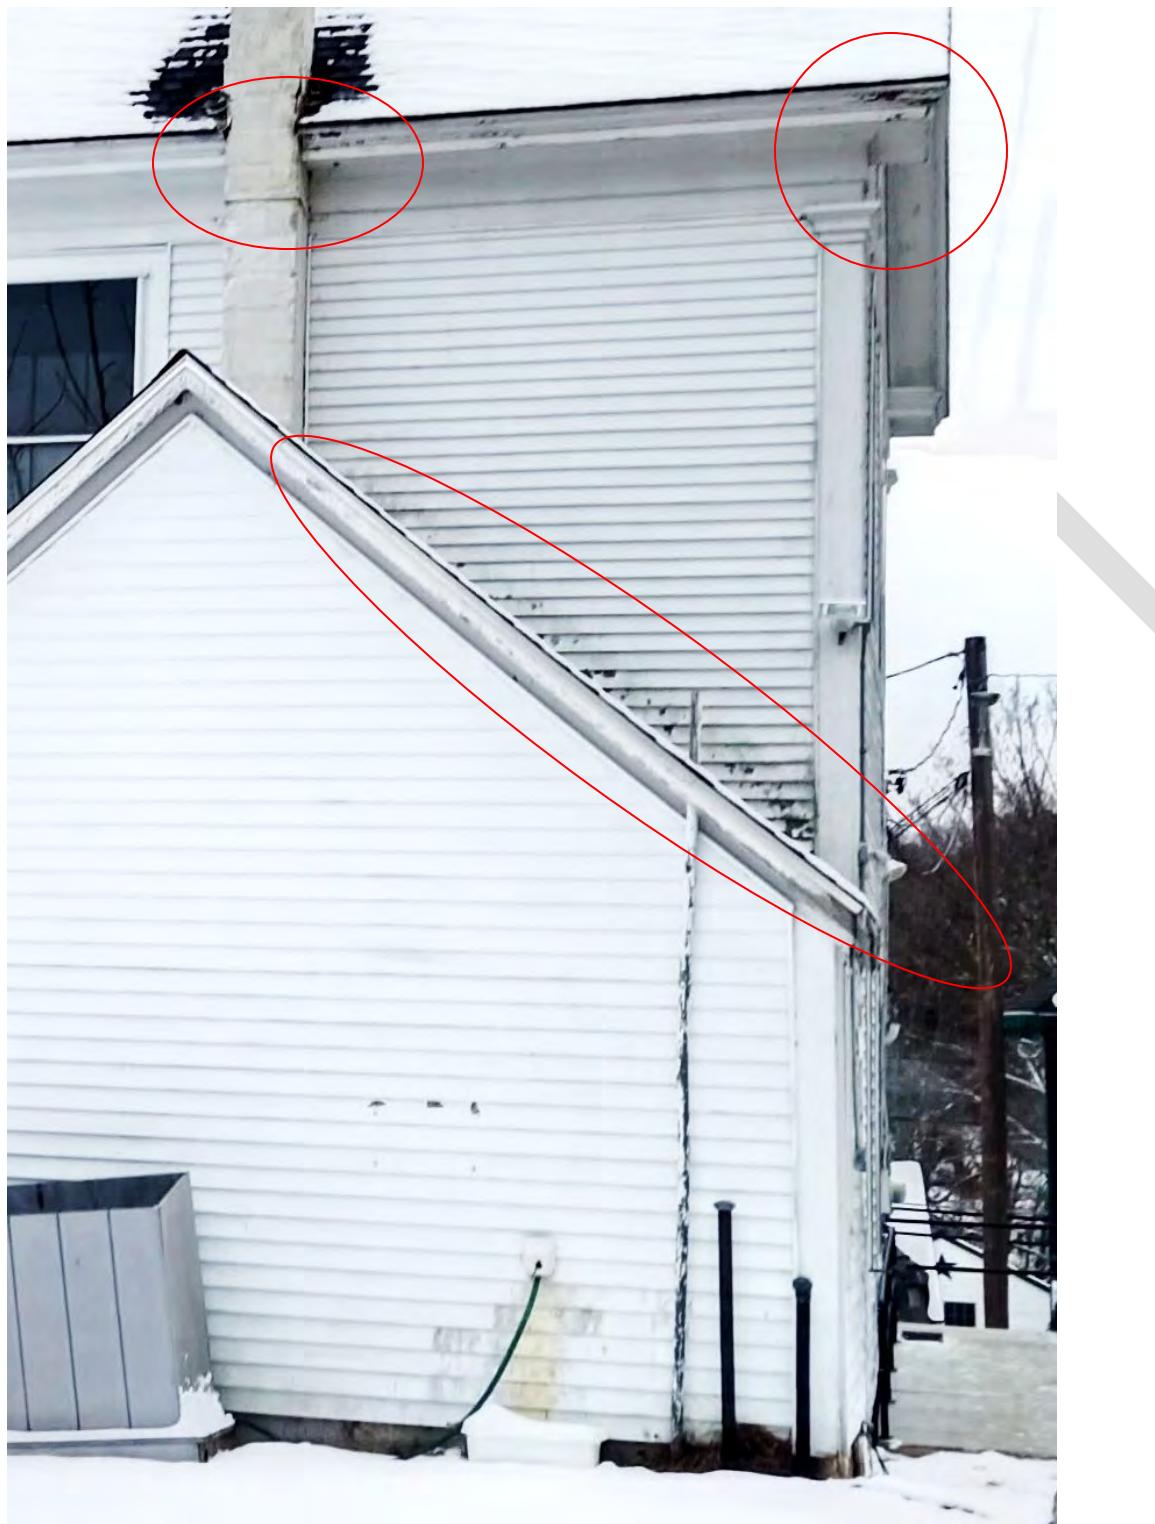
Figure 74: Paint loss and deterioration of wood trim at eaves and rake; Staining at vinyl siding.

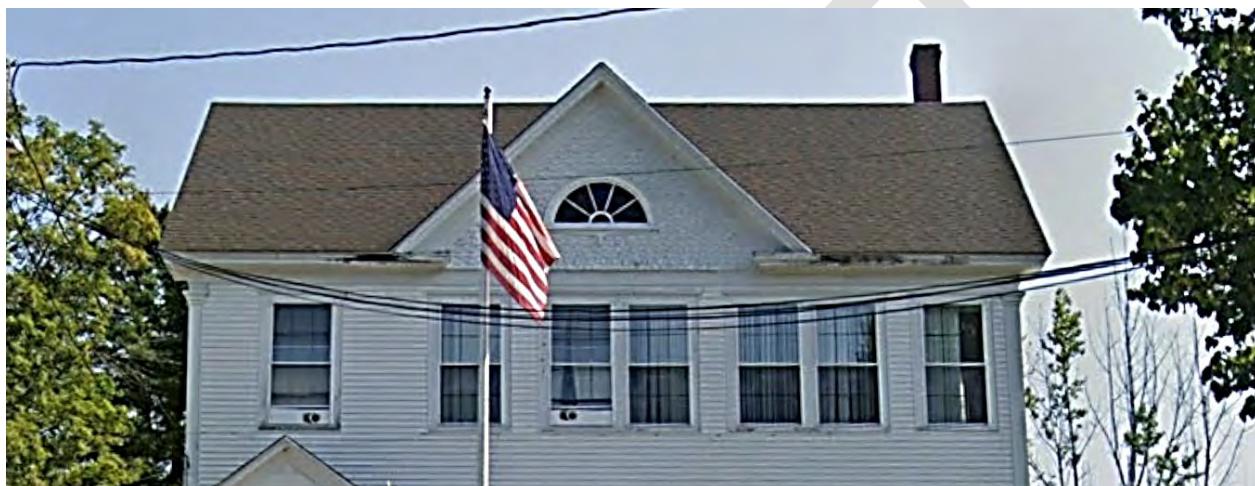
Figure 75: Front (south) roof plane

The asphalt shingles roofs were replaced in 2006-7. The roof appears in generally good condition but replacement should be anticipated in the next decade. Localized areas of repair are recommended – repoint open mortar joints at brick chimney corbel, tighten and seal stepped flashing at rear chimney, remove loose parging and repackage, ensure there is an adequate cricket on the high side. When the roof is replaced it is recommended to improve the detailing at problem areas where wood trim deterioration is clearly exacerbated. This includes the main front valleys which should have generous metal valleys, the roof edge in entirety should protect the wood below with a generous metal drip edge, and step flashing where roofs meet should have a clearance of 4" exposed flashing between roof and start of siding.

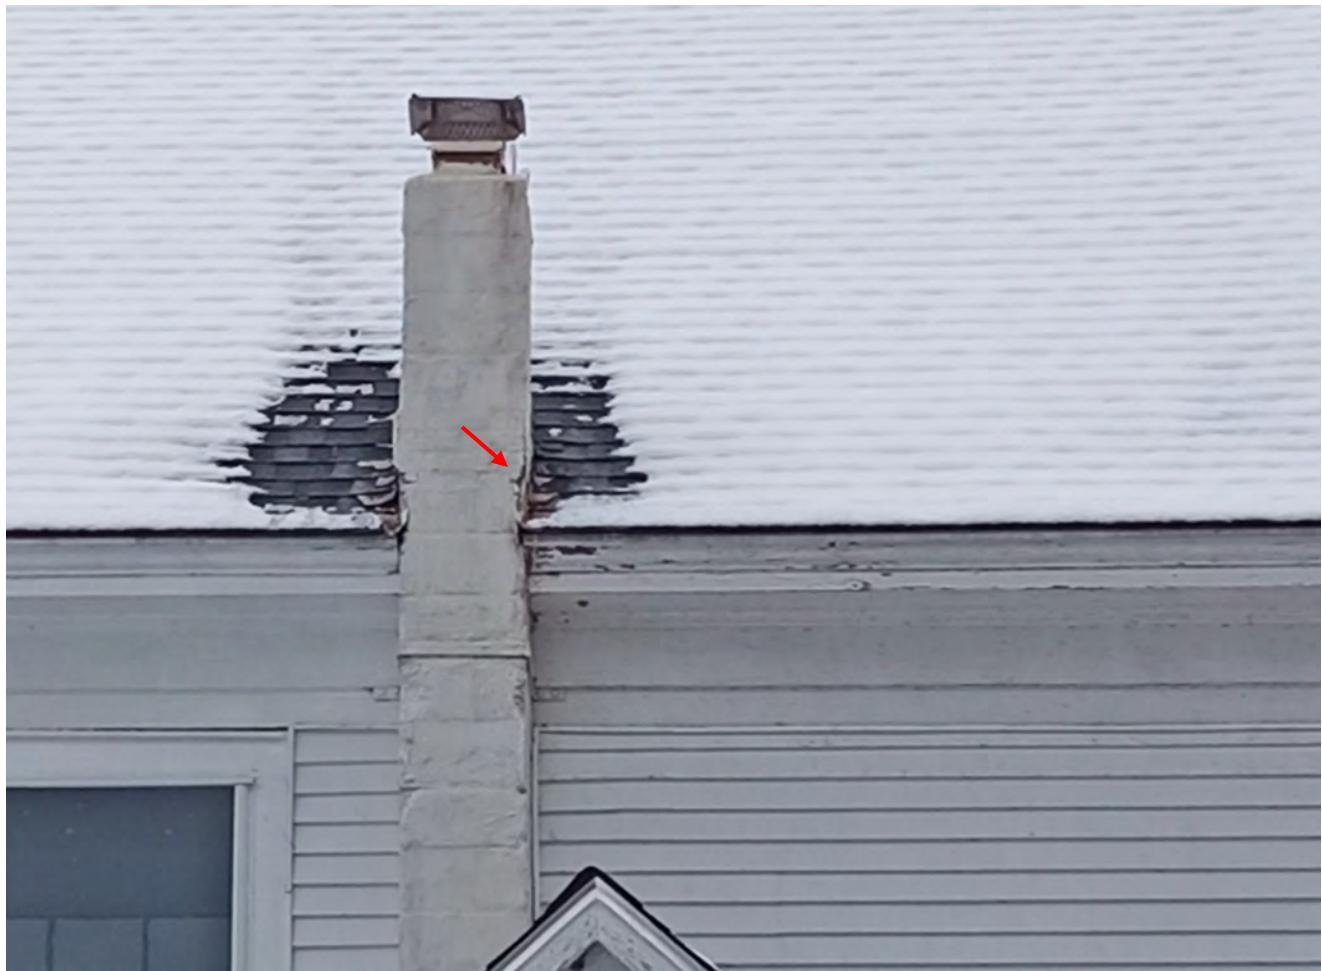
Figure 77: Separation at parging; Paint loss and deterioration at wood eave trim; Openings at step flashing.

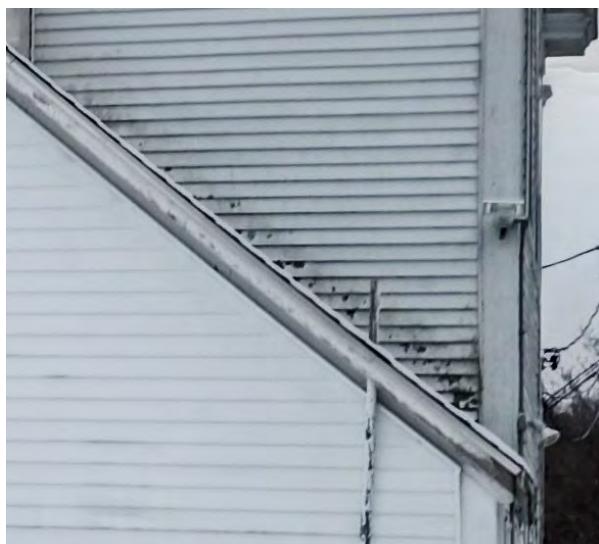
Figure 78: Staining and biological growth along addition roof indicates inadequate flashing, standing snow, poor drainage, and/or saturated shingles causing moisture to wick up wall. Rotted wood likely to be found behind siding.

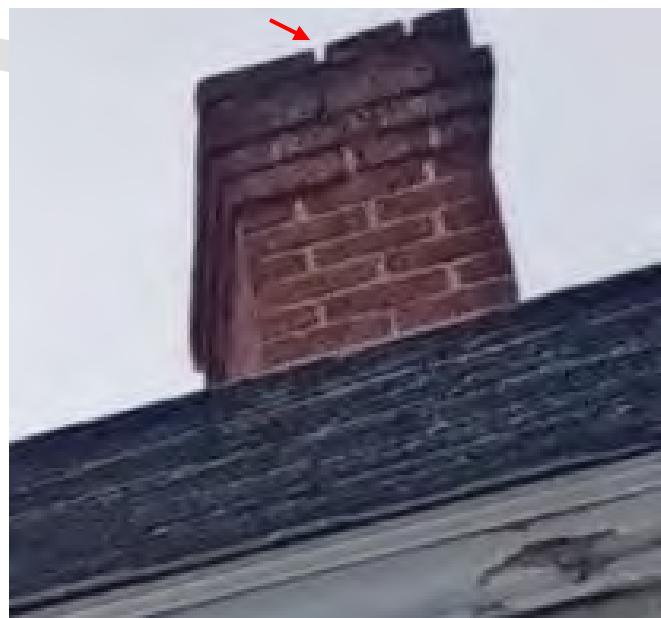
Figure 79: Open mortar joints at corbelled chimney top; Deteriorated wood trim in foreground.

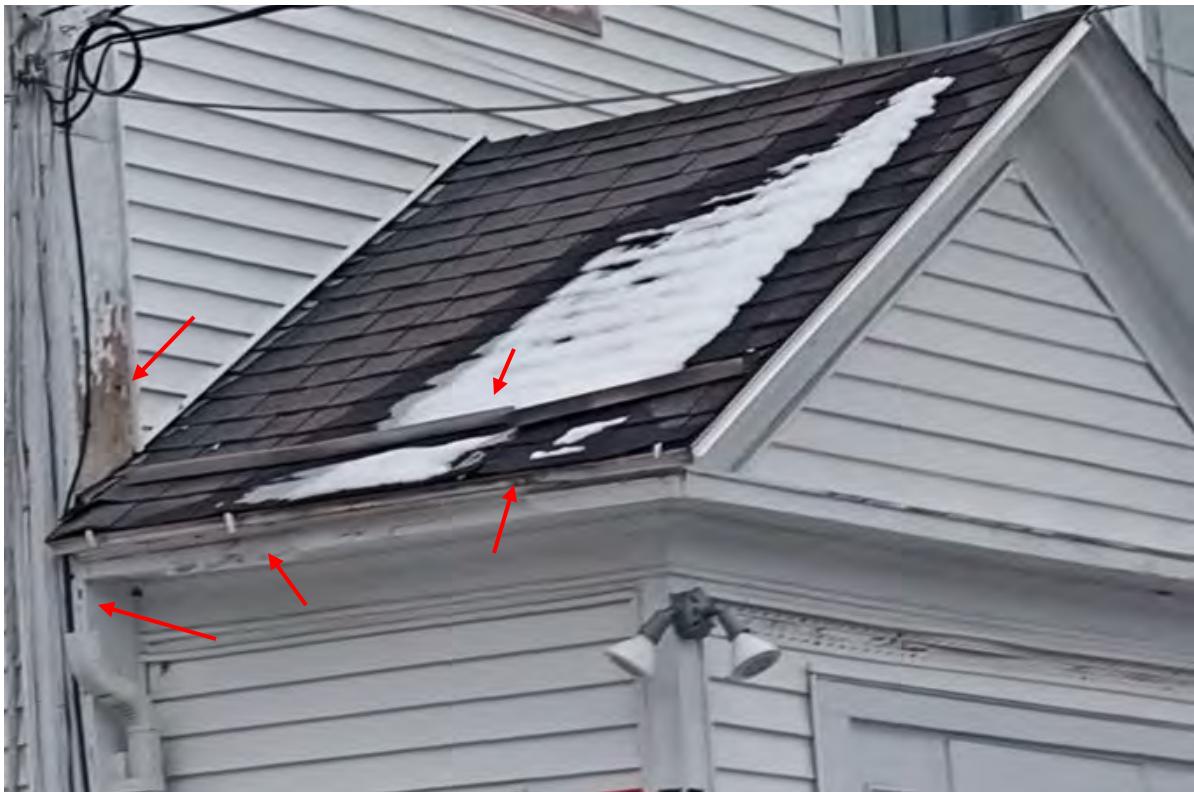
Figure 80: Non-functioning diverter causing deteriorated trim; Downspout elbow with no gutter.

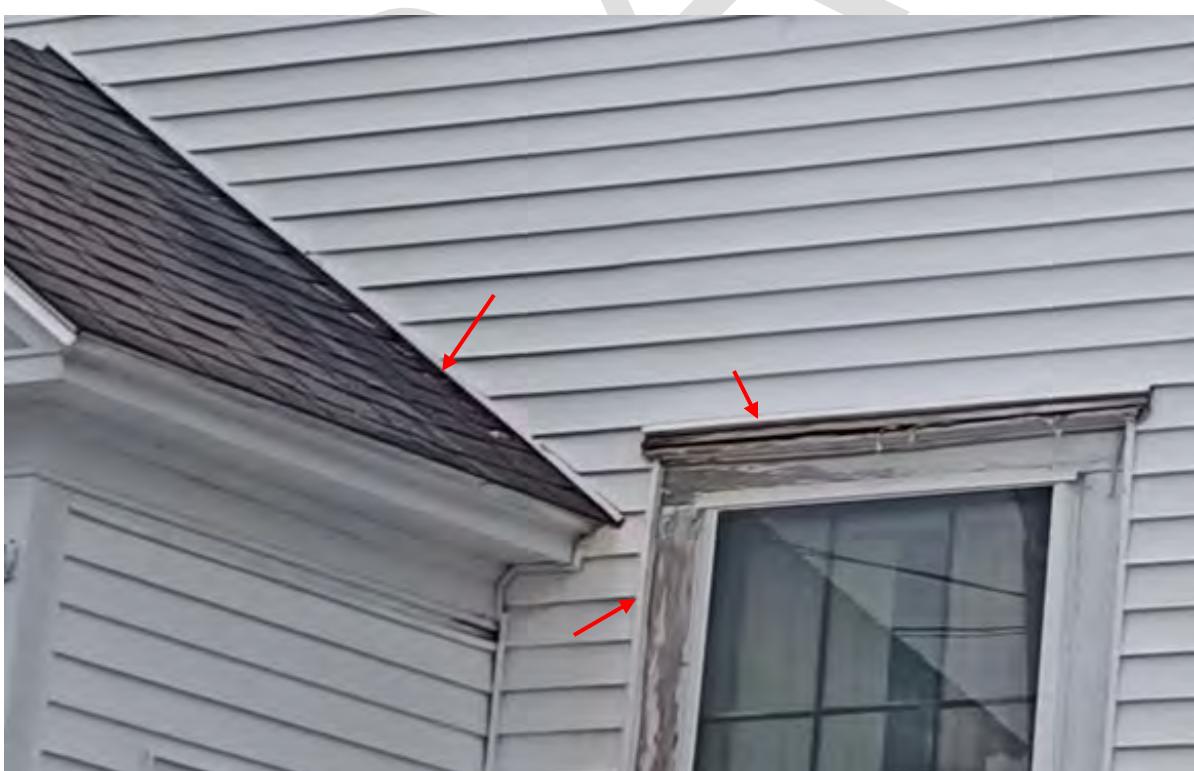
Figure 81: Roof run-off causing localized severe deterioration of window trim. Diverter or gutter sloped to exterior would be useful here and there should be a minimum 4" gap from shingles to bottom of siding with metal step flashing.

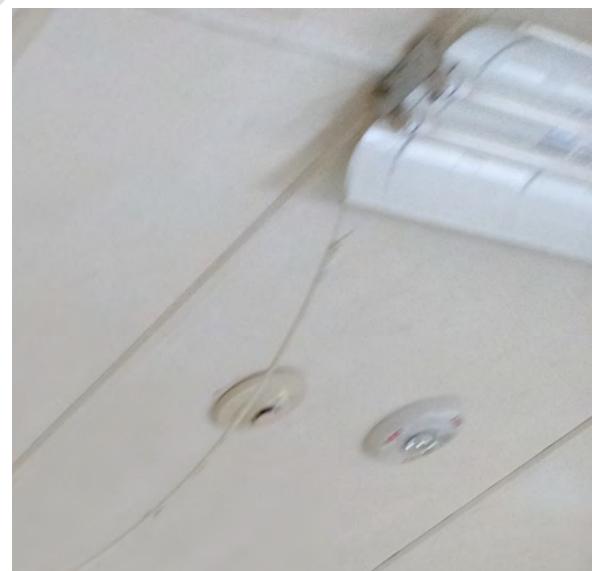
Figure 91: Outdated fluorescent fixture

Ceiling-mounted fluorescent lighting should be replaced throughout with modern LED fixtures and diffusers, with a mix of overhead and task lighting, and with dimmable switches to allow control of lighting levels.

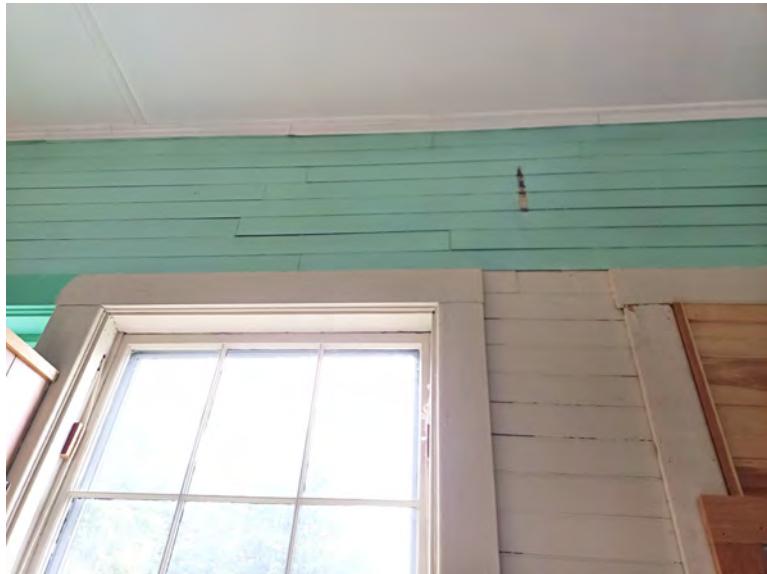
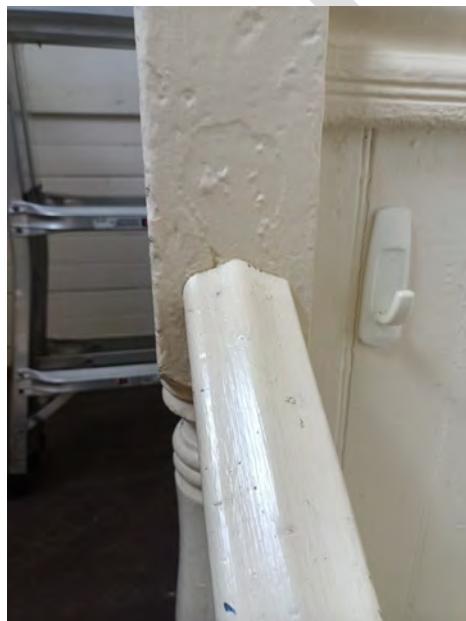
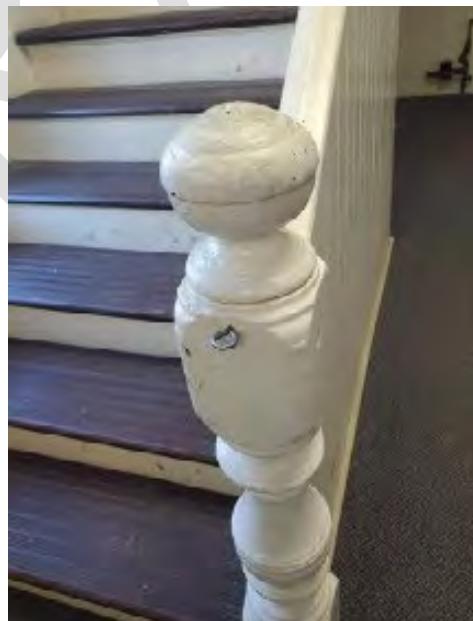
At the second floor, much of the original or early beadboard wall finish is extant and exposed. The original wood floors are carpeted and the ceiling finishes are an early drywall with battens that may have been installed after the 1935 fire and Celotex in the Tax Collector's office. The beadboard throughout and stair elements have clearly undergone many iterations of overpainting without full surface preparation. If full renovation of the interior is undertaken it would be a good opportunity to rehabilitate all of the original wood finishes and elements, using lead-safe practices. Paint sample analysis should also be performed.

Figures 92-94: Above - Original or early beadboard is intact at much of second floor; Below - Stair elements caked with paint.

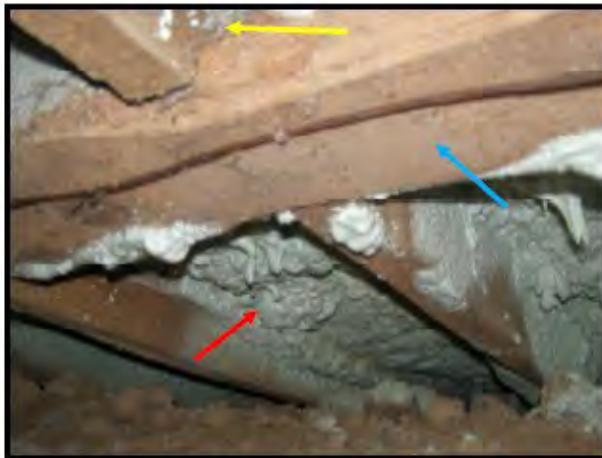
Photo of the first floor system taken from the crawl space. Blue arrow indicates a main carrying beam. The Yellow arrow indicates where the floor joists are 1/2 mortised into the beam. The red arrow indicates where approximately 6" of spray foam insulation has been installed between the floor joist bays.

Above is an excerpt from a recent assessment by Bergeron Technical Services. Before an extensive renovation of the building is undertaken, a thorough campaign of localized repair and reinforcement at first floor framing members should be performed. Excavate crawlspace for a minimum clearance of 18" from grade to underside of framing members. Install vapor barrier. Finally, finish insulating between joists and install sheathing boards to protect the insulation and mitigate pest intrusion.

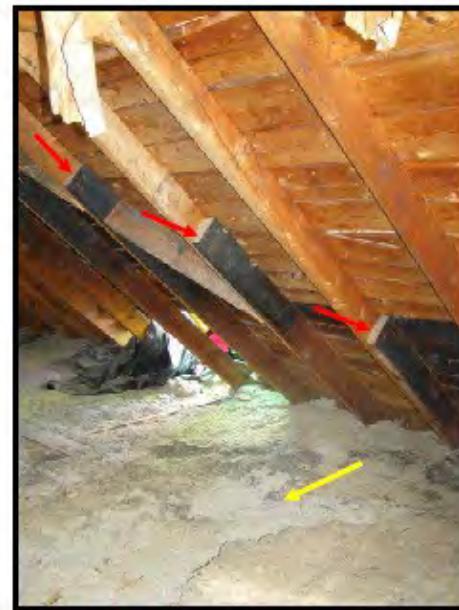
Photo of the attic. Red arrow indicates charred/cut rafters. Yellow arrow indicates blown-in cellulose insulation in the ceiling joist bays

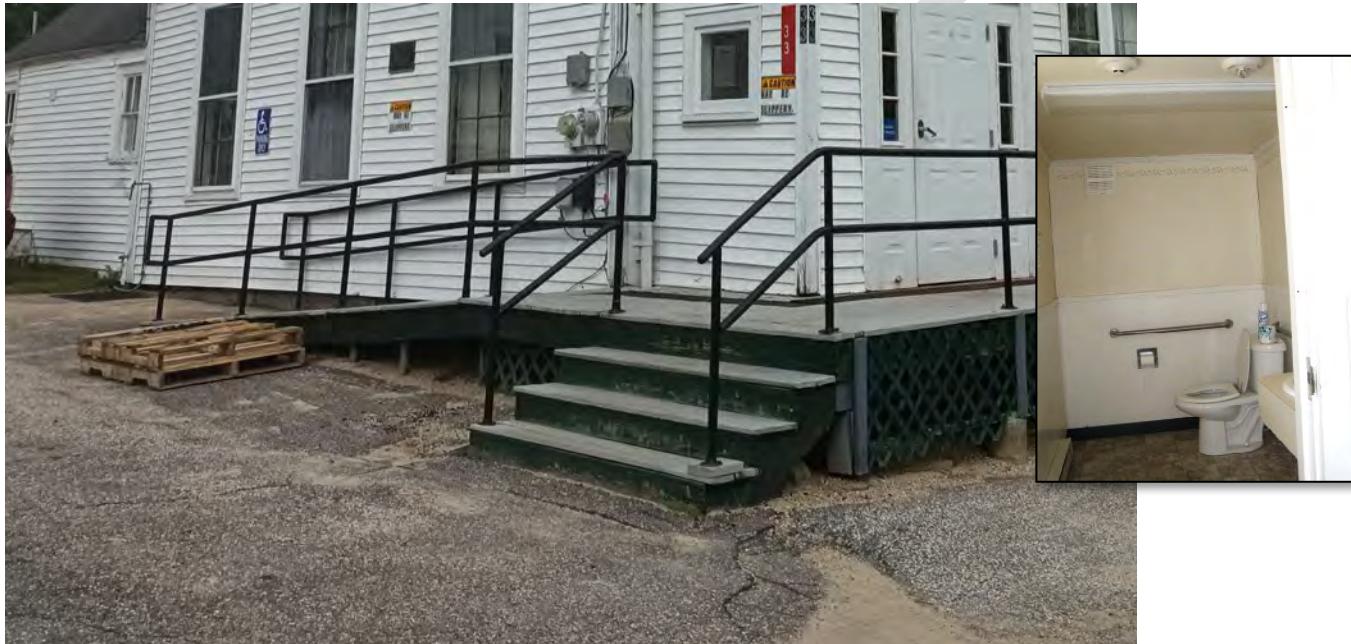
The existing bathroom is mostly accessible but lacks a vertical grab bar. The pedestal sink is not fully compliant.

Figure 99: Existing entry with accessible ramp; Inset: Staff & Public bathroom, accessible.

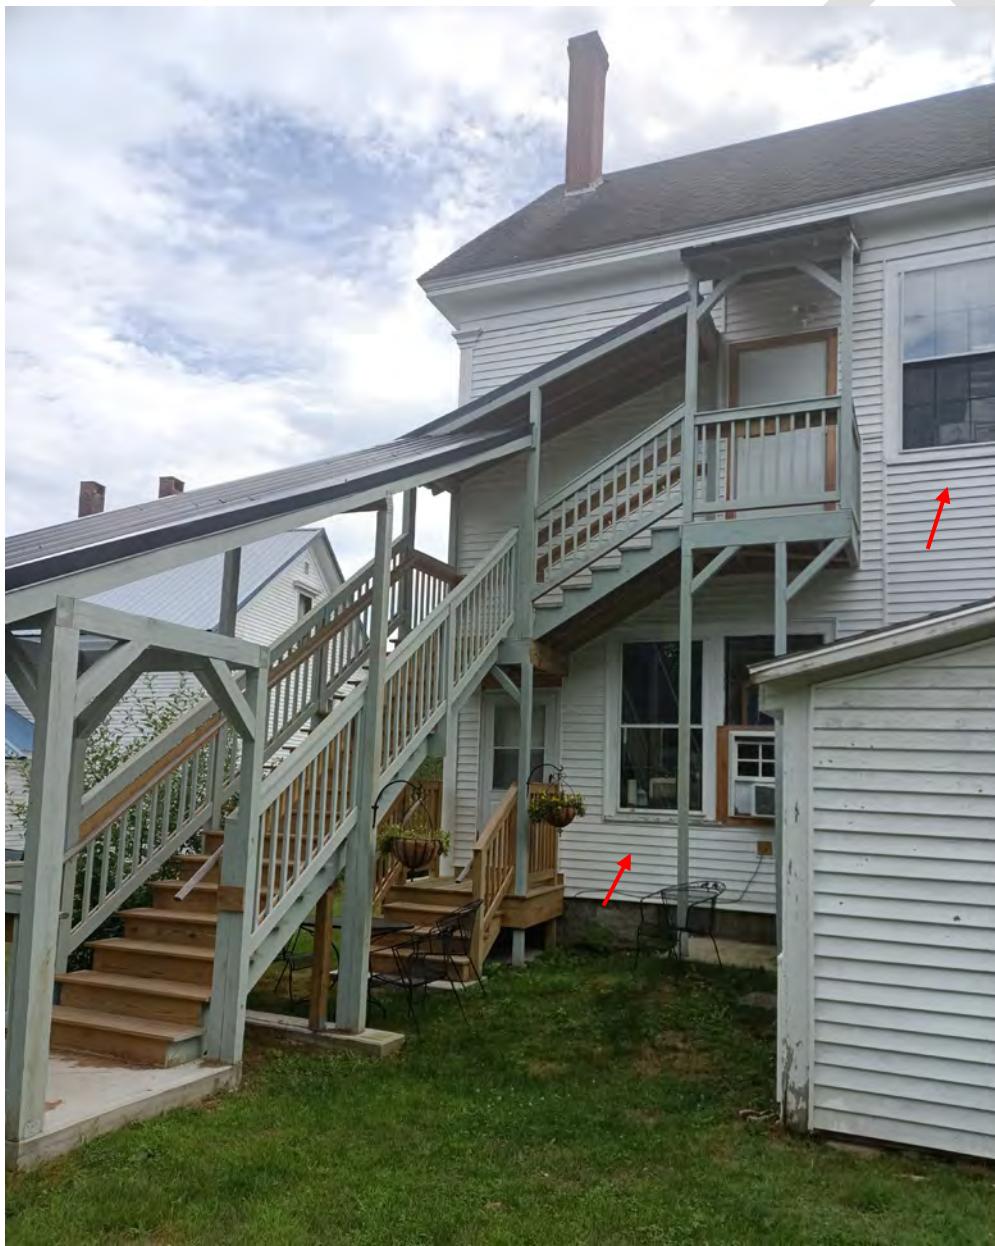
Figure 104: Rear exterior egress stair installed 2023 (confirm)

The rear exterior egress stairs were constructed in the last few years. In order for the first floor egress to be compliant the two interior doors leading to the exit must be un-lockable (see Fig. 105). Both interior exit doors should be equipped with panic bars and closers. Further, per IBC 705.8 there cannot be unprotected (windows without safety glazing, etc.) within 3-feet of an exit stair. Due to the historic status of the building, the Authority-Having-Jurisdiction is to make a determination on the above. The building is equipped with a fire alarm system, which should be tested regularly. There is no automatic fire suppression system and none is required. Detectors should be tested regularly.
