HISTORIC BUILDING ASSESSMENT FOR MASONIC HALL

**29 OLD PORTLAND ROAD
FREEDOM, NH**

PREPARED BY: BETH MILLER, RA LEED AP, OF NORTH COUNTRY ARCHITECT

FINAL ISSUED 9/22/2025

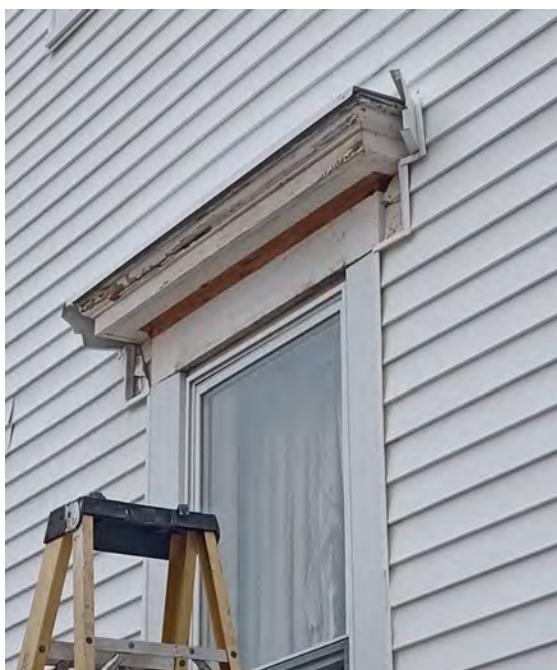
Figure 4: Masonic Hall front window with vinyl siding removed to reveal intact wood window head trim

Recommended Preservation tasks include resetting foundation stones and restoring the front entry door. Recommended Restoration tasks include removal of all vinyl siding and coverings from the exterior facades, and rehabilitation of the wood clapboard siding and trim beneath, restoring the building exterior to its 1926 appearance. The Town intends to undertake such restoration when funds allow and also plans to replace the present vinyl window sash with true-divided-lite wood 2/2 sash replicating those that the masons installed in 1926-1928.

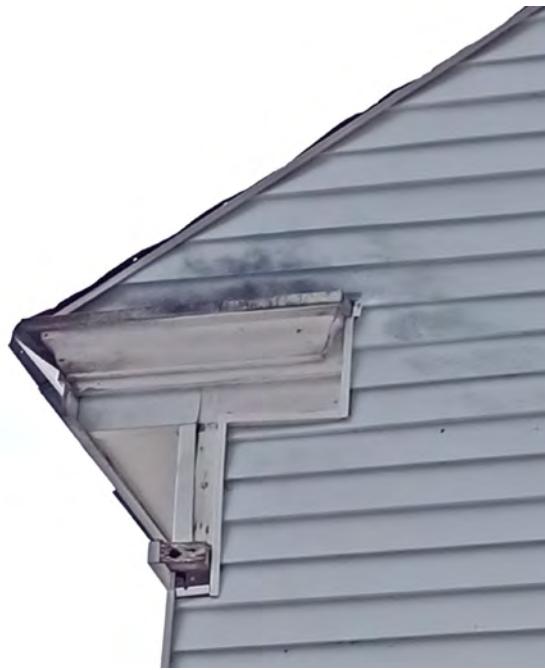
Figure 5: Intact wood cornice / eave trim at northeast corner of building

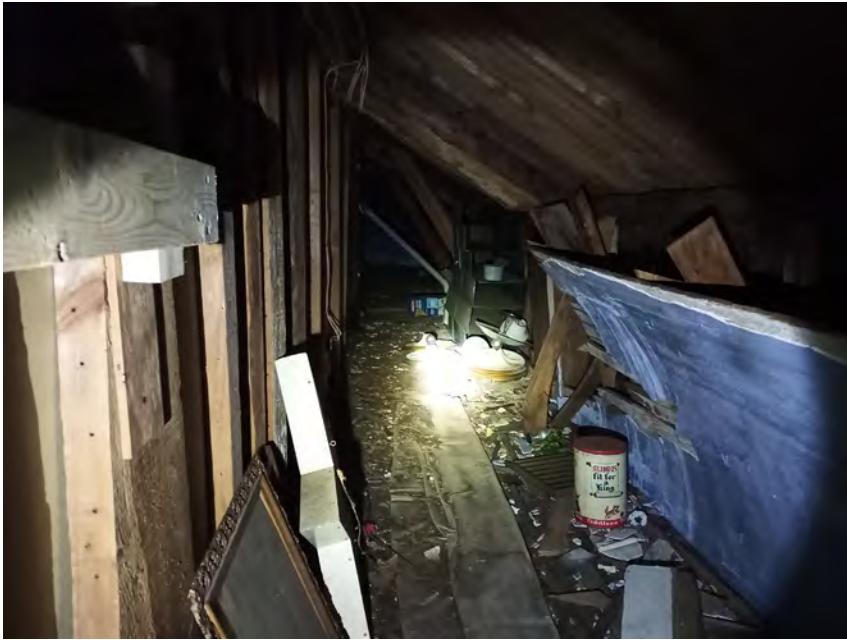
Figure 14: Remnant of blue-painted 1830 Church coved ceiling is visible in attic

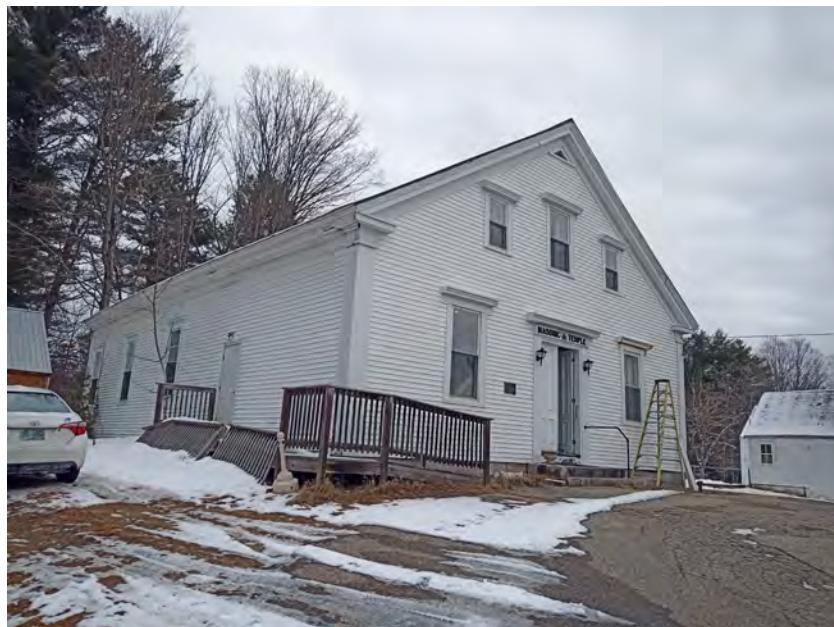
The Masonic Hall is sited atop the steep Schoolhouse Hill and the site appears to be generally well-graded away from the building with no signs of accumulated moisture observed. The exceptions are the front entry granite steps, which pitch back toward the building, and the seam where the wood accessibility ramp meets the building wall. The entry stones should be reset to be level, with slight pitch (1/8-1/4" per 1'-0") away from building to direct rainwater, and cleaned with a soft hose wash (<300psi), mild PH-neutral, non- ionic detergent, and scrubbed with a soft bristle brush. The parking lot asphalt will soon be due for a new tack coat, or the Town may consider re-paving the site after the upcoming major renovations are completed.

Figure 75: View of Masonic Hall site from southwest

The accessibility ramp is in poor condition and is due for replacement. The new ramp should be kept at least 1-foot off the building wall and should be set atop a gravel (crushed stone) pad of generous size to allow for better stormwater drainage and prevent weed growth around perimeter. This will protect both the building and the ramp. Reorienting or relocating the ramp in entirety should be considered to avoid continued damage from roof snow runoff.

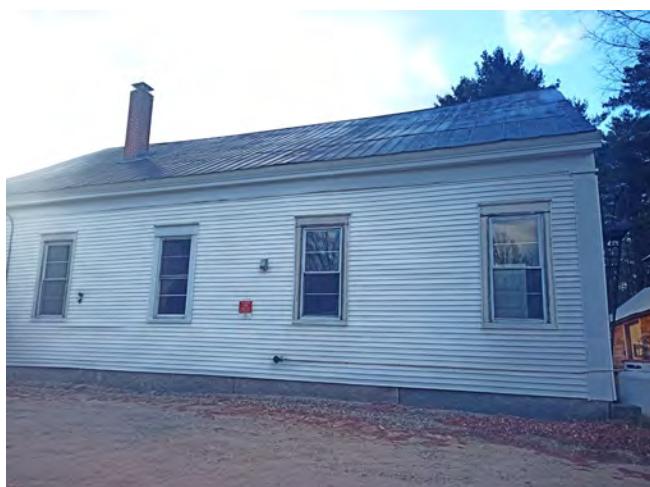
The existing corrugated steel roofing is reportedly 'old' but was re-screwed and re-painted in 2022/23. It may be the original metal roof installed in 1926-28 when the steeple was removed (the roof prior that is thought to have been wood shingles) or it may be a later replacement in-kind but, due to lack of detailing, is not likely to have been installed after the last big renovation when the vinyl siding installation was completed (circa 1990's). There is significant staining at the second-floor ceiling finishes, but most is in the vicinity of the chimney likely having resulted from a leak that has since been remedied by a flashing repair. The roof eaves have little to no drip edge, the ridge metal has minimal coverage, and the roof at rakes is essentially open to the elements. Roof replacement or repair, when undertaken (not recommended until all roof structural repair, currently in progress, is completed and proven), should include more substantial coverage at eave drip edges, at ridge, and a flashing detail at rake edges. Further, if upgrading the heating system is planned and is to include winter heating, insulation of the roof should be undertaken.

Figure 89: East roof plane, corrugated metal

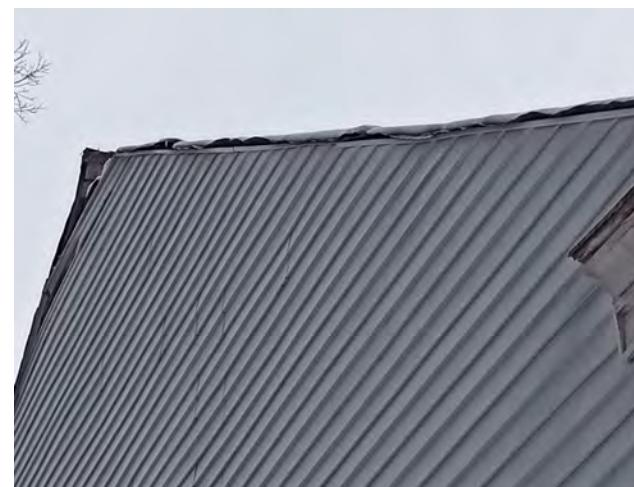
Figure 90: North roof rake, no drip or coverage

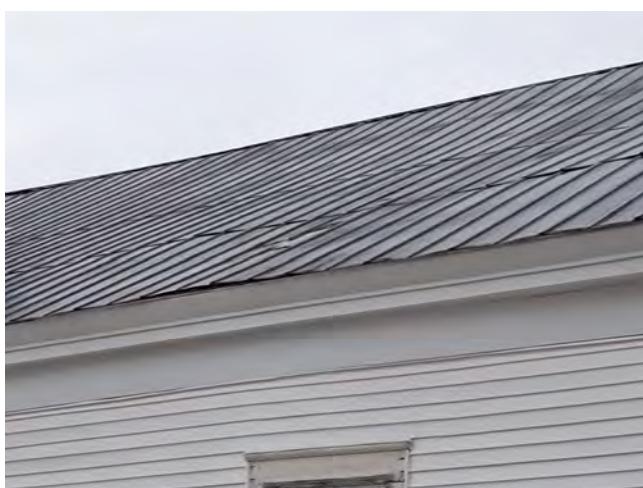
Figure 91: East roof plane, corrugated metal

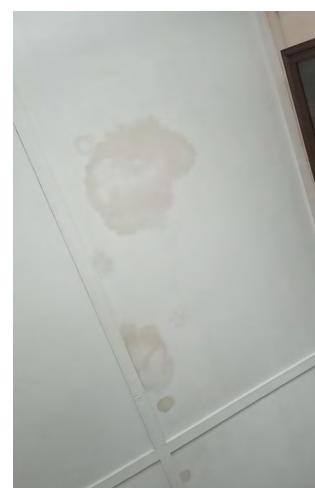
Figures 92 & 93: Staining due to water leaks at second floor ceiling

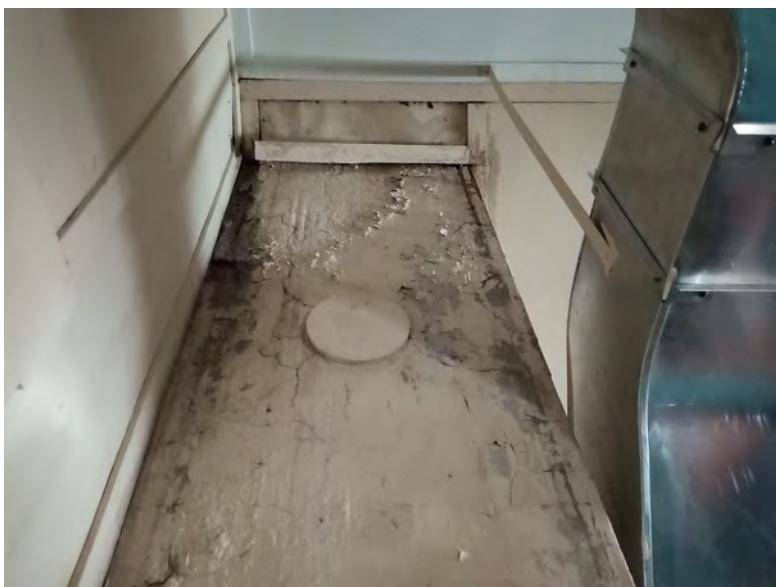
The chimney flashing is relatively new, installed to address leaks the result of which are still evident in bubbled, peeled interior paint and staining at interior finishes. The flashing appears well-installed and intact. Chimney brick masonry and mortar joints appear in good condition and intact, as does the vent cap.

Figure 95: Interior view of chimney & former stove pipe connection

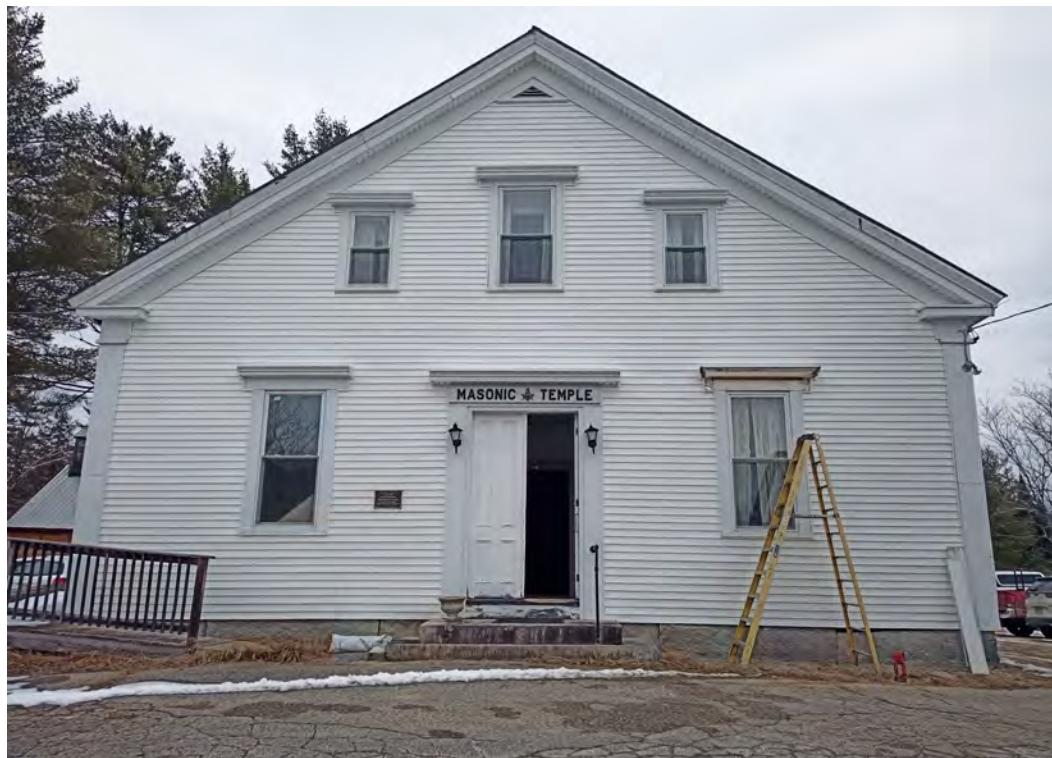
The exterior walls are clad with vinyl siding atop original wood clapboards. The exterior wood trim that has remained exposed exhibits paint-loss, cracking, and material loss. Where vinyl-clad, the original wood clapboards and trim behind appear to be intact and restorable. It is recommended to remove all vinyl siding and restore facades to their 1926 appearance. It is further recommended, once exposed, to undertake paint sample analysis and implement a circa-1926 scheme if discovered.

Figure 96: Front (south) facade

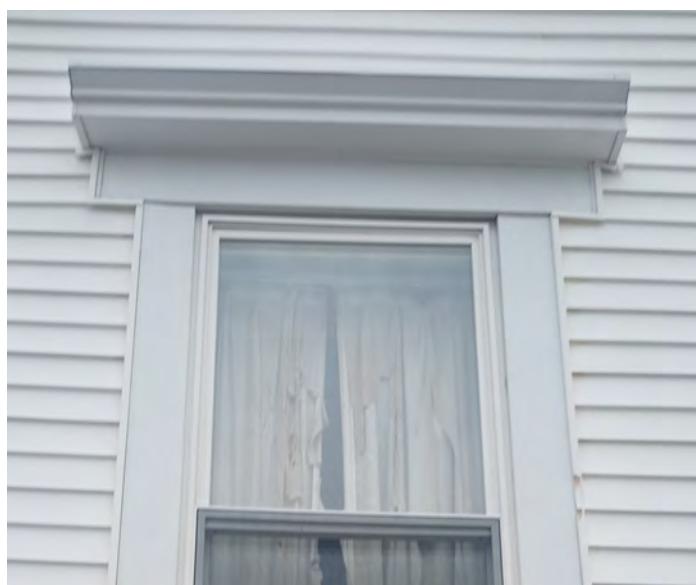
Figure 97: Window head trim with vinyl covering

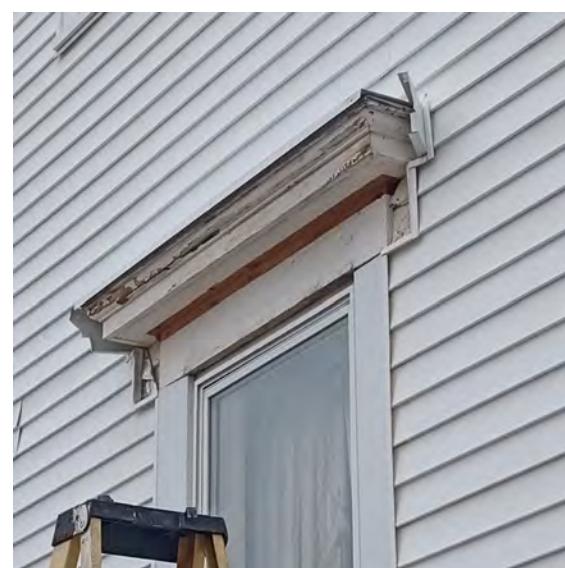
Figure 98: Window head trim with vinyl removed, intact wood trim revealed

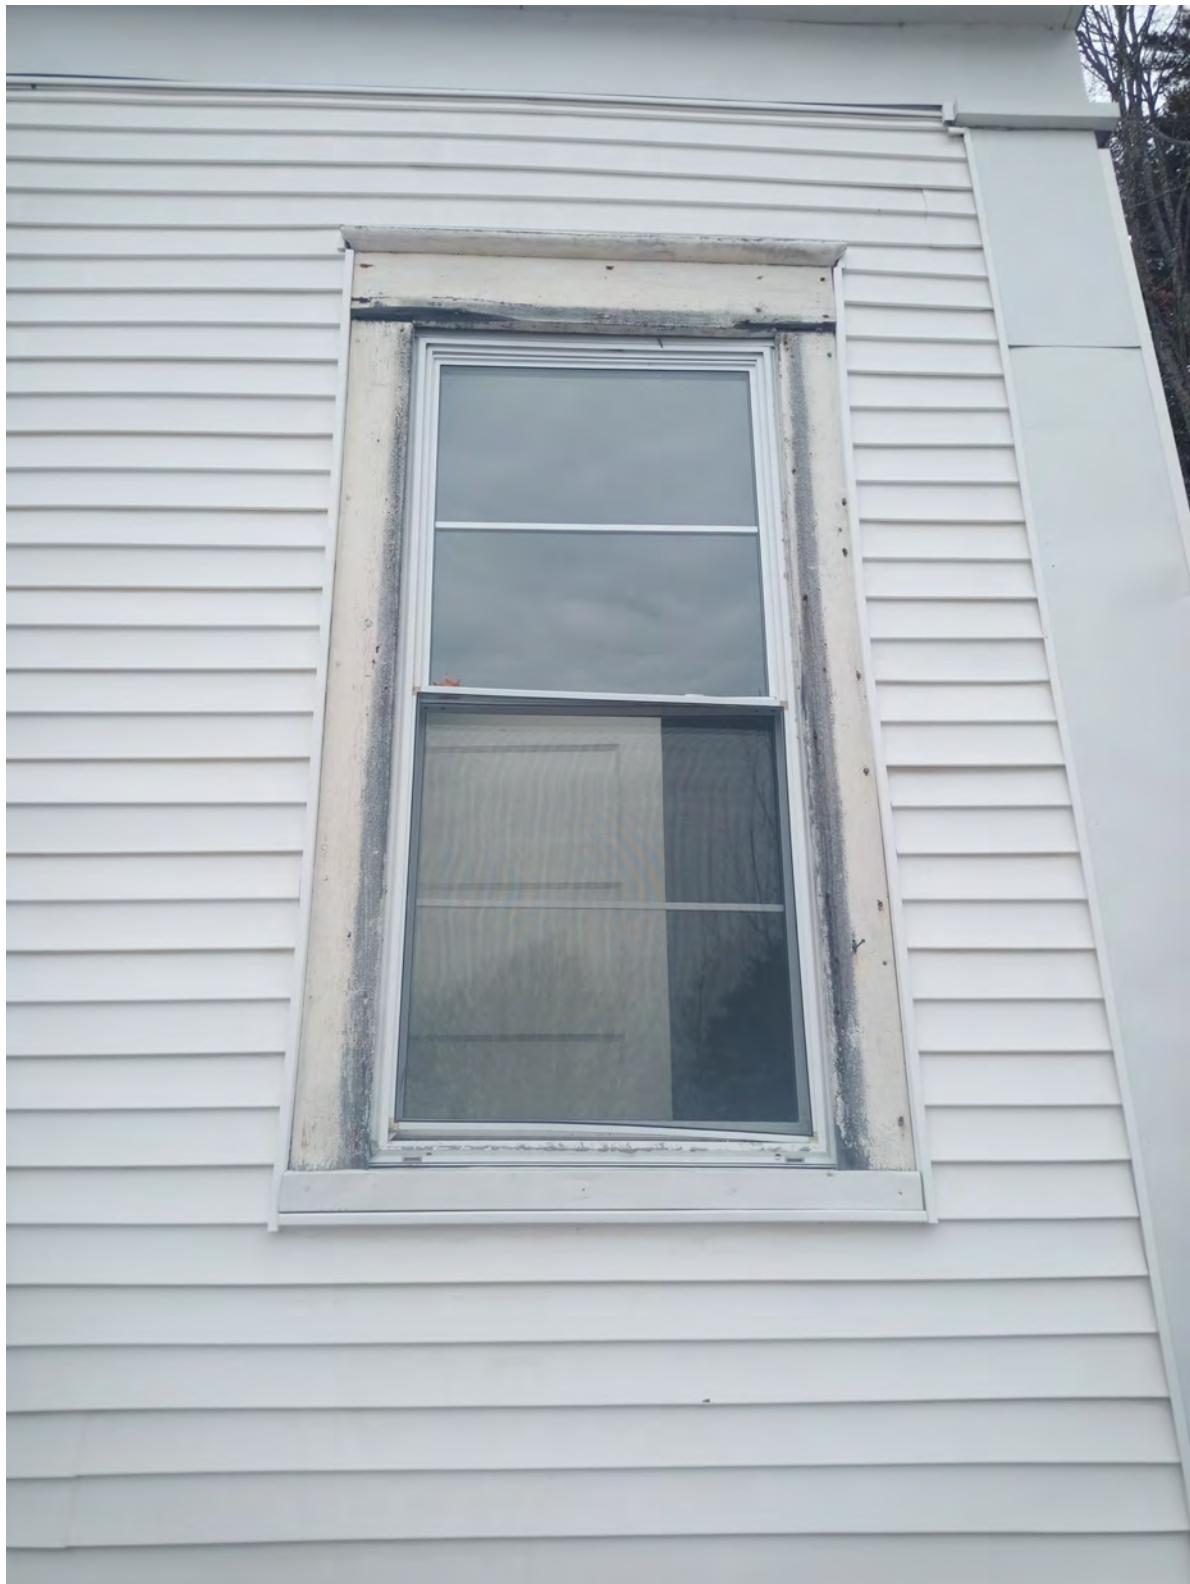
Figure 99: East side window with flat wood trim exposed

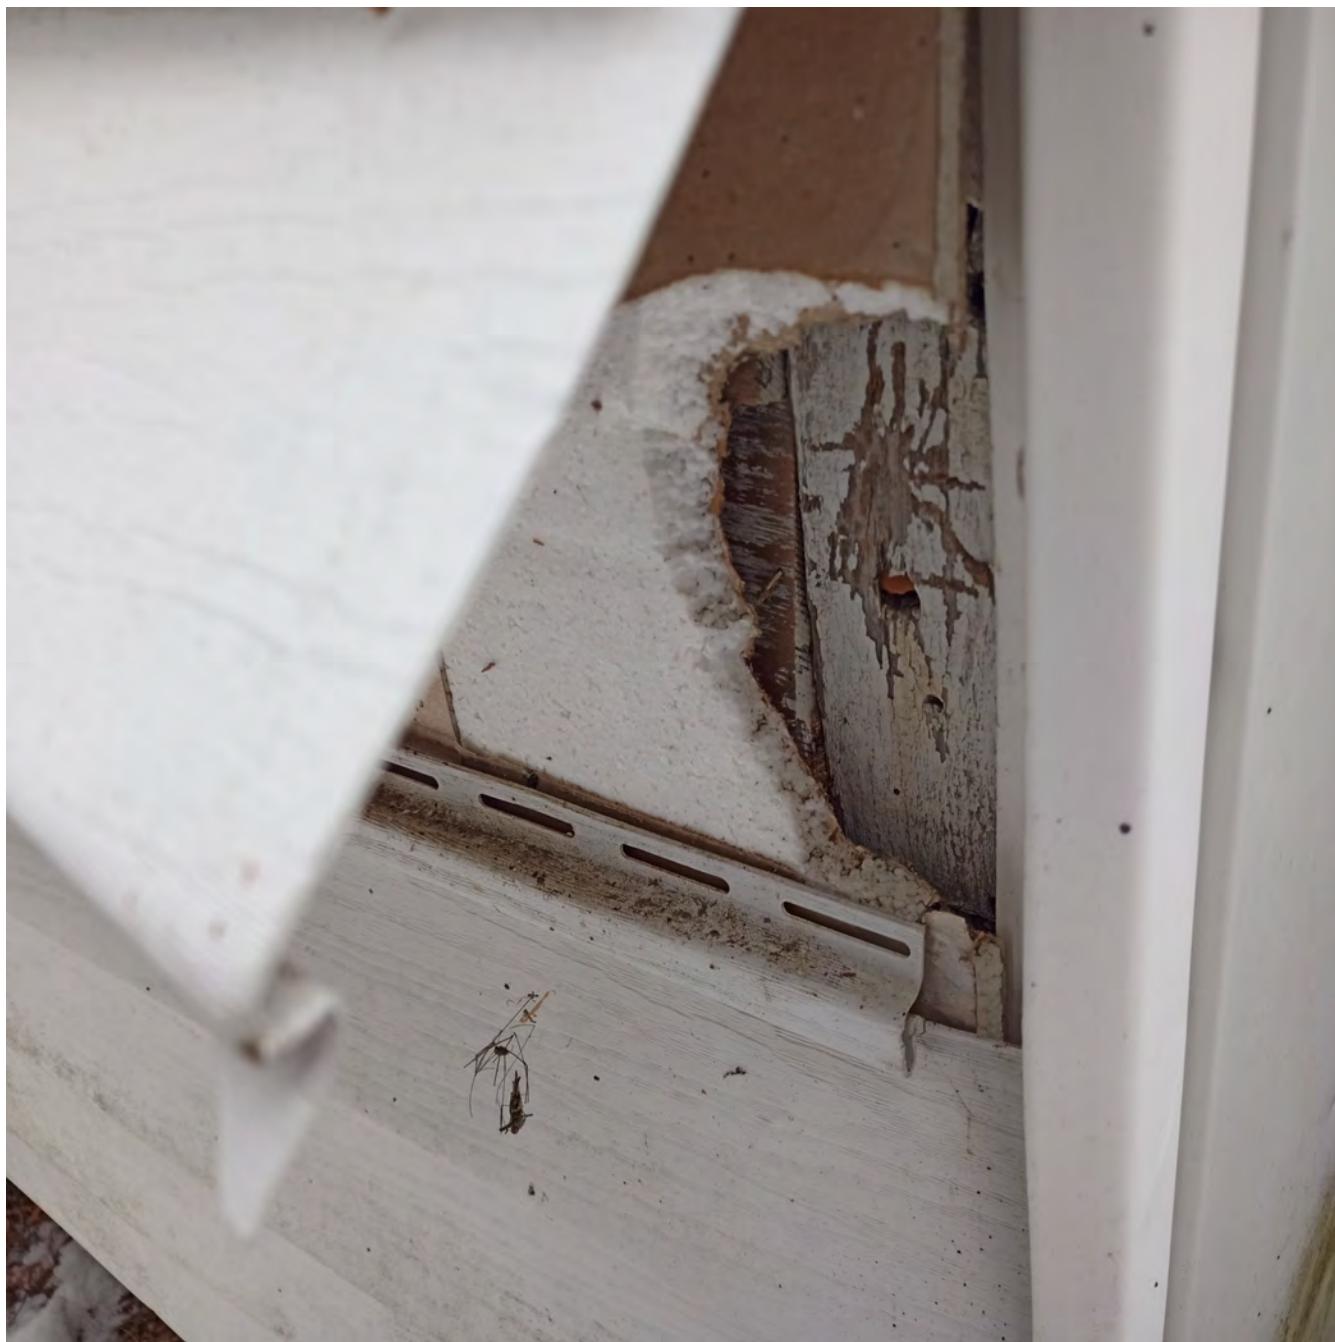
Figure 100: Vinyl siding lifted to reveal intact wood corner board and clapboards

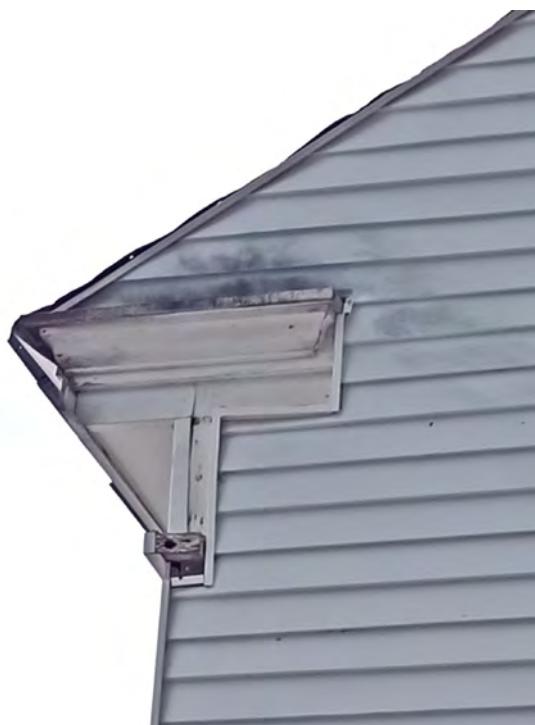
Figure 101: Intact wood cornice / eave trim

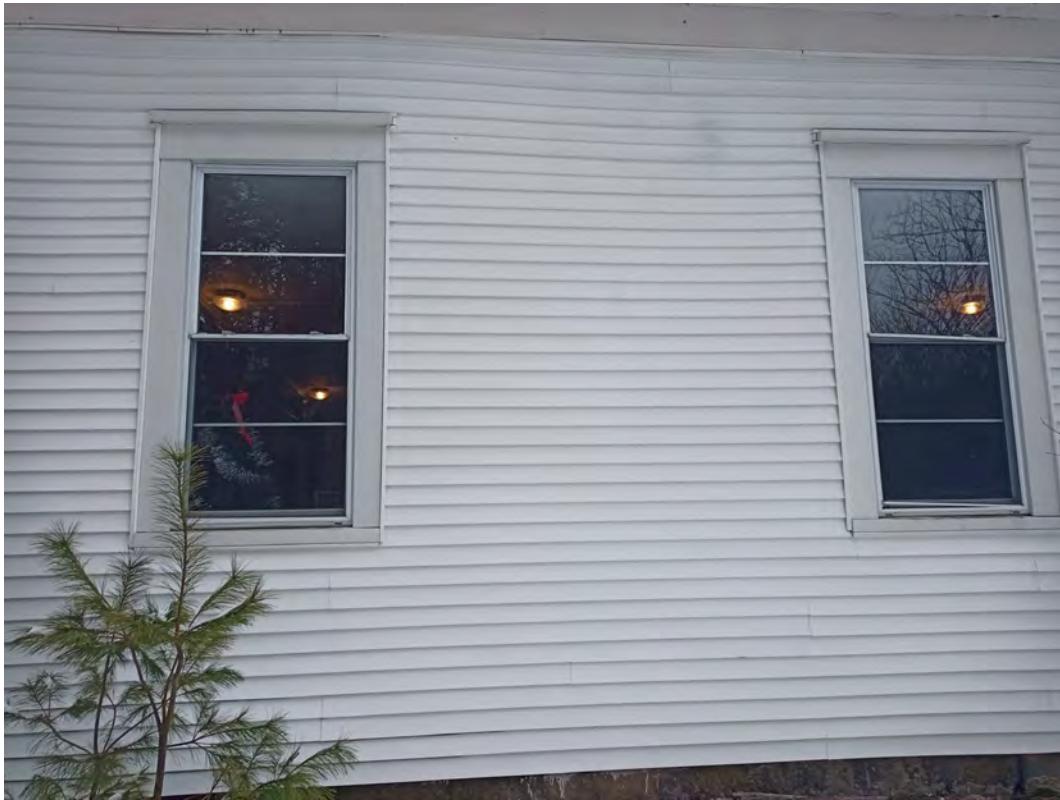
Figure 104: West façade window trim, wood window trim exposed and intact

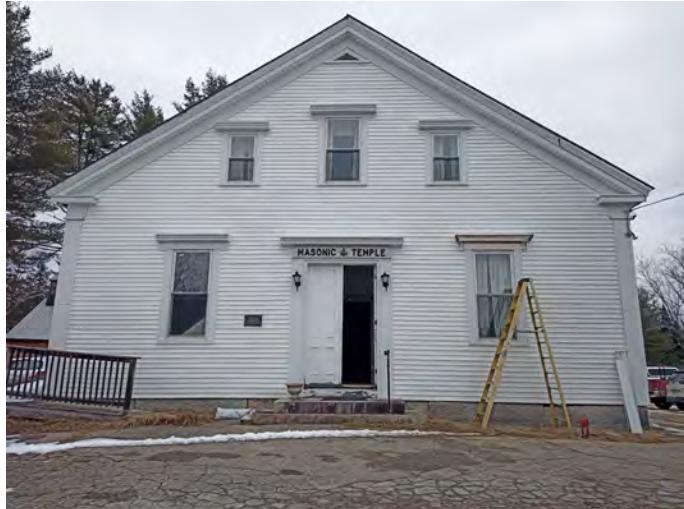
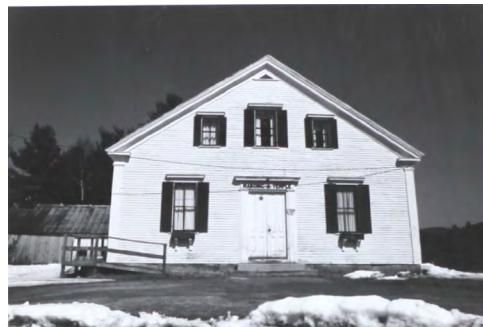
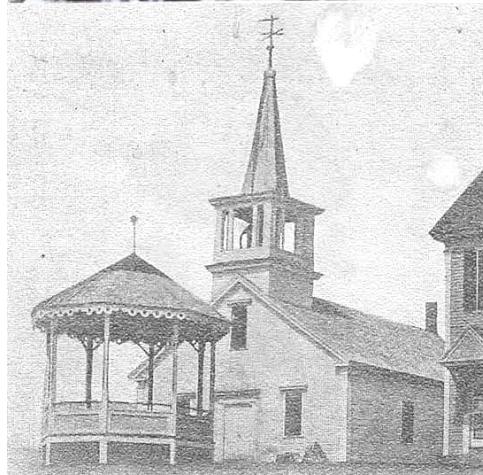
Figure 108: Front faced 2025; Top right: Front façade circa 1989, note 2/2 windows and shutters; Bottom right: front façade circa 1930, windows appear to be shuttered.

The present vinyl window sash were installed between 1989 and 2013. They are in acceptable working condition. Prior to these existed 2/2 double-hung wood sash, which are believed to have been installed by the Masons in the major 1926-1928 renovation. As part of the planned full exterior restoration, the Town intends to replace all vinyl sash with 2/2 true divided-lite wood sash, as well as to restore the louvered shutters and window boxes.

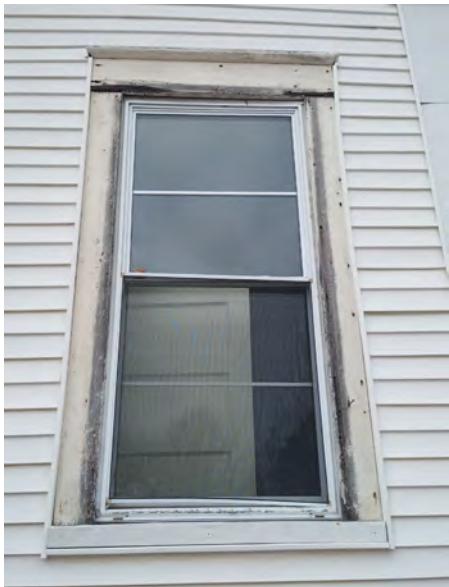
Figure 109: Typical side façade window

The following is applicable to existing wood sash at the rear façade, and to future restored wood sash & units: It is recommended to undertake inspection and repair of all windows annually or biannually, such as before and after winter, checking for paint loss, operation, and deterioration of wood. As full window restoration is a large endeavor, restoring groups of windows in phases or on rotation may be an option. It is recommended to number each window and keep a log of conditions observed and repairs performed.

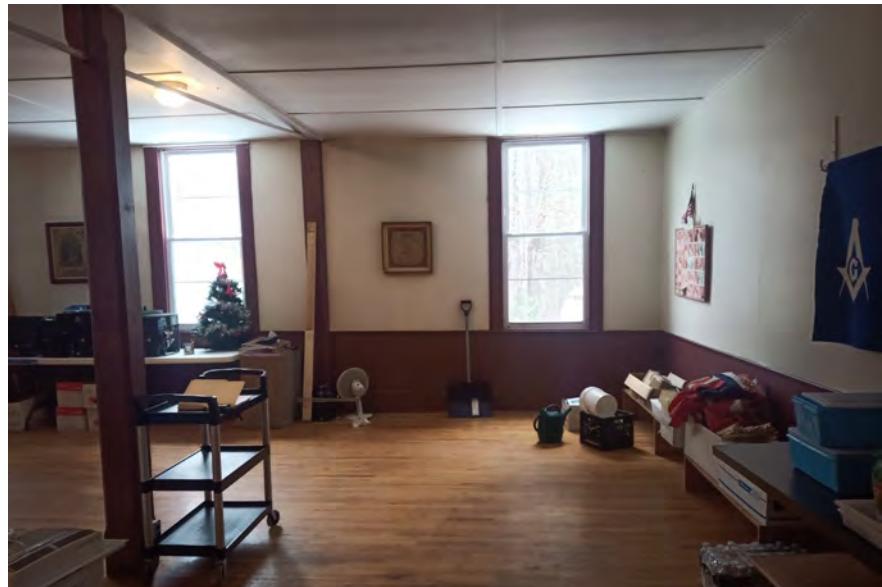
Figure 110: Typical side façade windows

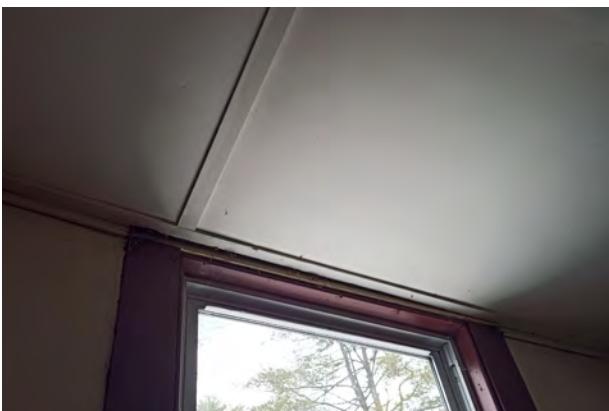
Figure 111: Typical side façade window

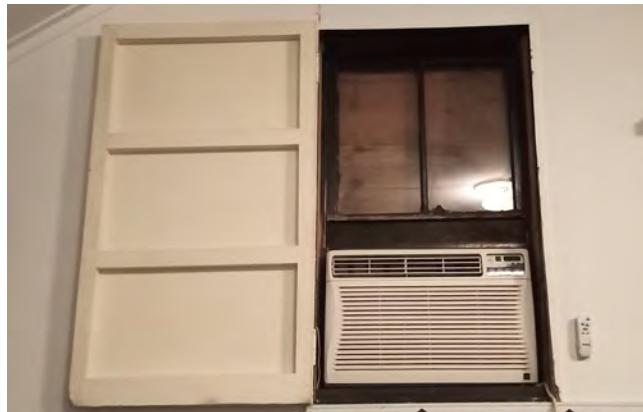
Figure 112: Sheathed over rear window with 1926-era 2/2 sash intact

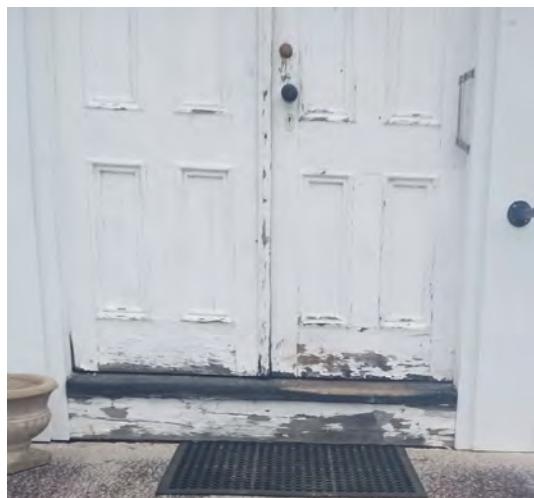
Figure 113: Front entry door – Paint loss and wood loss throughout, most severe at bottom rail. Sill and fascia also exhibit severe wear and deterioration. Restoration of all elements is recommended.

The four-panel front entry doors, reportedly original to the 1830 Church, but certainly dating to the 1926 Masonic Lodge, should be restored in full by a qualified restoration specialist including leafs, frame, sill, sill fascia, and all hardware. The front doors currently swing in. It is recommended to re-hang the restored doors with an outswing for improved egress safety.

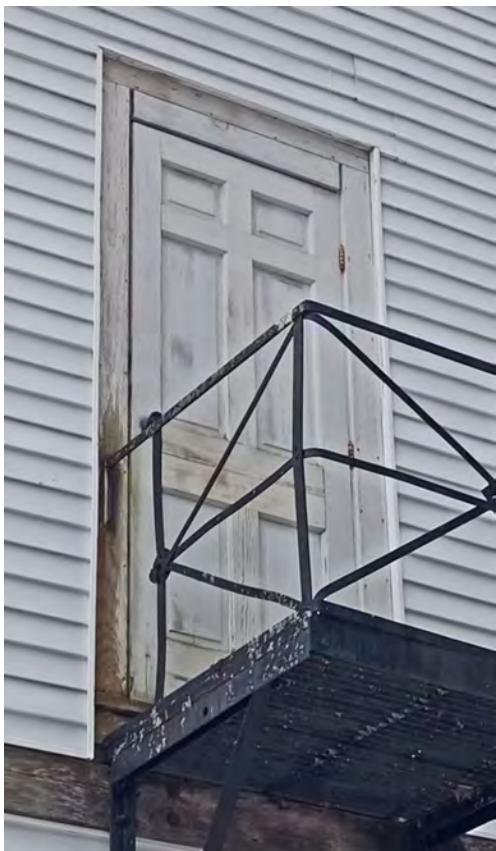
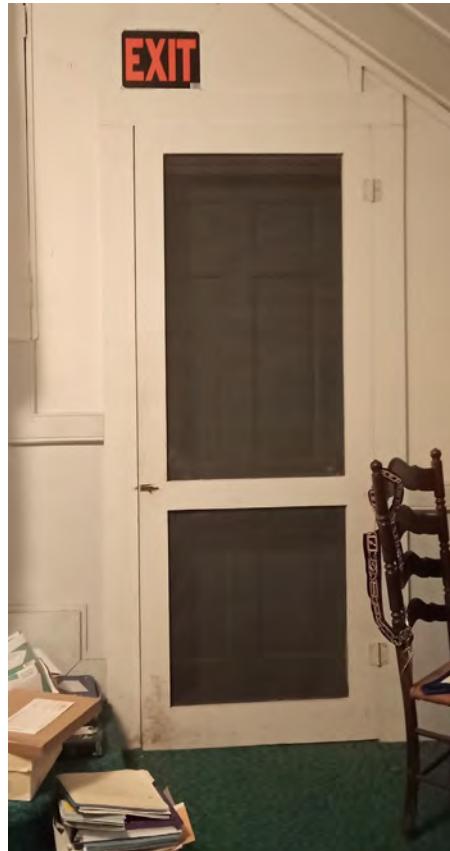
Figures 114 & 115: Rear second floor 6-panel wood egress door (Dates to 1960's or 70s)

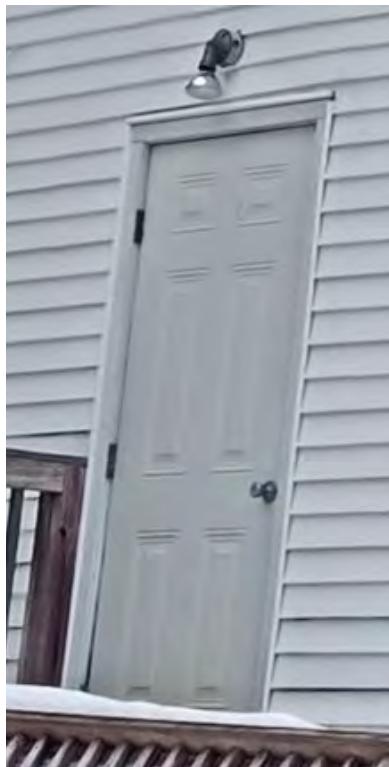
Figure 116: West facade, first floor egress door is a modern 6-panel fiberglass door

It is recommended to swap the existing west exit door location with the northwest window location if the building is to be used for anything other than occasional events and storage. However, the local code authority may accept the large windows with sills only a few feet above grade as acceptable egress.

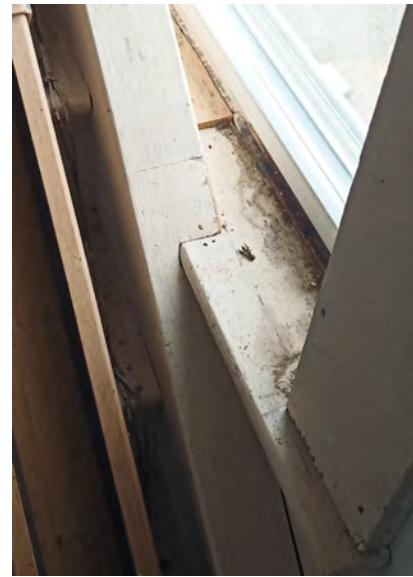
Figure 118: Staining at window sill due to water leak

Interiors are in fair condition with localized areas of staining and damage. When all structural and exterior repair and restoration is complete an interior repair campaign is recommended.

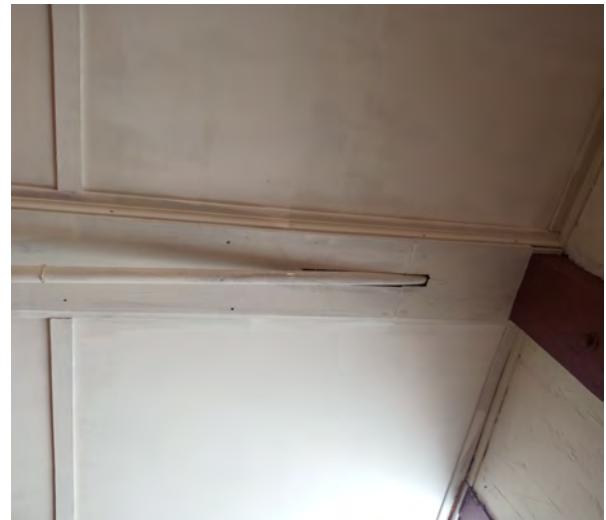
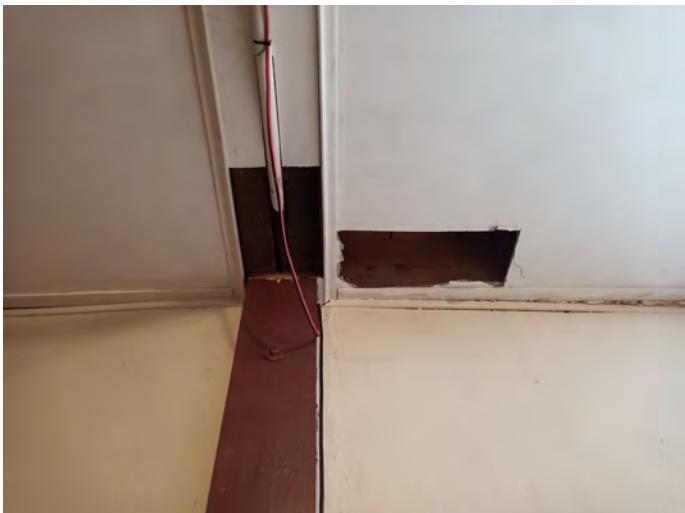
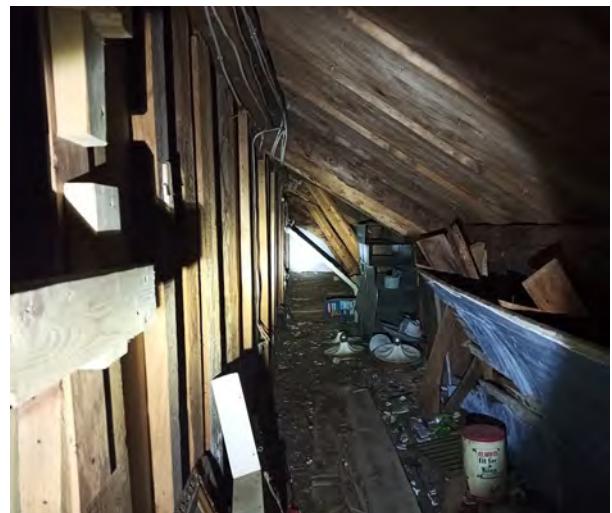
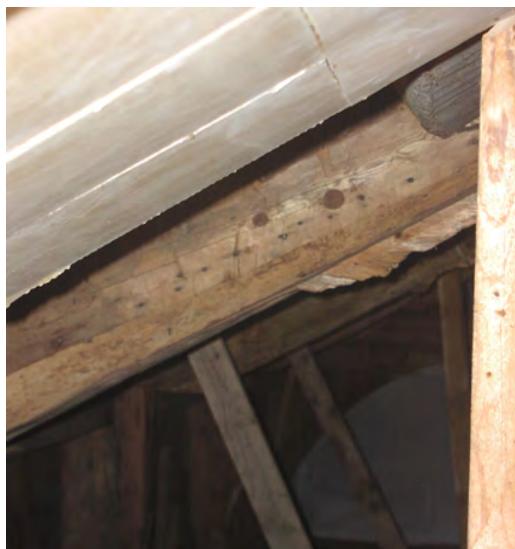
Figures 126-130: First floor tension rods, attic roof timbers, cut collar ties.

Structural deficiencies of the roof framing were identified by Bergeron Technical Services in 2022. In 2024/25, Annette Dey Engineering LLC was contracted to design reinforcement and that remediation work is currently underway. Scope includes installation of new knee braces at roof trusses, installation of custom angles tying rafters to second floor girders, and additional screws to reinforce all joints. All relevant documents are included in the Appendix of this report.

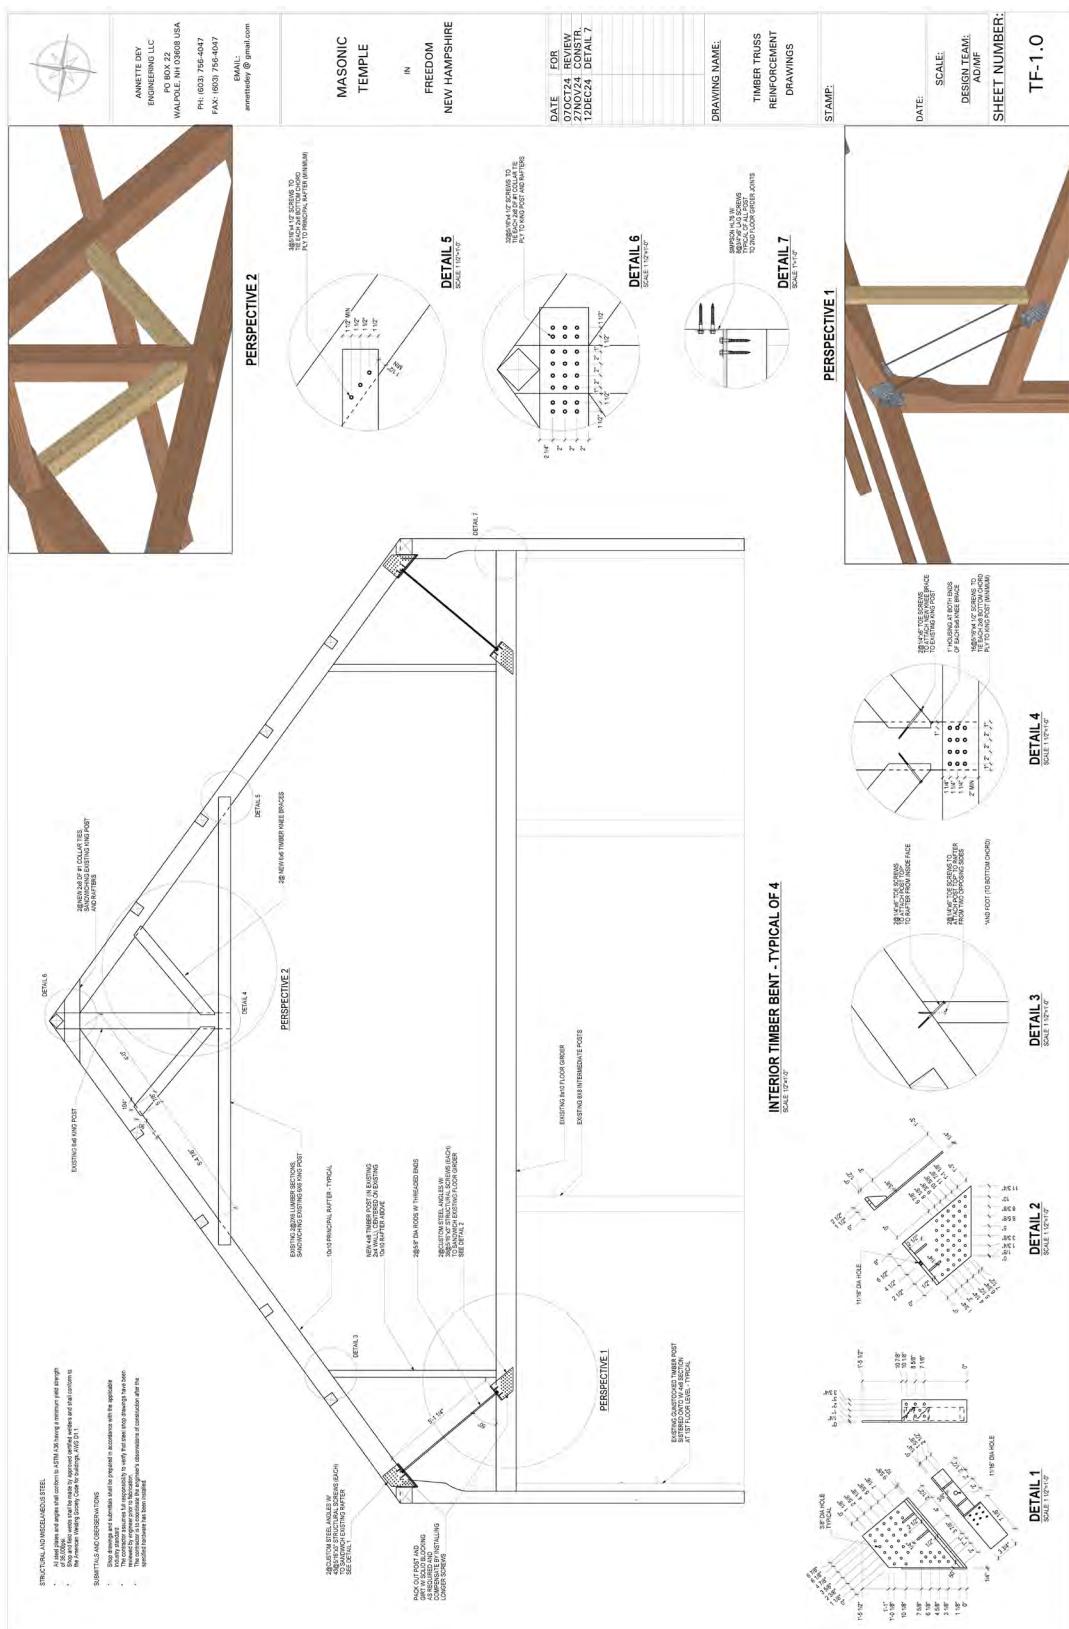
Structural reinforcement project underway, per design by Annette Dey Engineering, LLC

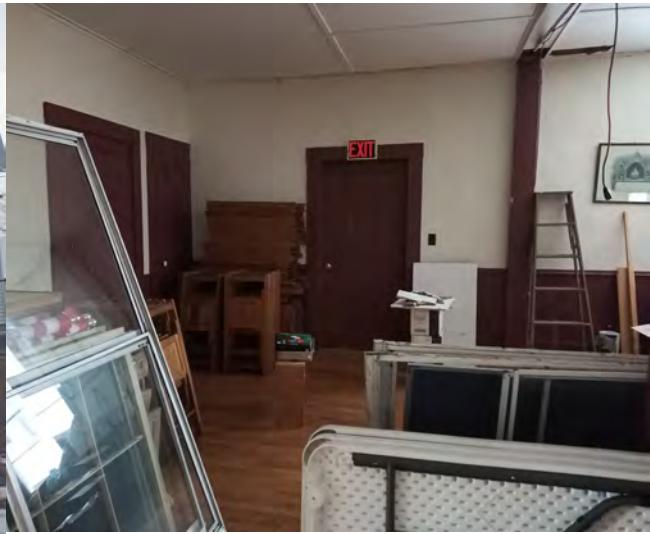
Figure 132: West egress door, access to ADA ramp

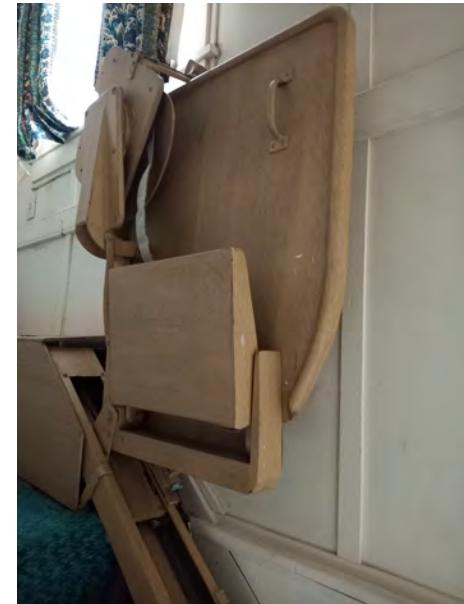
Figures 133 & 134: Access to the second floor is via a wooden stair chairlift that is no longer functional. If replaced in-kind, standby power must be maintained for this to be considered a code-compliant accessible means of egress.

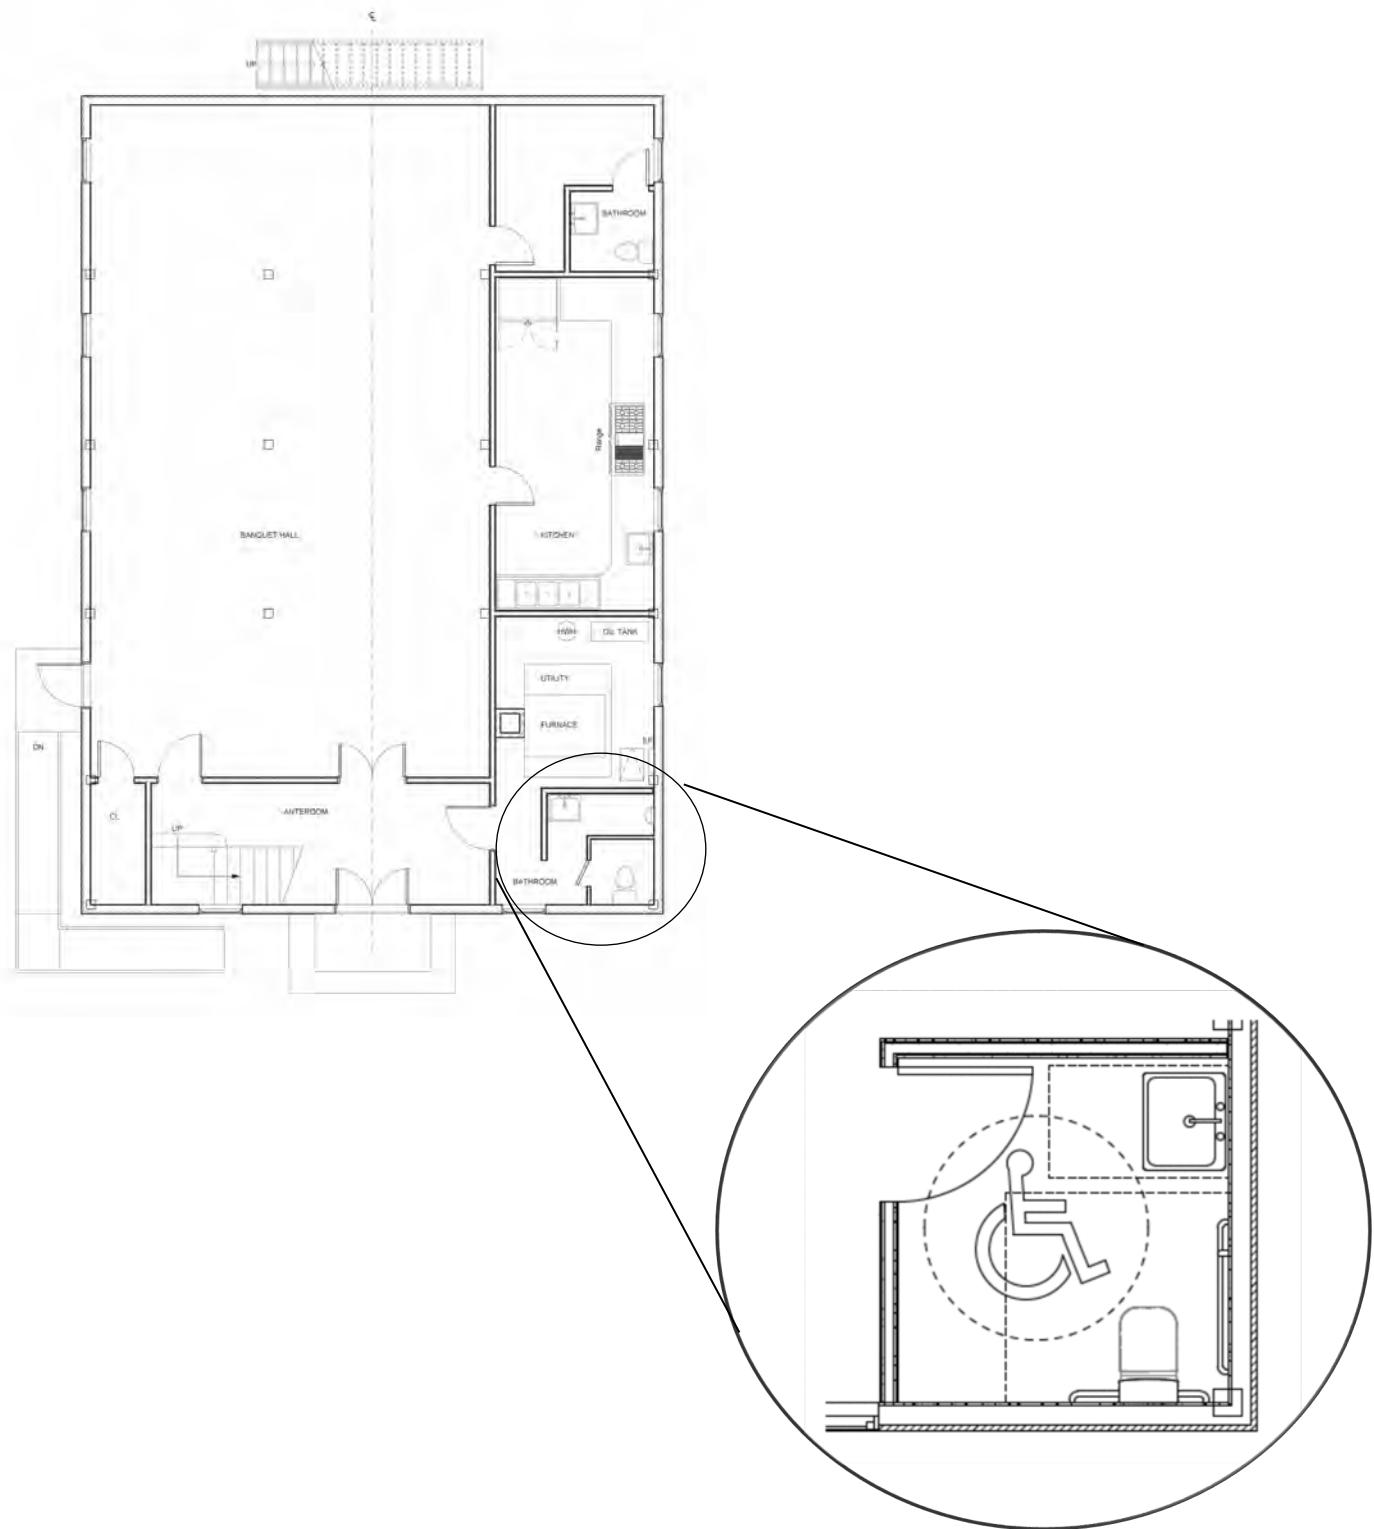
Figures 135: Front southeast bathroom can be reconfigured for ADA-compliant access.

<i>Preservation Brief 32: Making Historic Properties Accessible</i>	
H5. CONSTRUCT ADA-COMPATIBLE BATHROOM (<i>Modernization</i>)	\$25,000
<i>Preservation Brief 32: Making Historic Properties Accessible</i>	
H6. INSTALL LIGHTNING PROTECTION SYSTEM (<i>Modernization</i>)	\$15,000
Total HIGH PRIORITY Recommendations (Materials & Labor)	\$110,000
