HISTORIC BUILDING ASSESSMENT FOR MASONIC HALL

**29 OLD PORTLAND ROAD
FREEDOM, NH**

PREPARED BY: BETH MILLER, RA LEED AP, OF NORTH COUNTRY ARCHITECT

FINAL ISSUED 9/22/2025

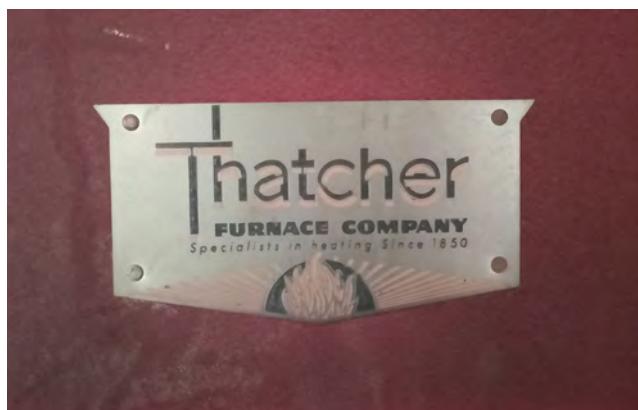
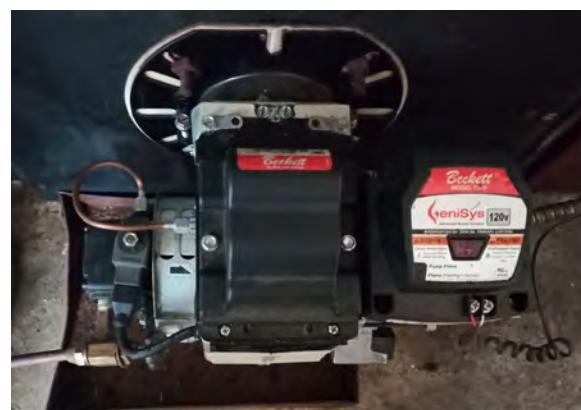
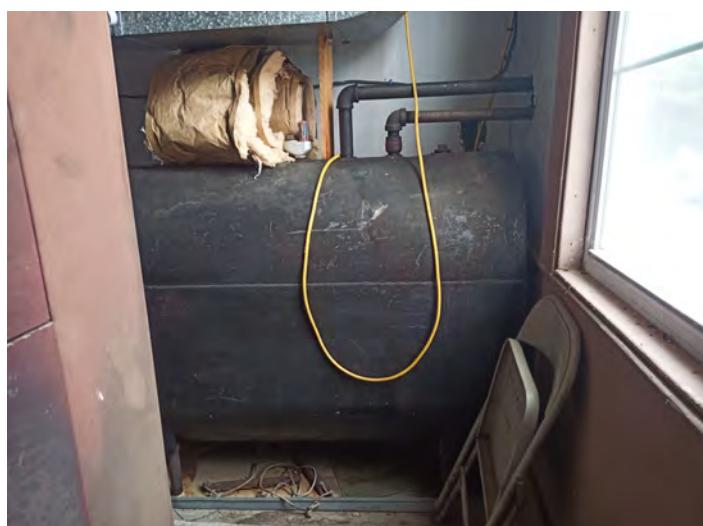
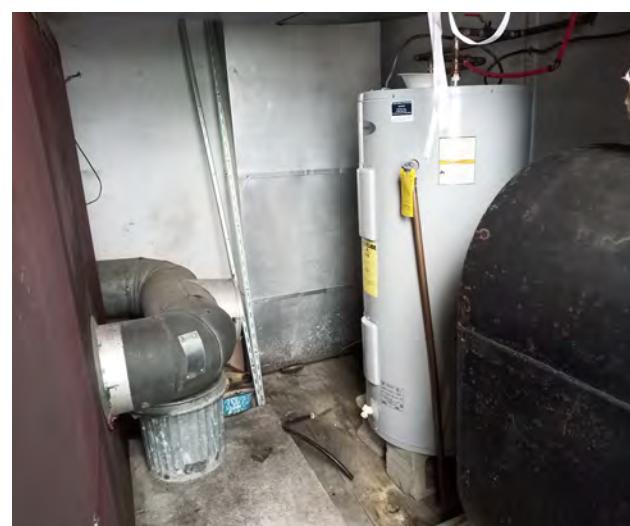
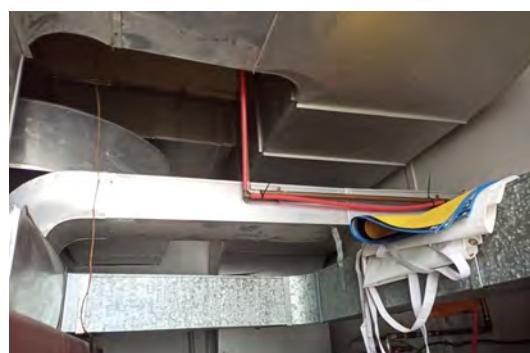
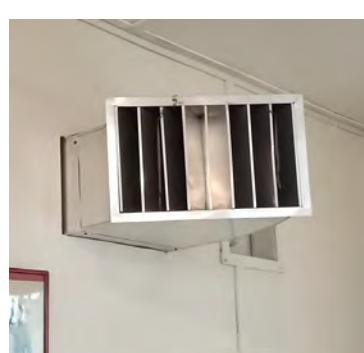
The building is heated via an oil-fired furnace supplying forced hot air with large metal ductwork. A single duct register serves the banquet hall. There has been interest expressed in upgrading the heating system for improved thermal comfort and zoning-type controls, as well as adding cooling since the building is currently cooled by a single in-window air conditioner unit in the upstairs Lodge room. If the heating system is updated and cooling capacity added, replacing ductwork would be recommended as modern ductwork offers smaller diameters and flexible options. If the building is to remain in use primarily as storage space with only occasional meetings, as is the consensus as of submission of this report, minimal modifications to the existing system should be sufficient. However, if the building is to be renovated to house offices in the future, whether temporarily or permanently, replacement of the heating system and/or installation of supplementary heat pumps may be needed.

Figures 136-141: From top left to bottom right: Thatcher furnace, oil tank, hot water heater, large rigid metal ductwork, sole main hall heat supply register

MEDIUM PRIORITY RECOMMENDATIONS (2-5 YEARS)	ESTIMATED COST
M1. ELECTRICAL SYSTEM UPGRADE (Modernization) Add outlets, update lighting.	\$35,000
M2. HEATING SYSTEM UPGRADE (Modernization) Add zoning, and replace large rigid ducts with smaller, flexible ductwork. Add heat pump at rear façade for cooling. Heating system upgrade estimate assumes that the Masonic Hall will continue to be used only for occasional meetings and storage (as is the consensus at the time of submitting this report). If the Hall is to be renovated to house offices in the future, whether temporary or permanent, assume double the estimate provided for a new heating/cooling system. Preservation Brief 24: HVAC in Historic Buildings	\$50,000
M3. STAIR WHEELCHAIR LIFT REPLACEMENT (Modernization) Replace existing stair wheelchair lift with modern unit, including standby power. Preservation Brief 32: Making Historic Properties Accessible	\$25,000

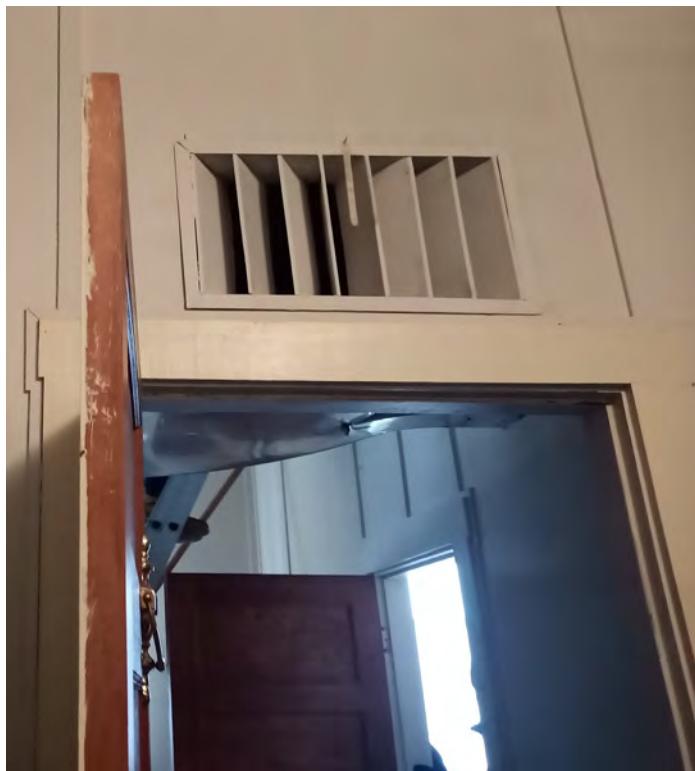
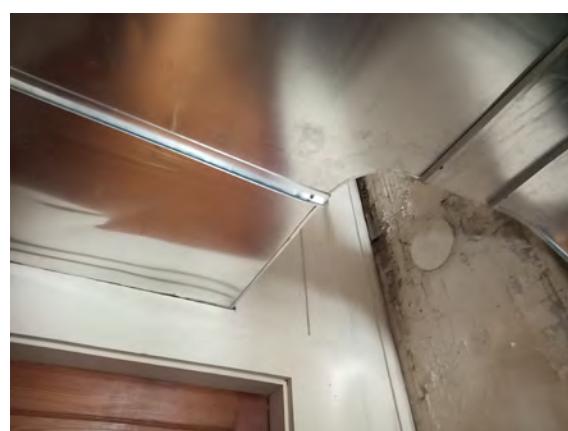
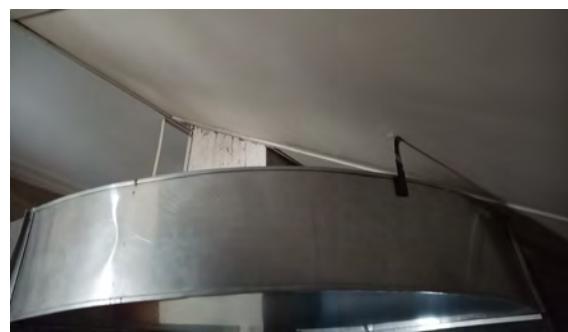
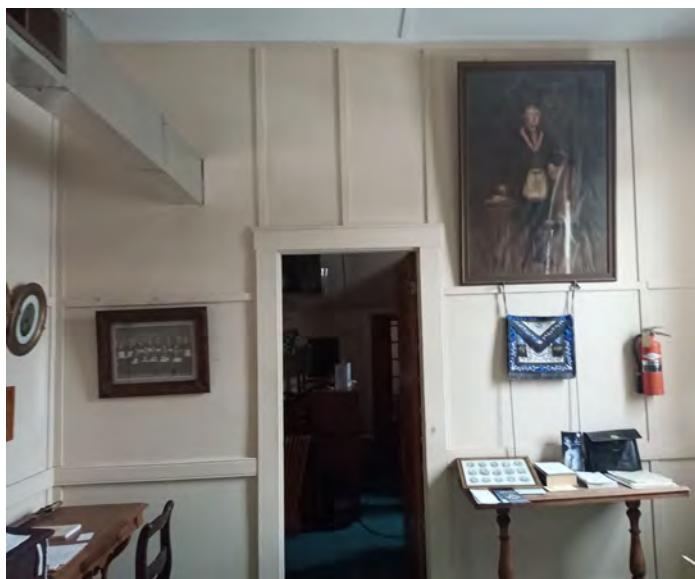
Figures 142-145 From top left to bottom right: Lodge heat supply register, large fixed metal ductwork.

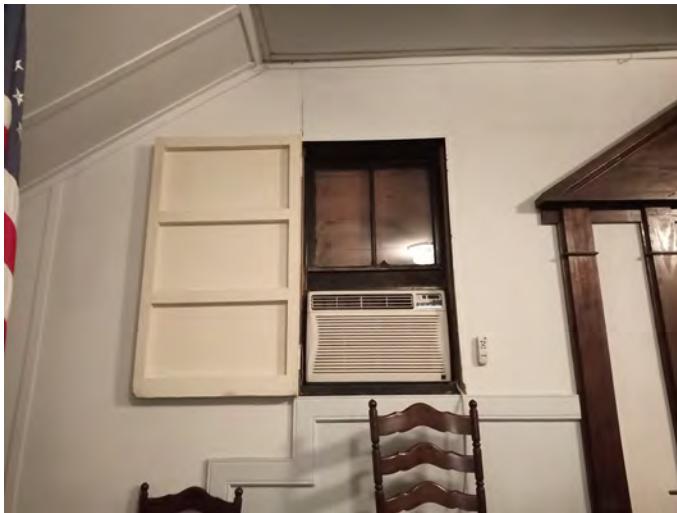
Figures 146-147: Blocked up rear second floor window (2/2 double-hung) with air conditioner unit. AC supports are not safe and should be repaired as soon as possible.

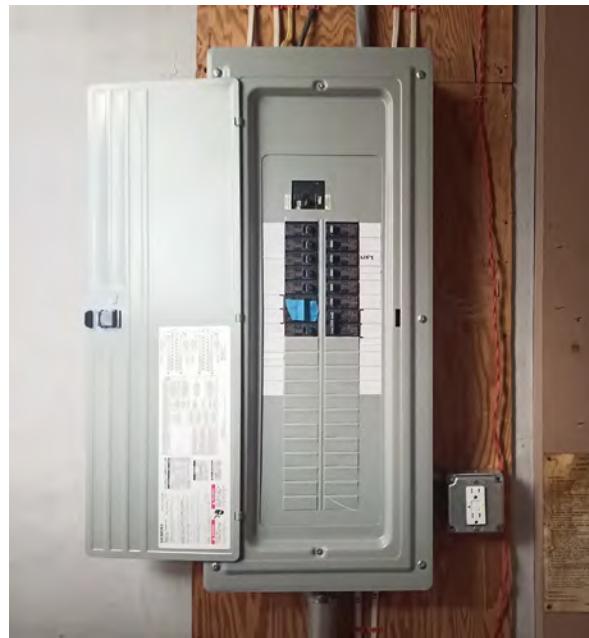
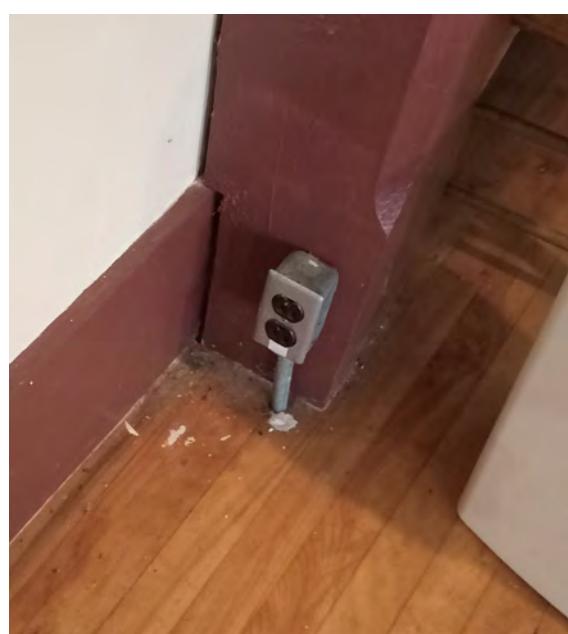
Figures 148-149: Electrical panel, surface-mounted conduit and outlets, typical.

The electrical system was reportedly updated in the 1960's / 70's and again in 2022. There is a 200 Amp panel in the utility room. Most rooms have in-wall wiring. The Banquet room is an exception with surface-mounted conduit and surface-mounted outlets throughout. If this room is to be used for anything other than occasional events and/or storage, additional and code-compliant outlets and wiring should be installed.

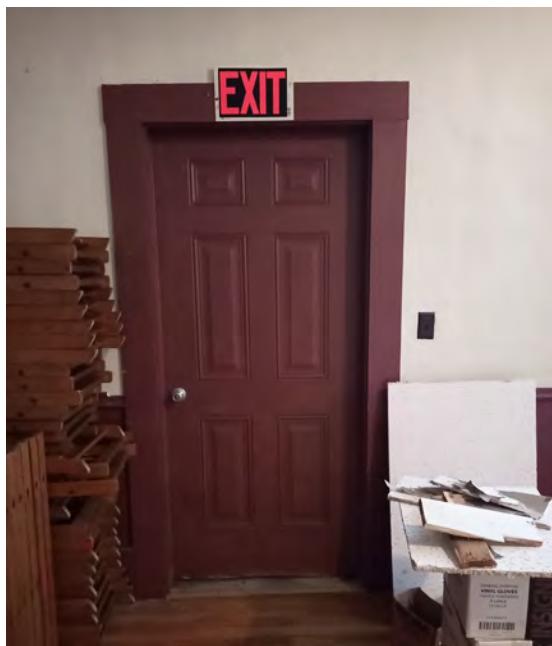
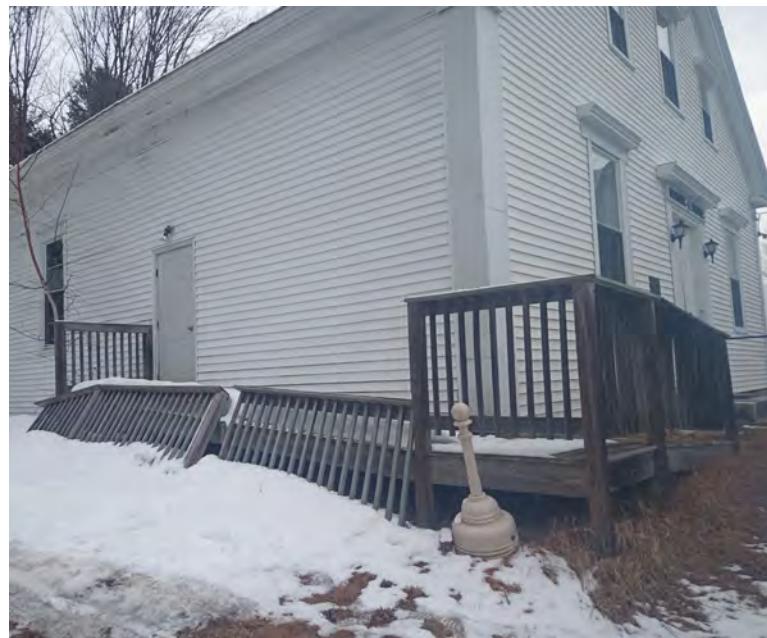
Figures 150-151: West egress door and west ADA ramp

At approximately 24.75-feet apart, the distance between first-floor exits is approximately 36.5% of the 67.75-foot diagonal, so does not meet the one-half length requirement and therefore is not code-compliant. Per IBC 1007.1.1, the two exits must be located at a distance apart that is “equal to not less than one-half of the length of the maximum overall diagonal dimension of the building or area to be served.”

It is recommended to swap the existing west exit door location with the northwest window location if the building is to be used for anything other than occasional events and storage. However, the local code authority may accept the large windows with sills only a few feet above grade as acceptable egress.

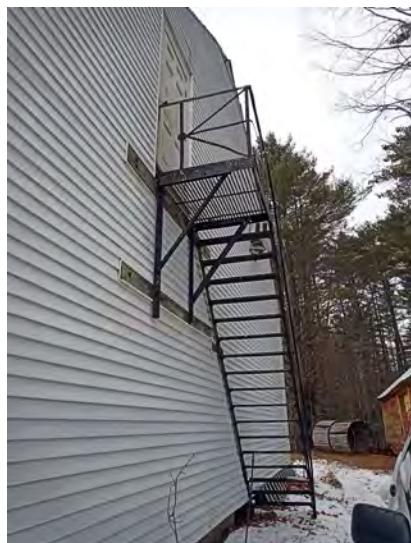
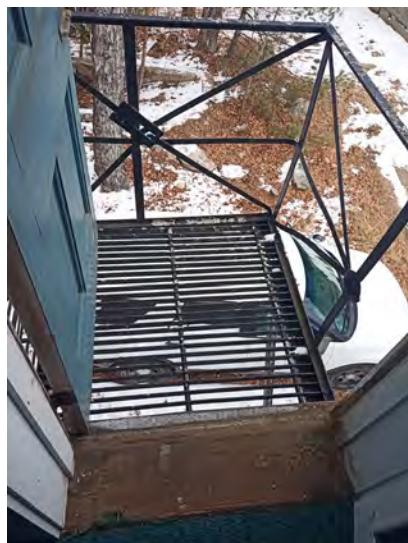
Figures 152-153: Rear fire escape

While the rear metal fire escape appears to be intact, it should be inspected biannually. If the second-floor lodge room is to allow a maximum occupancy of 84 persons, the fire escape must be able to sustain a load of at least 100 psf. The fire escape was reportedly recently inspected and accepted by the local Fire Chief, as well as engineer Annette Dey, who recommended installing vertical posts for added stability.

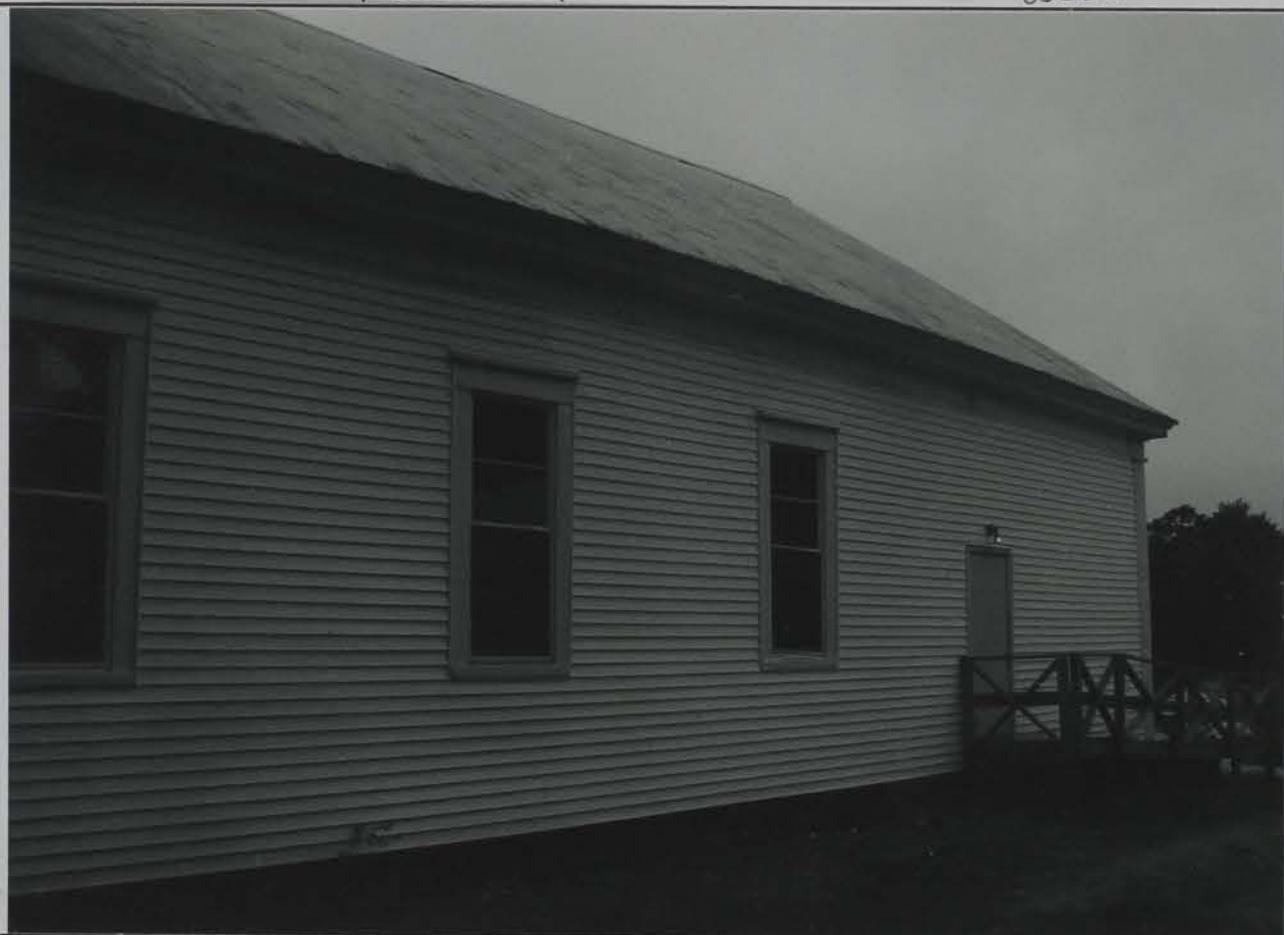
Photo # 9 Description: West side, emergency door where window was
Roll and Frame # OR Digital file name: P6080108

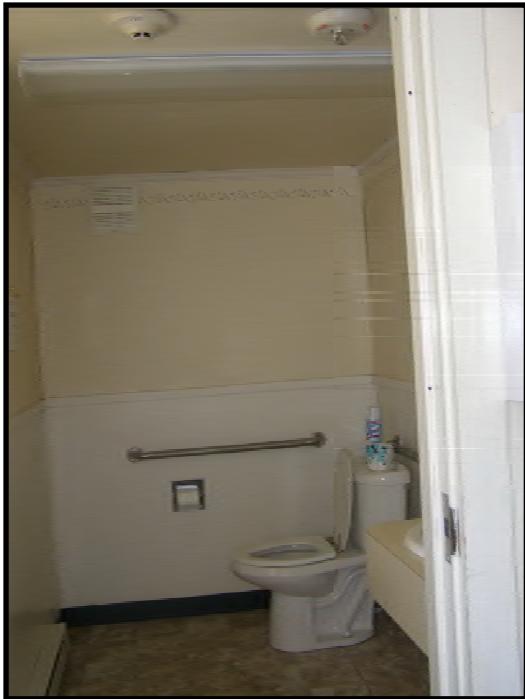
Town Office Restroom. 18" ver. cal grab bar on the sidewall of the toilet required for accessibility is not installed.

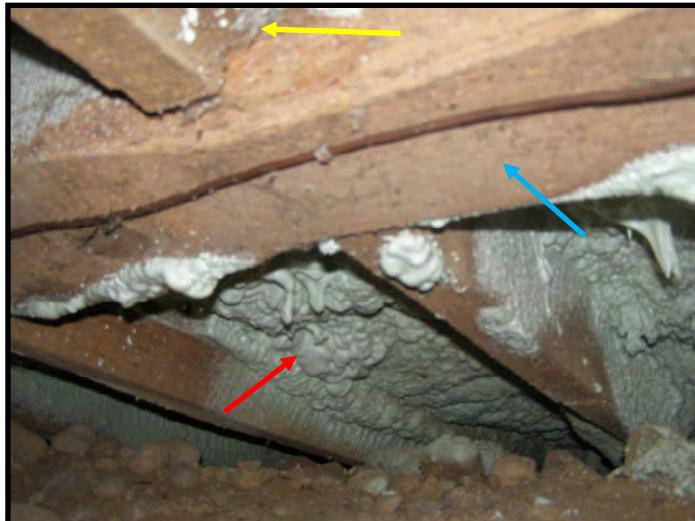
Photo of the first floor system taken from the crawl space. Blue arrow indicates a main carrying beam. The Yellow arrow indicates where the floor joists are 1/2 mortised into the beam. The red arrow indicates where approximately 6" of spray foam insulation has been installed between the floor joist bays.

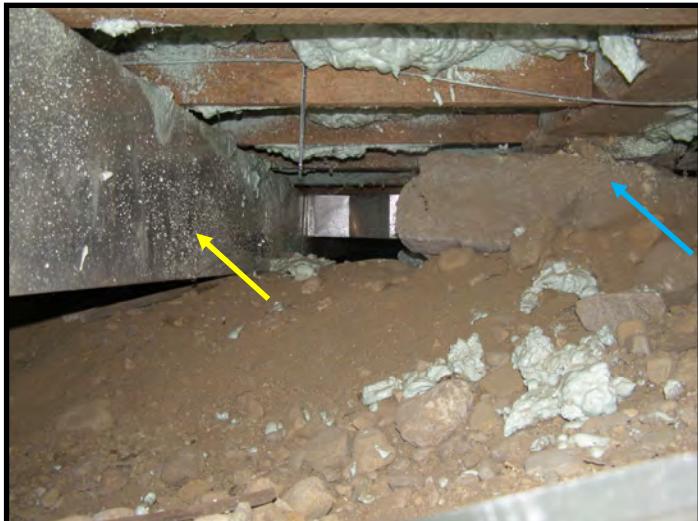
Photo of the first floor system taken from the crawl space. Blue arrow indicates a stone support. The yellow arrow indicates metal distribution ducting for the oil furnace.

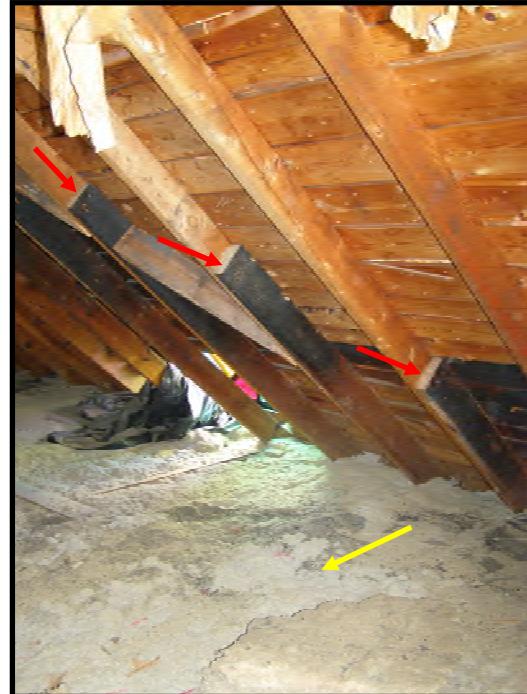
Photo of the attic. Red arrow indicates charred/cut rafters. Yellow arrow indicates blown-in cellulose insulation in the ceiling joist bays

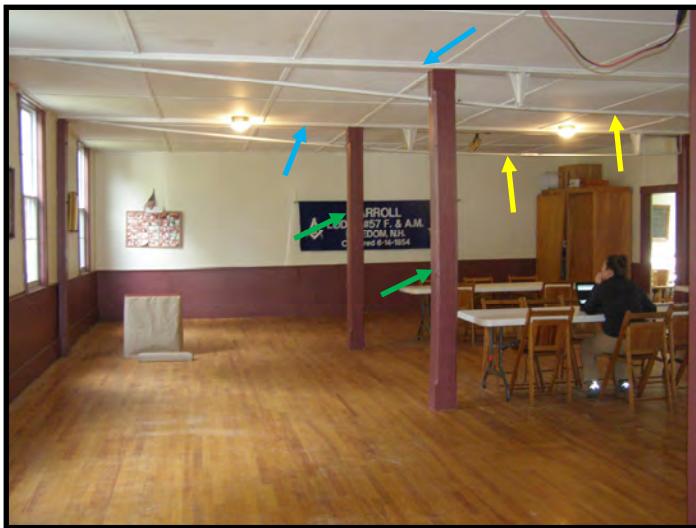
Existing banquet hall at first floor of Masonic Temple. Blue arrow indicates carrying beams for the second story floor. Green arrow indicates the mid-span columns supporting the floor beams. The yellow arrow indicates the steel tension rods.

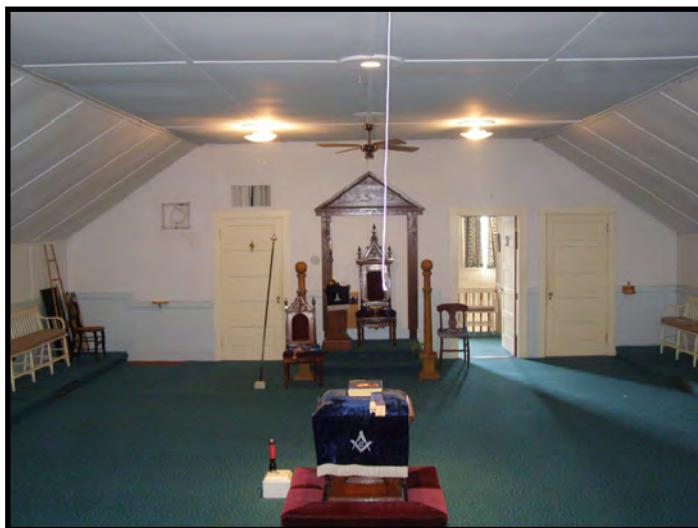
Masonic Temple looking south toward upper lobby.

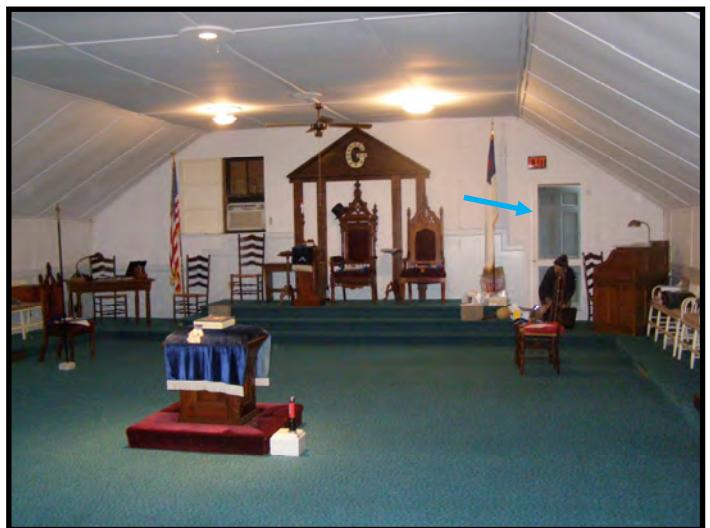
Masonic Temple looking north. Emergency exit door leading to exterior metal fire escape indicated with blue arrow.

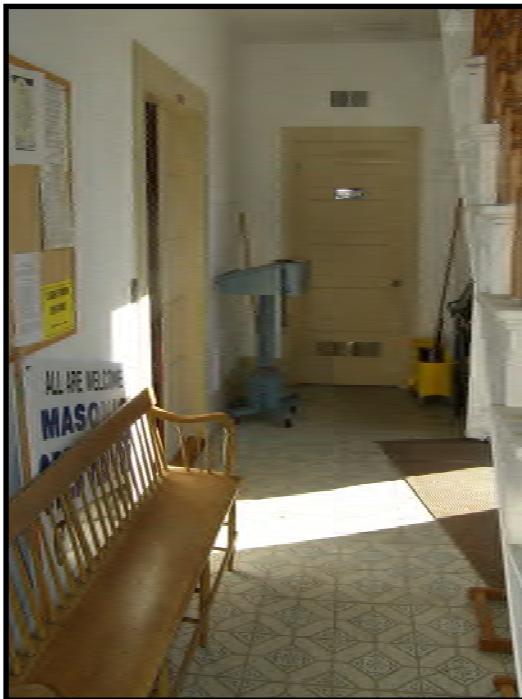
Masonic Temple first floor lobby, looking towards the east.
The tile floor in this space has tested positive for asbestos.

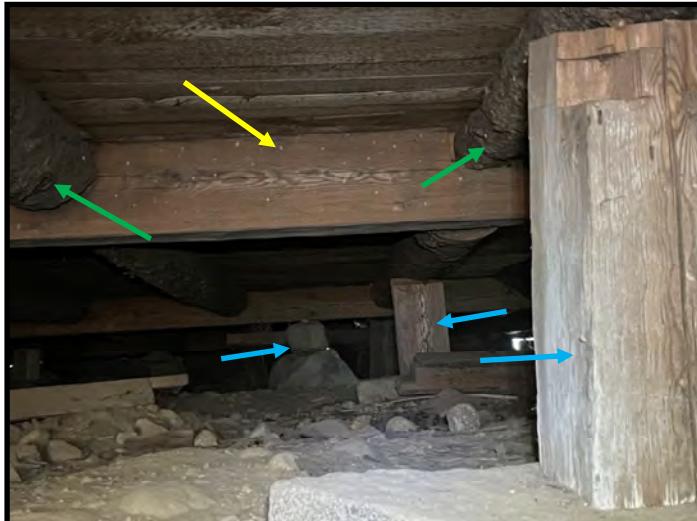
Masonic Temple crawl space/floor system. Yellow arrow indicates main carrying beam (with powder post beetle frass). Green arrow indicates 3/4 timber joists. Wood post and stone piers can be seen in this photo, supporting both beams and bolstering joists, (blue arrows).

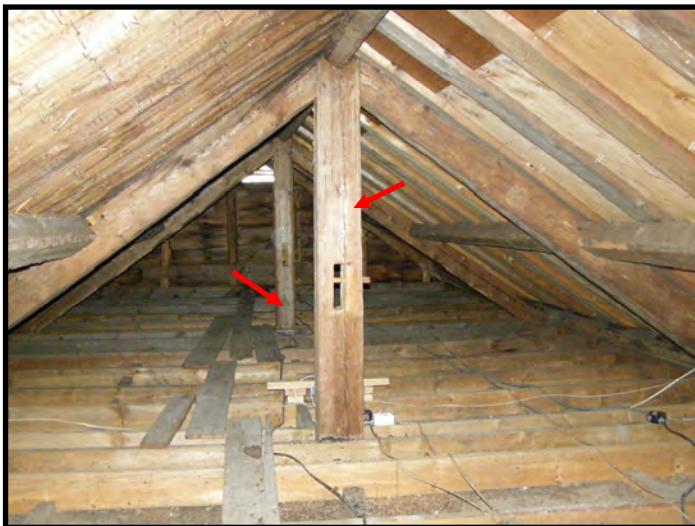
Attic space above second floor at the Masonic Temple. The king posts are indicated in red, these have been cut off the ceiling level, sandwiched and fastened between the 2x6 ceiling joists.

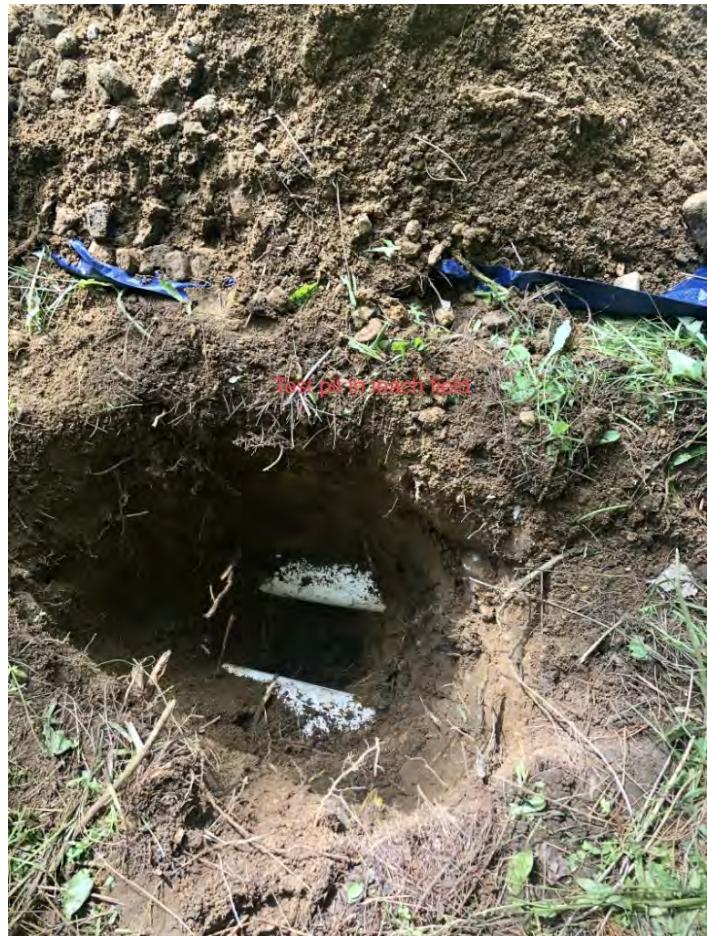
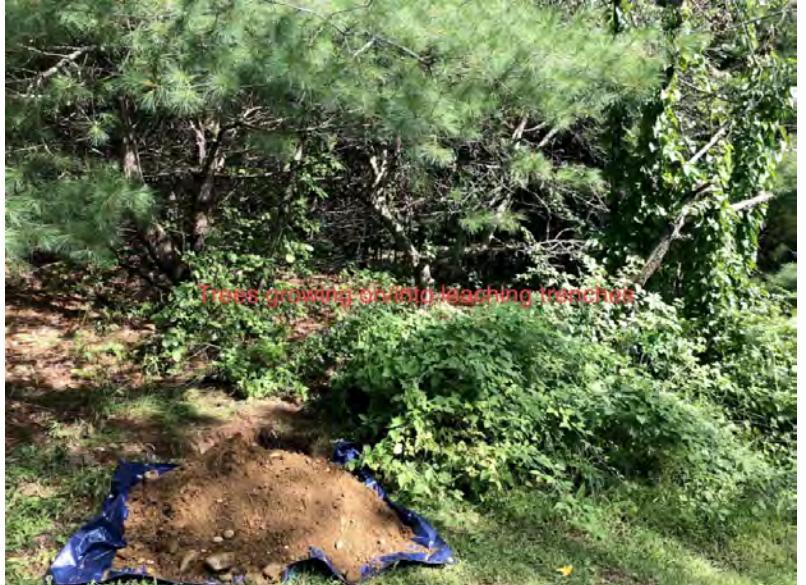
septic system appears in working condition. septic tank was pumped prior to inspection, so system could not be loaded for perc test.

trees in/above leach field should be removed, and Root Kill applied

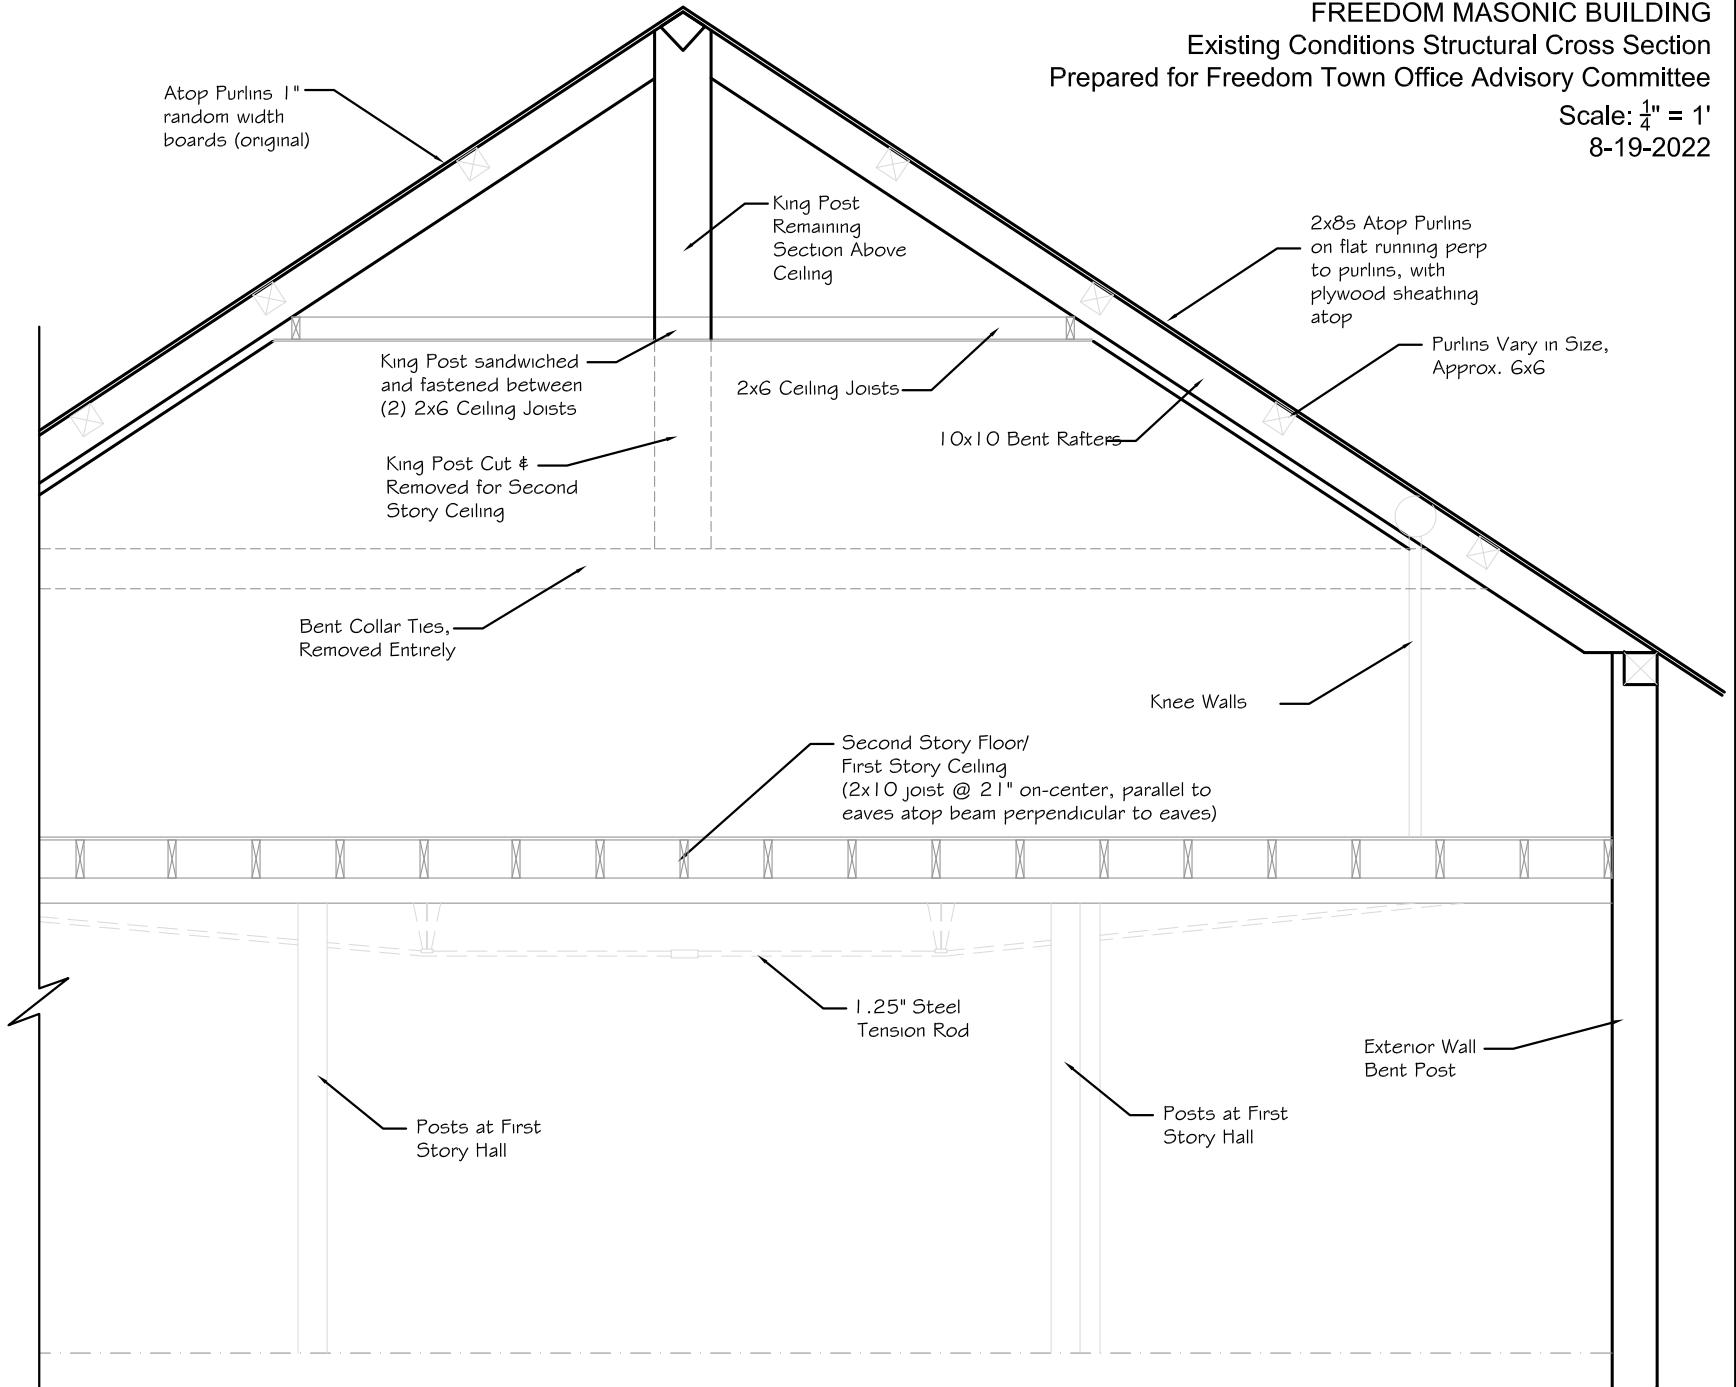
Cross Section View Looking To North Gable Wall

FREEDOM MASONIC BUILDING
Existing Conditions Structural Cross Section
Prepared for Freedom Town Office Advisory Committee
