**HISTORIC BUILDING ASSESSMENT  
FOR  
FREEDOM TOWN OFFICE**

**33 OLD PORTLAND ROAD  
FREEDOM, NH**

PREPARED BY: BETH MILLER, RA LEED AP, OF NORTH COUNTRY ARCHITECT

DRAFT ISSUED 12/15/2025

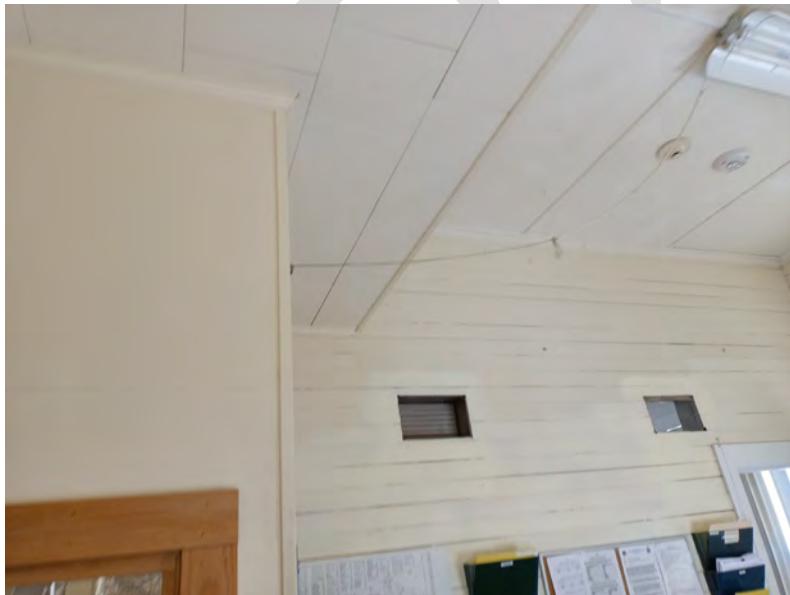
Figure 59: View of complex multi-level dropped ceilings in Tax Collector's office, to be investigated in future renovation

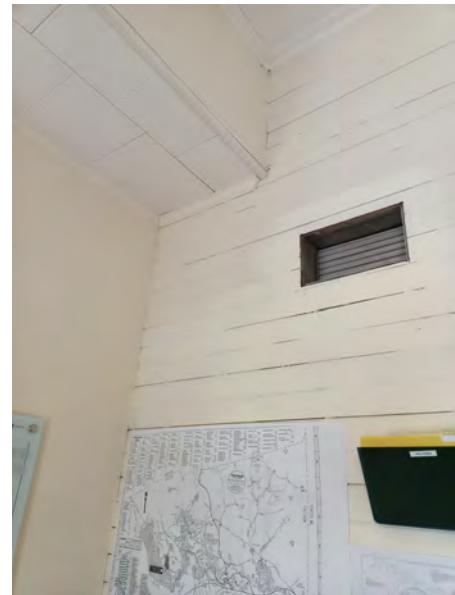
Figure 60: View of complex multi-level dropped ceilings in Tax Collector's office, to be investigated in future renovation

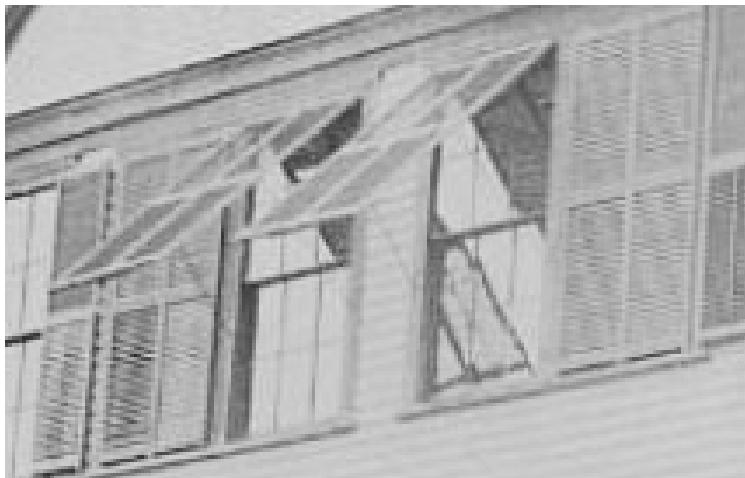
Figure 82: Original shutters

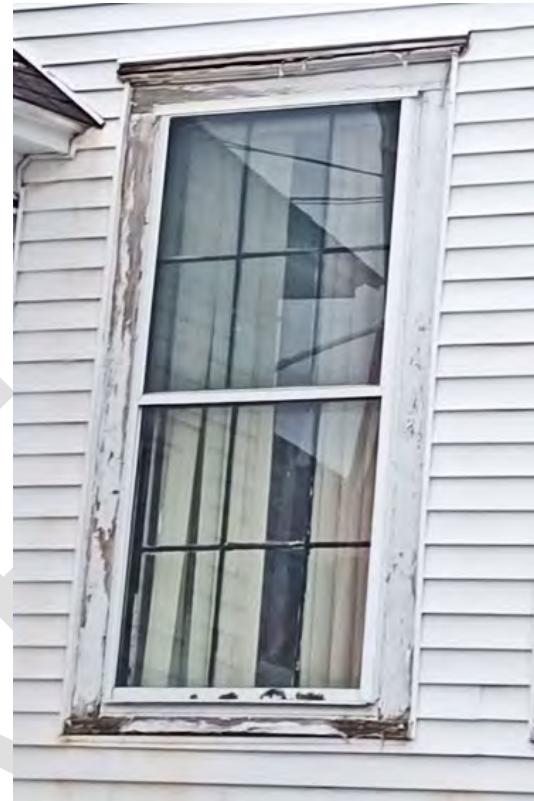
Figure 83: Typical original (1895) 6/6 double-hung window

The building has nearly all of the original 6/6 double-hung windows intact and the Town is eager to preserve them. It is recommended to begin rehabilitating the windows in batches, starting with the first floor sash and trim which are more deteriorated. The south, east, and west facades originally had shutters, which should be replicated ideally. Exterior storm windows should be updated and interior storm windows and treatments to mitigate solar heat gain considered.

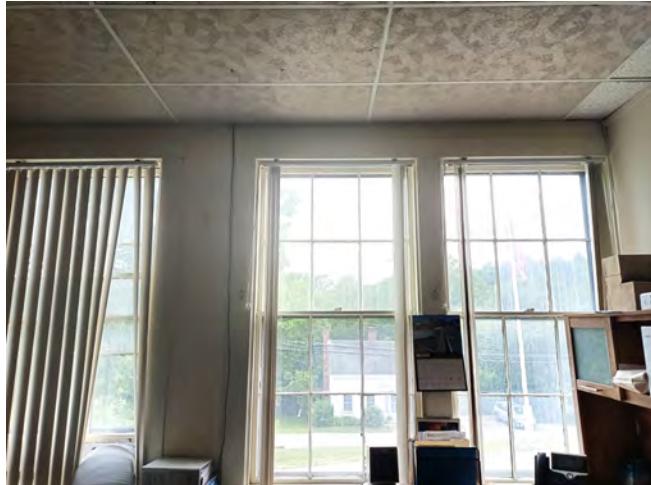
Figure 88: First floor office features outdated textured acoustic tile suspended ceiling and vertical blinds, which are not ideal for south windows.

The first floor interior finishes have, with the exception of the stair, been obscured with modern carpeting, drywall, and suspended acoustic tiling. The original ceiling finish is reportedly intact above the tiling. The Town may consider removing all modern finishes to reveal and preserve the original wood flooring and beadboard.

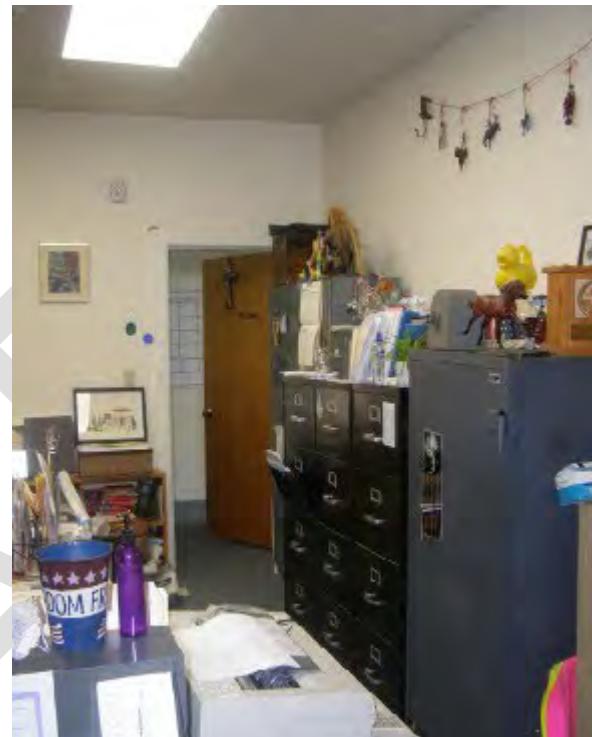
Figure 89: First floor office – Drywall, suspended ACT, carpet, fluorescent lighting

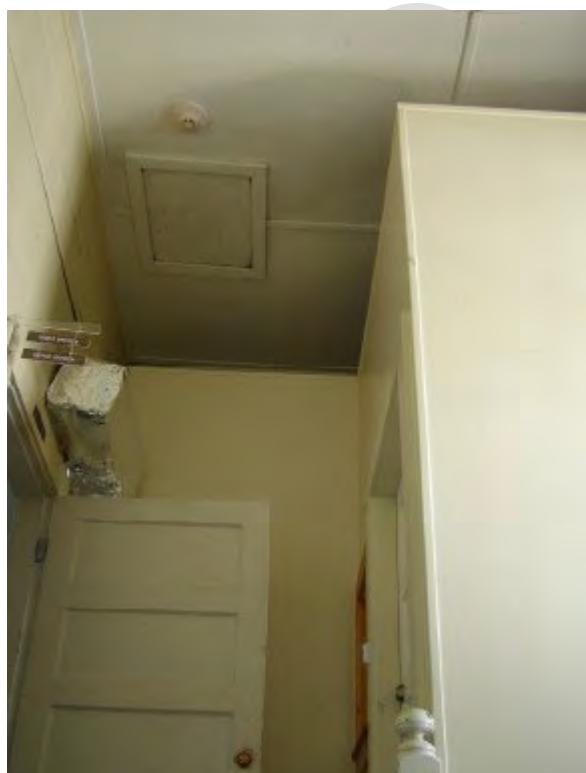
Figure 90: Second floor stair hall, drywall and board ceiling

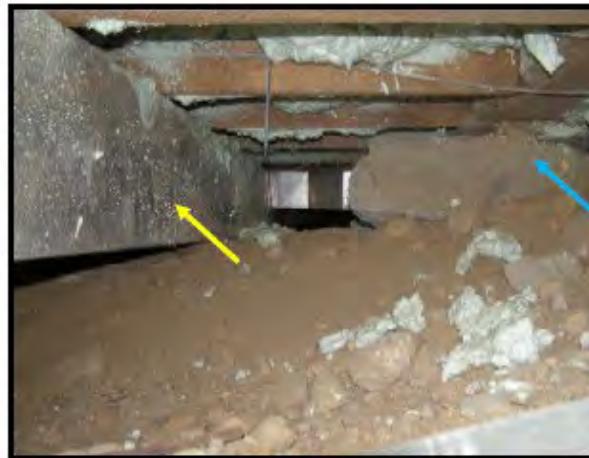
Photo of the first floor system taken from the crawl space. Blue arrow indicates a stone support. The yellow arrow indicates metal distribution ducting for the oil furnace.

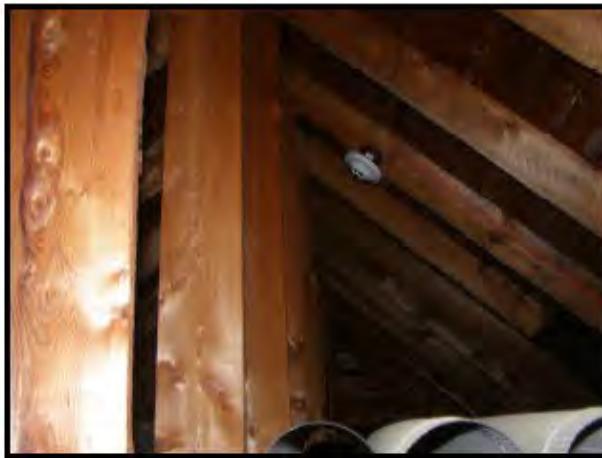
Photo of the attic above the original schoolhouse section of the building.

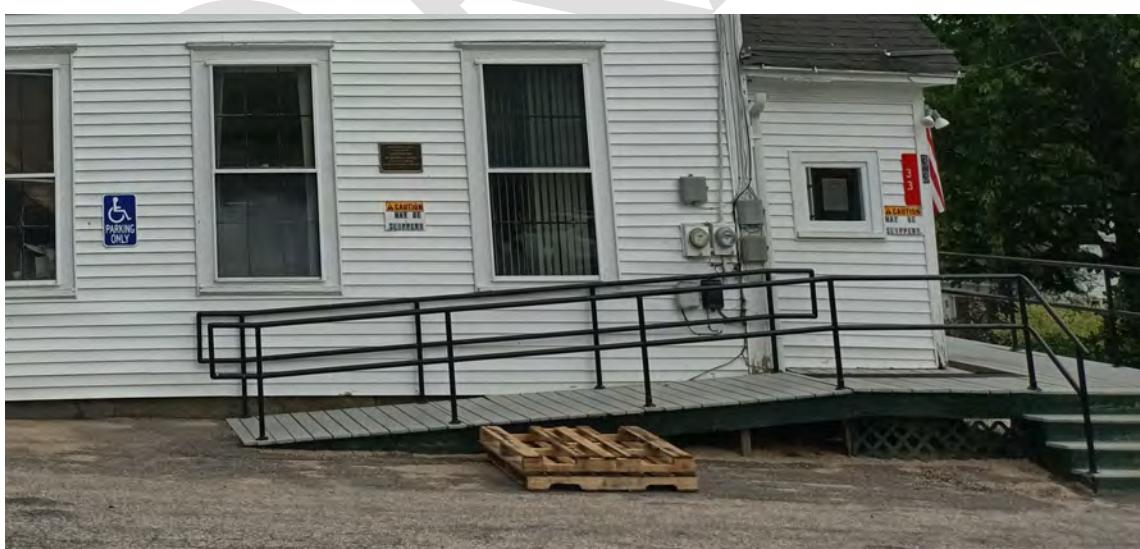
An accessibility ramp was installed in 1992 leading to the front porch and entry vestibule. Entry doors openings were also widened and doors replaced. While the ramp appears to be in good condition and the doors themselves are compliant, the entry vestibule door approach clearances do not comply with ADA guidelines. If the building is to be fully renovated, it is recommended to consider a new accessible entrance at the northwest corner of the building, at grade, where no ramp would be required.

Figure 100: Existing entry with accessible ramp

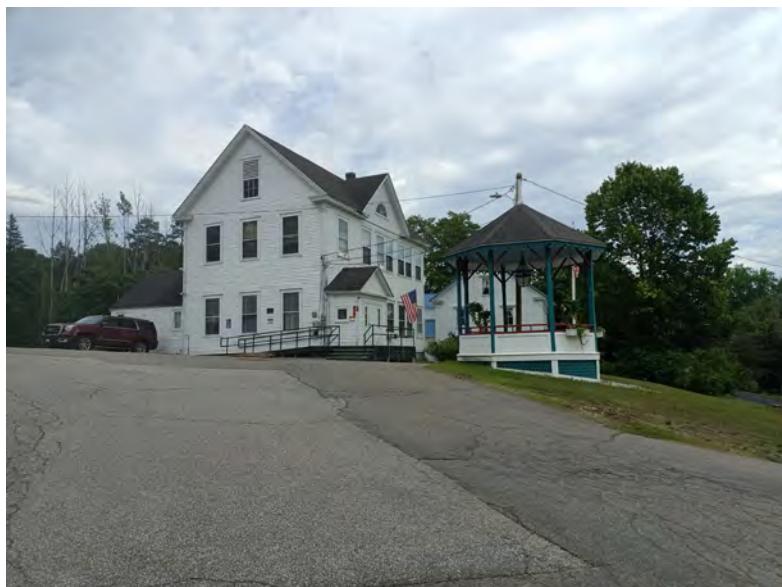
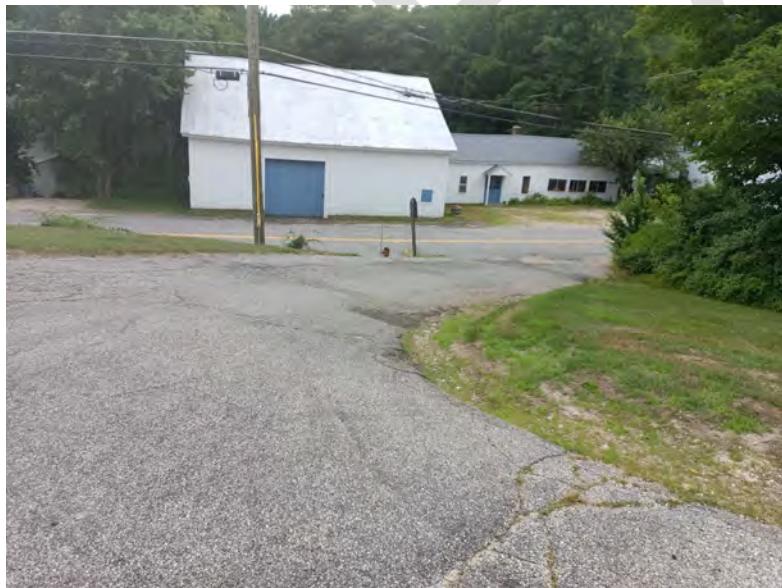
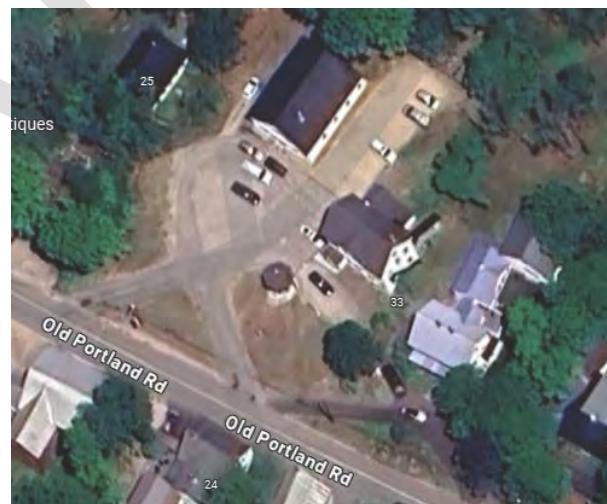
The looped, steeply-sloped driveway is considered a character-defining feature of the site – aptly named Schoolhouse Hill. Accessing the Hill in winter, and parking any time of year, can feel precarious. The parking layout should be formalized, perhaps with a parking plan for regular staff work days and a special parking plan for events. Parking for staff, and at least one accessible parking spot, should be dedicated and marked as separated from parking for the general public. Signage should be installed directing public to alternate parking nearby in the case that dedicated parking fills up.

Figures 101-103: Views of steeply-sloped, looped driveway and parking

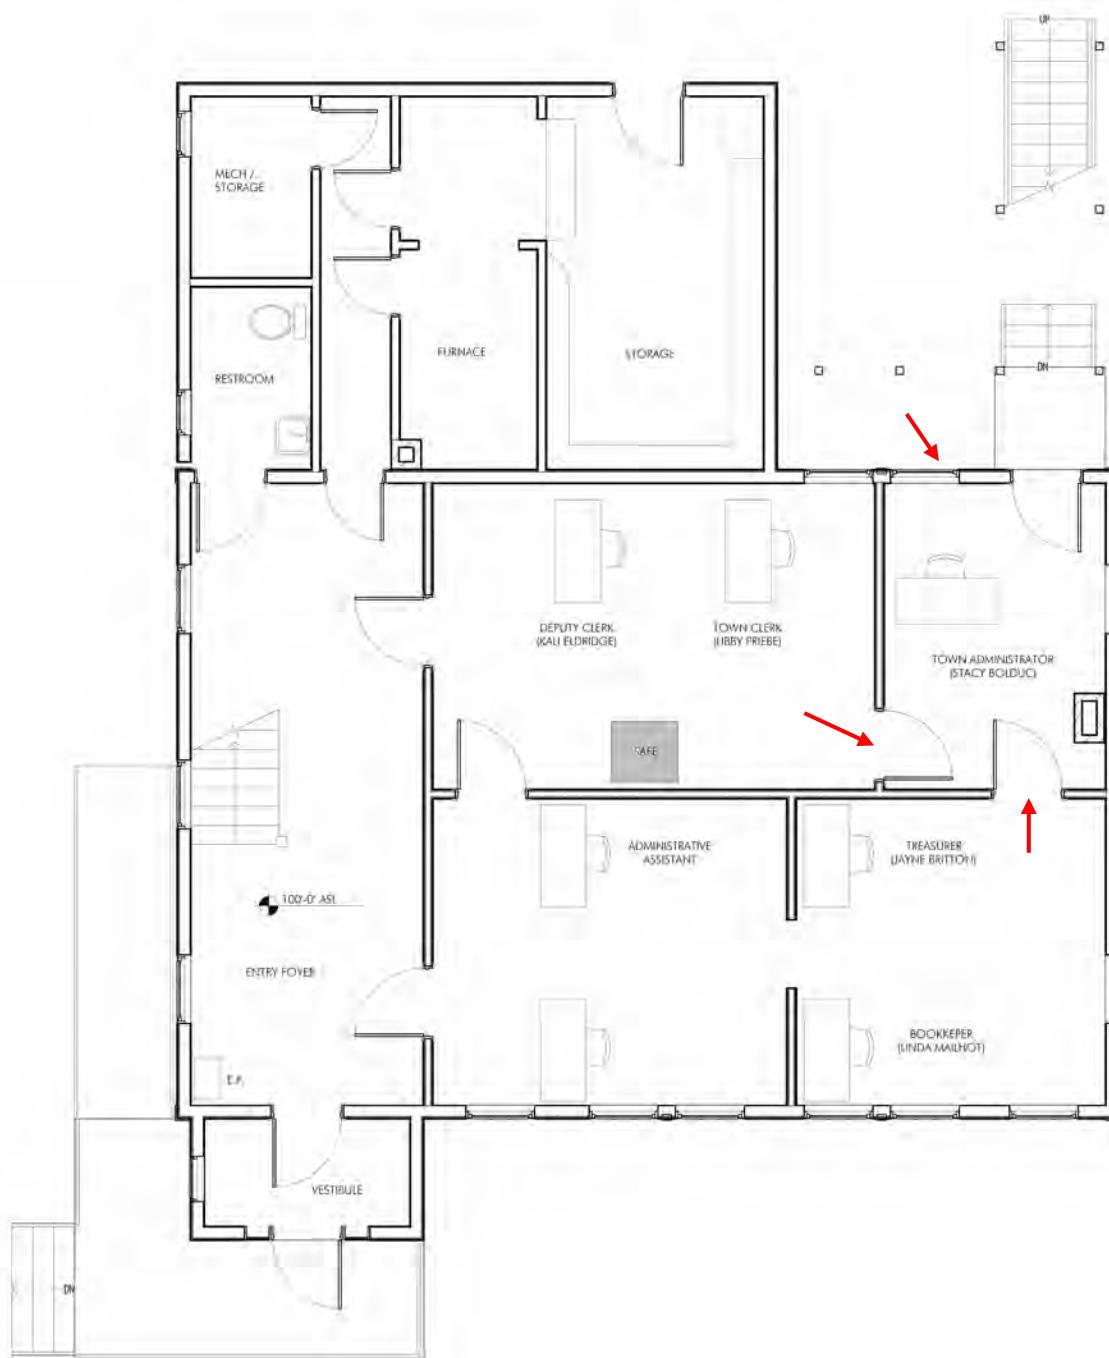
The rear exterior egress stairs were constructed in the last few years. In order for the first floor egress to be compliant the two interior doors leading to the exit must be un-lockable (see Fig. 105). Both interior exit doors should be equipped with panic bars and closers. Further, per IBC 705.8 there cannot be unprotected (windows without safety glazing, etc.) within 3-feet of an exit stair. Due to the historic status of the building, the Authority-Having-Jurisdiction is to make a determination on the above. The building is equipped with a fire alarm system, which should be tested regularly. There is no automatic fire suppression system and none is required. Detectors should be tested regularly.

Figure 105: First Floor plan - Rear egress

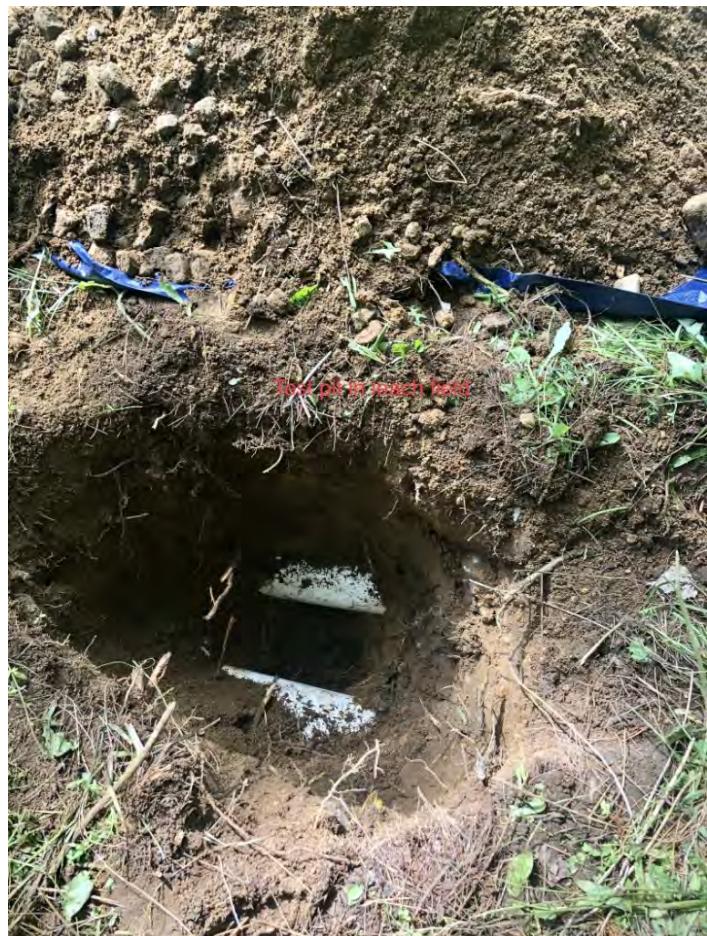
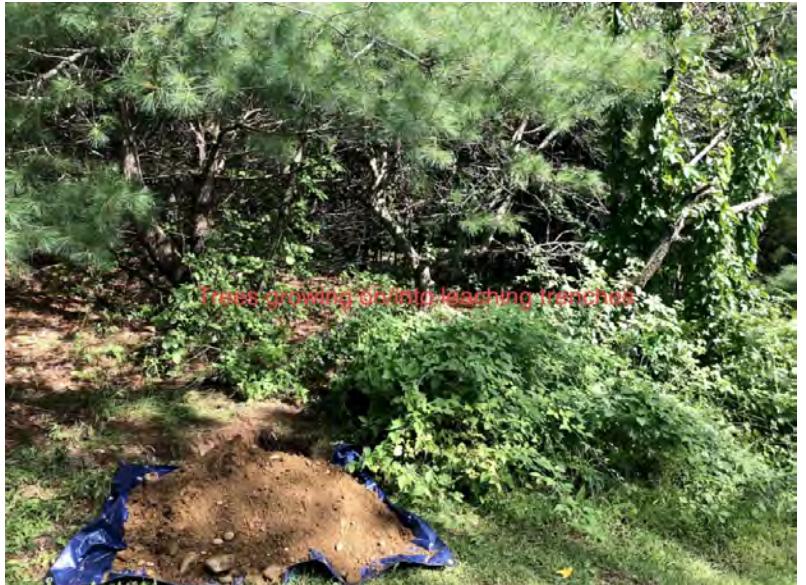
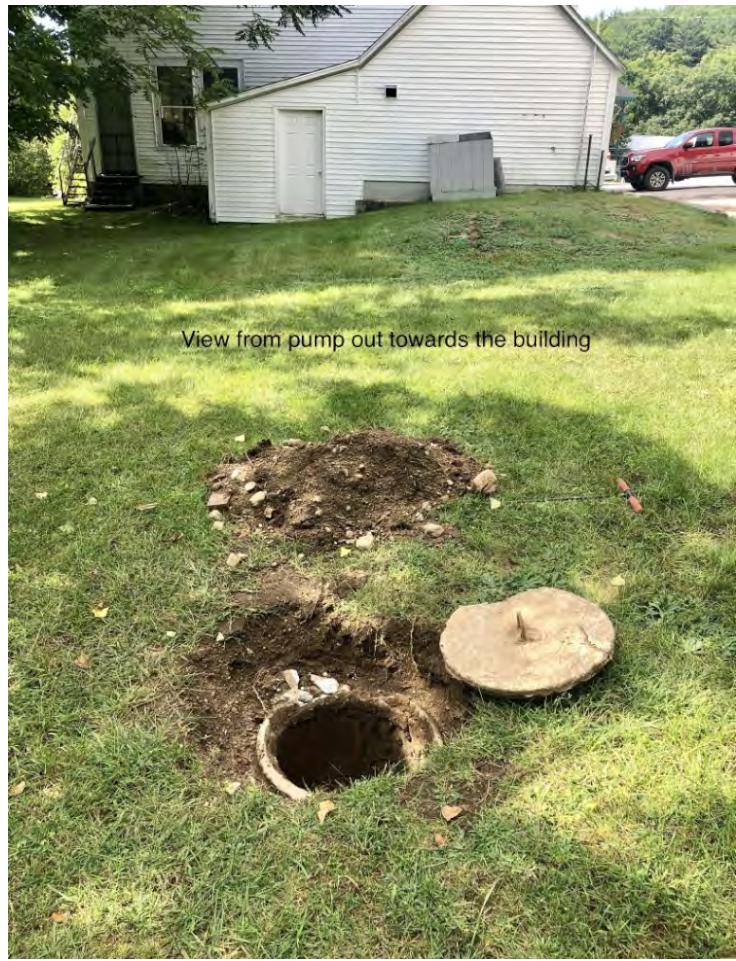
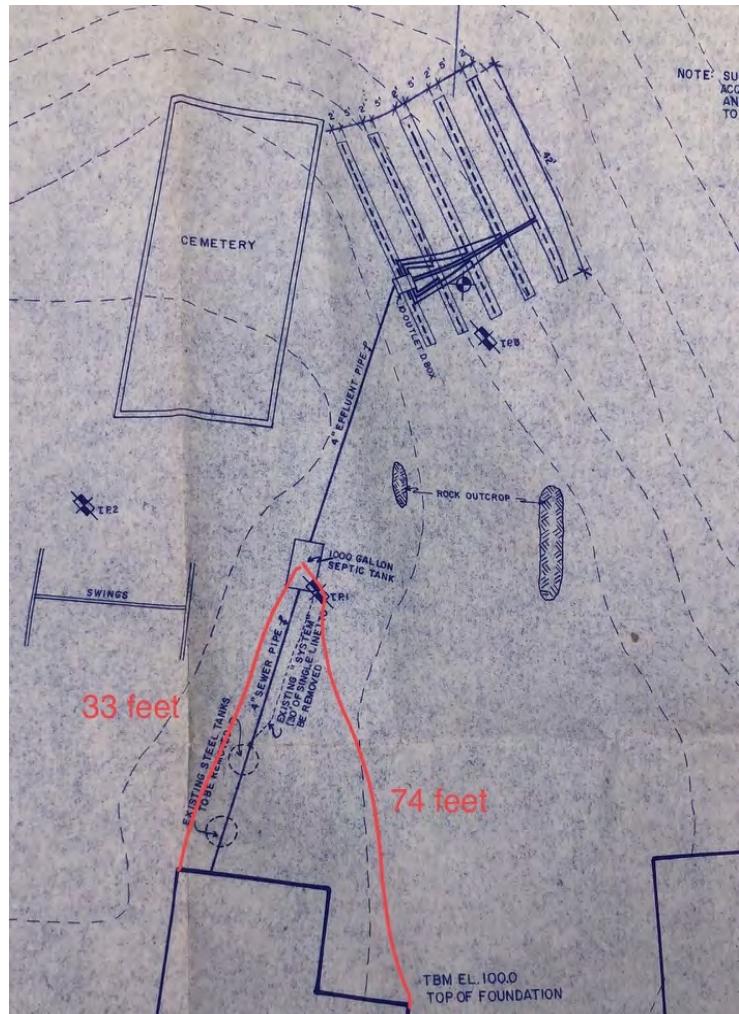
septic system appears in working condition. septic tank was pumped prior to inspection, so system could not be loaded for perc test.

trees in/above leach field should be removed, and Root Kill applied
